Draft Louth County Development Plan 2021-2027

No 18. Ship Street

Condition Report No.18 Ship Street.

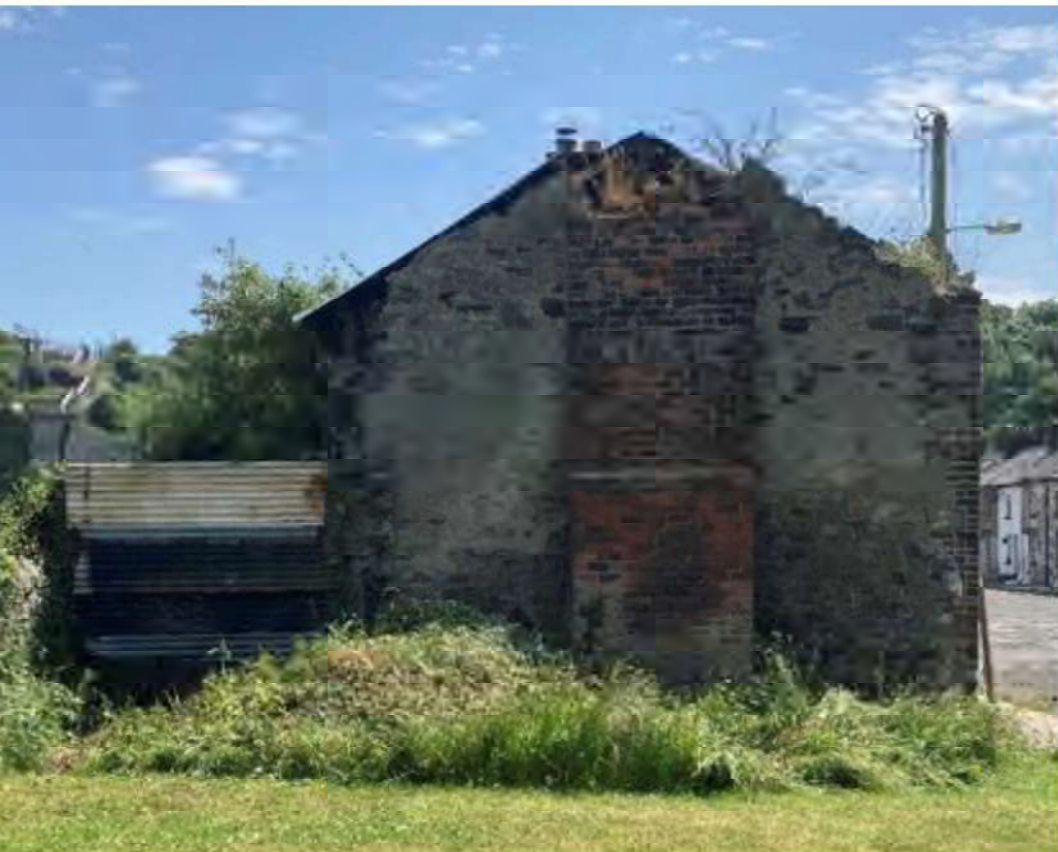
Plate 2.1 Side Elevation (North)

Side Elevation- The gable wall is constructed in stone, with a lined render and is in poor condition. A large brick chimney stack has partially collapsed at the top with the loss of the clay pots and the upper brick courses. The brick stack has a significant crack along the west joint. The corner to the west has also collapsed and a shrub has rooted within the stone core with further vegetation along the gable. A voussoir brick-arched opening with cast-iron head is bricked up at first floor and at ground level the chimney opening has been partially reconstructed.

The external walls should be inspected by a structural engineer prior to the works being undertaken to address the structural cracks within the rear wall and chimney and the lack of restraint between the external walls and the internal party walls causing bulging at each party wall to the eastern terrace. A suitable helifix system should be designed by a qualified structural engineer.

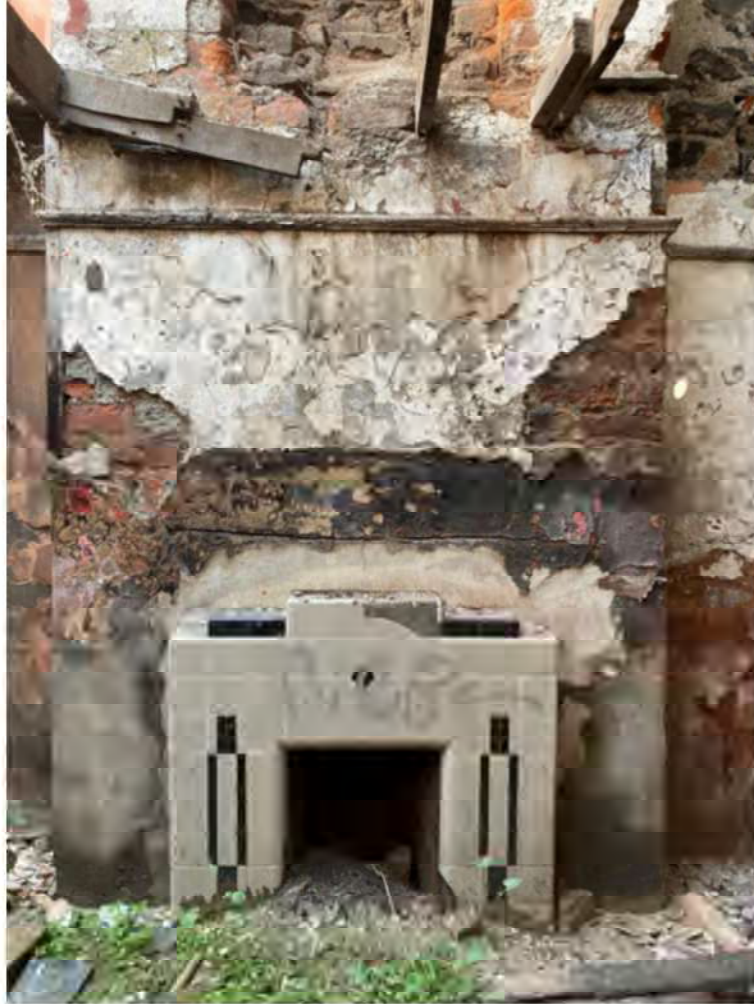
*Plate 0.3
North wall showing: the chimney breast with 1950's art deco ceramic tile fire surround; lime render over brickwork at upper level, timber moulded picture rail under collapsed timber first floor structure*

Fireplaces: The 1950's art deco style ceramic tile fire place should be retained.

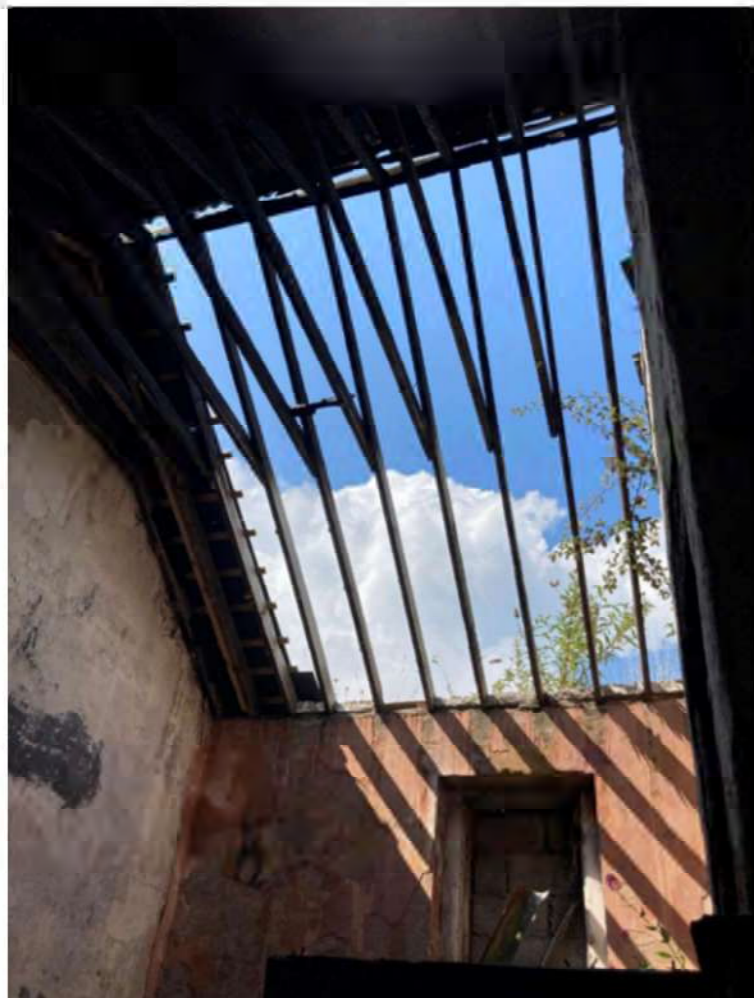
Condition: The roof cladding is lost, has been partially replaced to the east side with corrugated metal sheeting and is open to the elements on the west side. The roof structure consists of 11 No. timber rafters with collar beams charred by fire. The charred remains of the timber purlins with felt to the east slope are still extant. Within the rubble at ground floor level, the following remnants are found: 600mm Bangor blue slates; 150mm clay ridge tile; 115 Ø half round cast iron gutter.

*Plate 0.6
View towards west slope of roof showing; charred timber trusses with collared beams; vegetation at eaves level; boxed timber sash window frame within blocked up opening; gypsum plaster over cement render to front wall*

The structure should be inspected by a structural engineer to support the following recommendations. The roof structure within 1.5M of the adjacent dwelling to be retained for structural support and historic record. The remainder of the charred structure to be removed and a new treated timber structure should be installed to match the existing @300mm centres to a structural engineers design. A new slate roof should be installed by an experienced heritage roofing contractor as follows:

- 600 x 300 x 9mm Welsh Penrhyn Bangor Blue Slate or equivalent (conforming to I.S 12326-1) with an 80 year min warranty should be fixed using 2 jagged shank copper slate nails, 3.5mm thick longer than two thickness of slates to;
- 50 X 25MM treated timber battens on;
- Breathable membrane, Proclima Solitex plus or equivalent with;
- Insulation to consist of two layers of breathable insulation, gutex wood fibre (0.036W/(mK)) to an overall thickness of 135mm (depth of rafters) with;
- New lath plaster ceiling / 15mm plasterboard ceiling;
- Roof Ventilation to be provided by means of inline compact slate roof ventilators at 1m centres to the rear pitch of the roof.

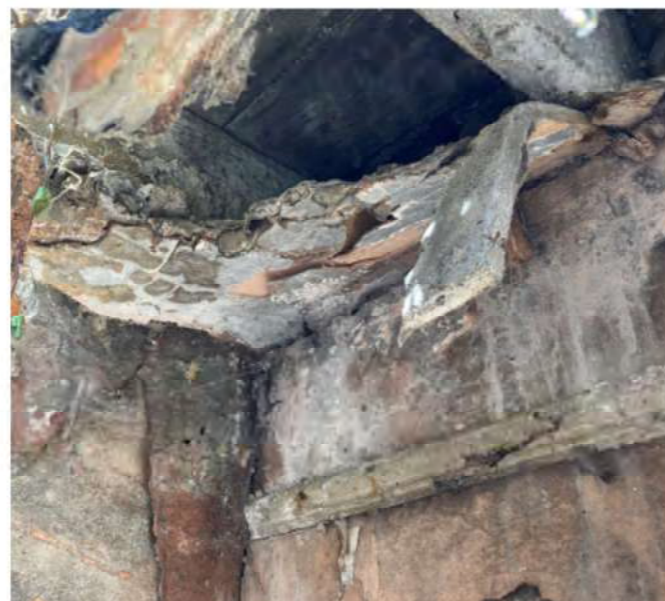
*Plate 0.15
View of moulded timber picture rail and remains of later plasterboard ceiling*

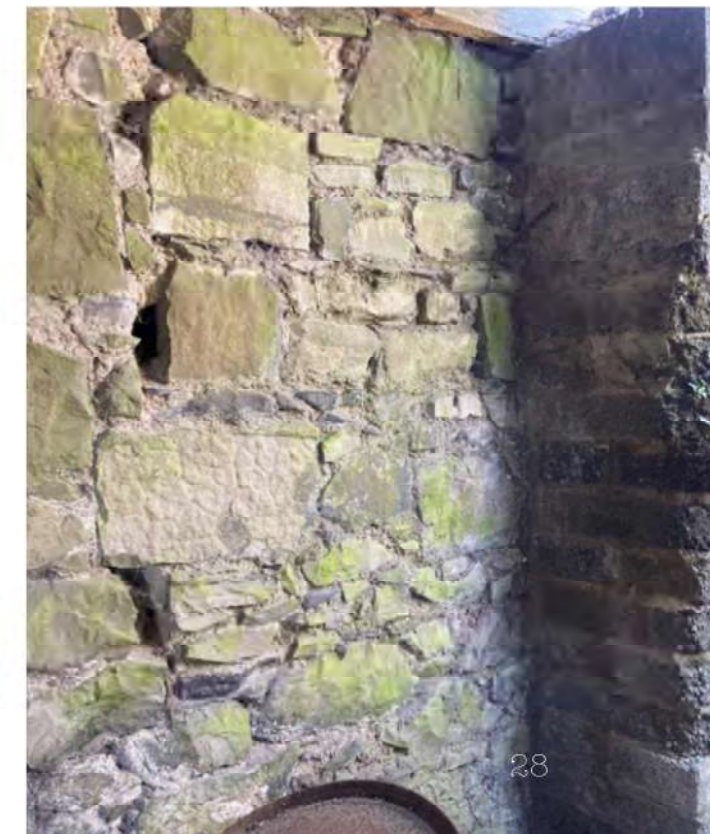
Rear Elevation- A large structural crack has formed in the north-west corner exacerbated by vegetation roots.

*Plate 0.12
View of rear stone wall within covered yard showing the extension of crack to base of wall with large openings within structure*

The north east corner of the structure to be dismantled as required by structural engineer to facilitate the removal of the embedded root system and repair of the large structural crack in this area. A sample of the core to be analysed for record. The wall to be reconstructed in limestone with lime pointing. The window and door opening to be repaired in brick. Samples of brick and limestone to be approved by Conservation Architect. The covered yard area to be fully demolished to allow for a suitable extension to the rear of the structure to provide kitchen and sanitary facilities.

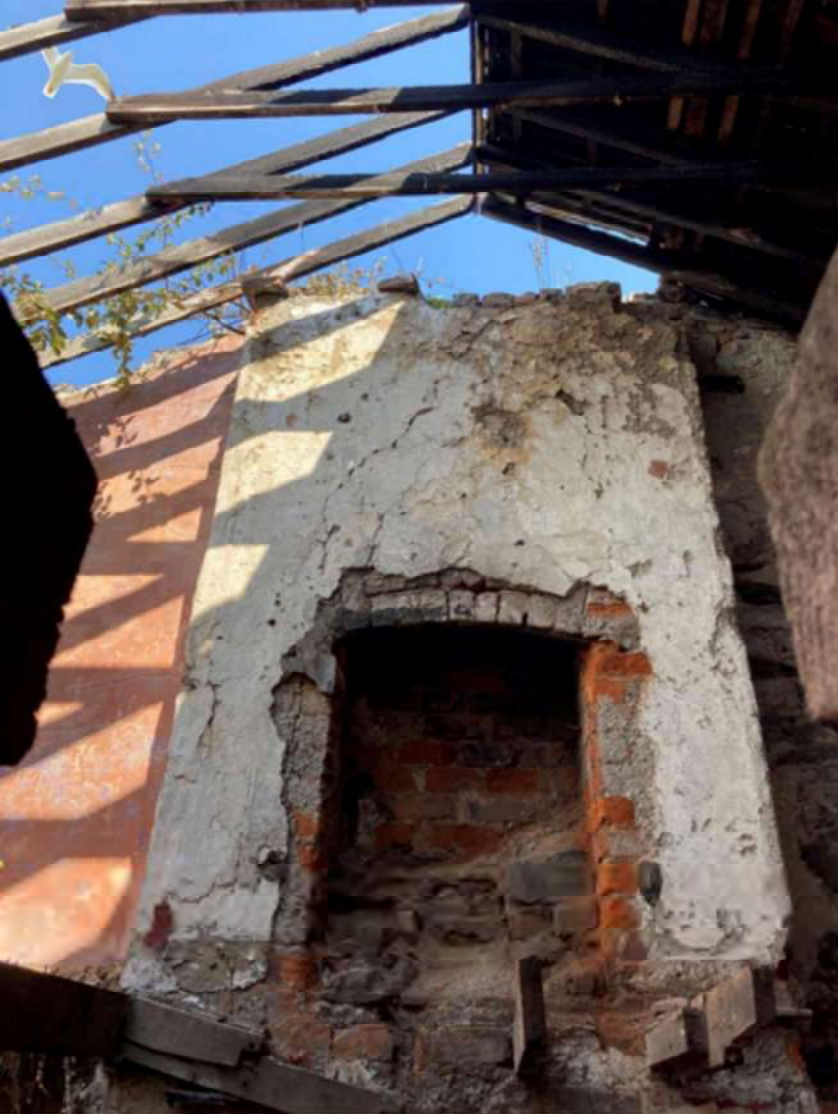
Plate 0.4
North wall showing: the chimney breast at upper level.

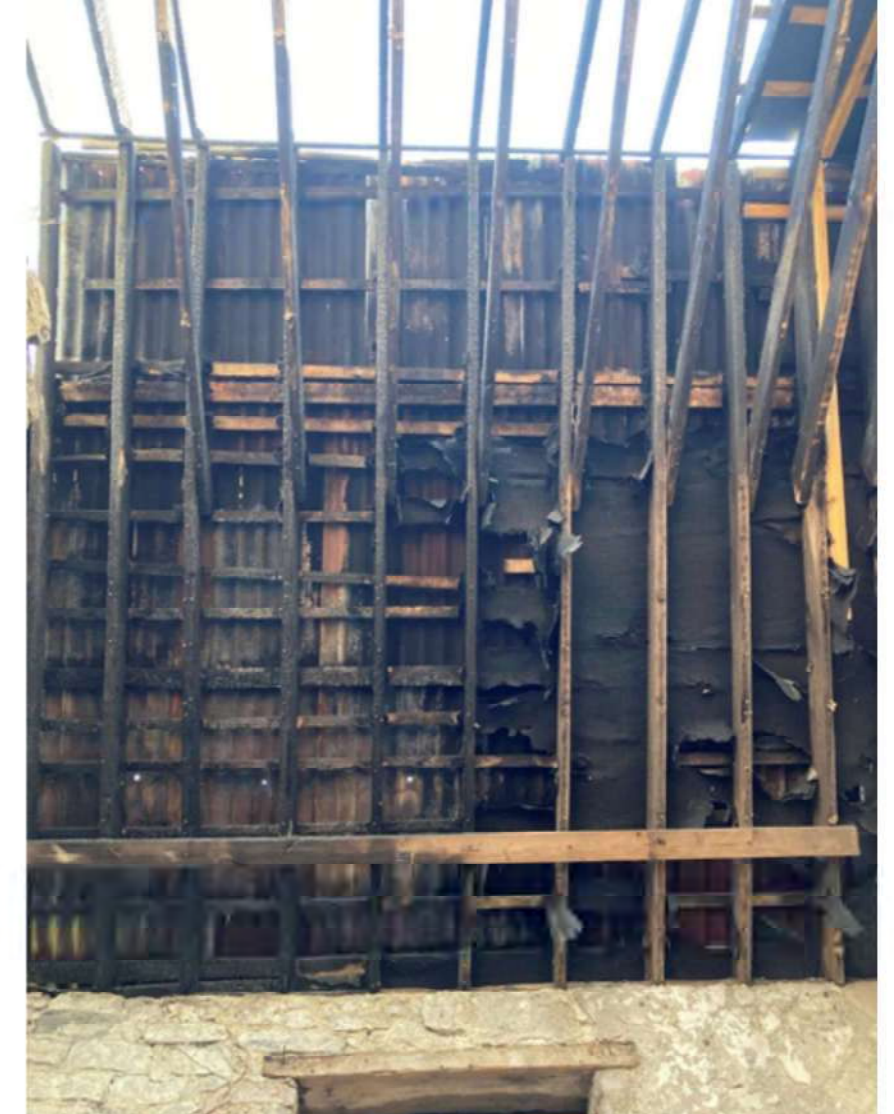
Plate 0.7
View towards east slope of roof showing; charred timber trusses with collared beams; charred timber purlins and felt with corrugated sheeting over; timber head to first floor window.

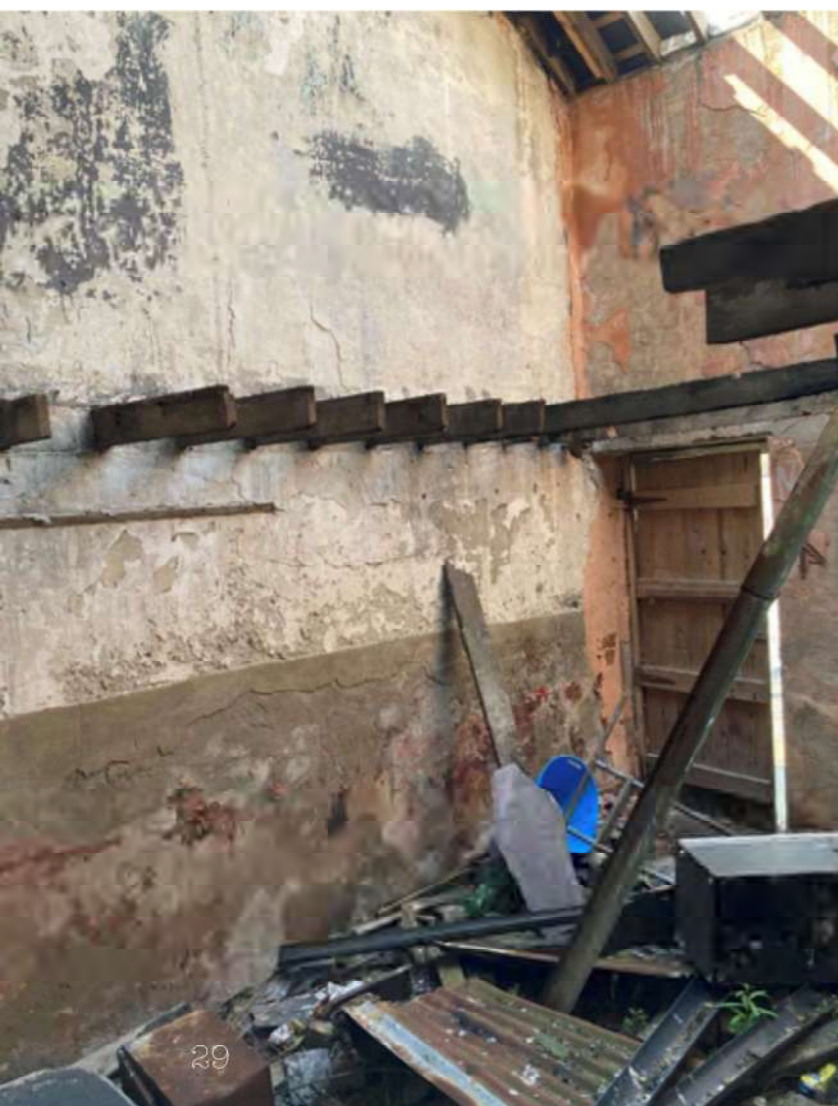
Plate 0.5
South separating wall showing: liquid tanking membrane over lime plaster at lower level; collapsed timber first floor structure; half round cast-iron gutter within rubble.

Walls: All gypsum plaster to be removed. Existing sound lime plaster to be retained. The base of the external walls up to 1M in height should be plastered in a cork infused lime plaster with high dehumidifying capacities such as Diathonite Deumix. This product consists of a mix of clay, diatomaceous earth and NHL 5. At a higher level, a NHL 2.5 lime plaster or cork infused lime plaster with less strength to be applied in accordance with suppliers' recommendations. The thickness will be determined by the overall BER required and renewable solutions provided by M&E engineer.

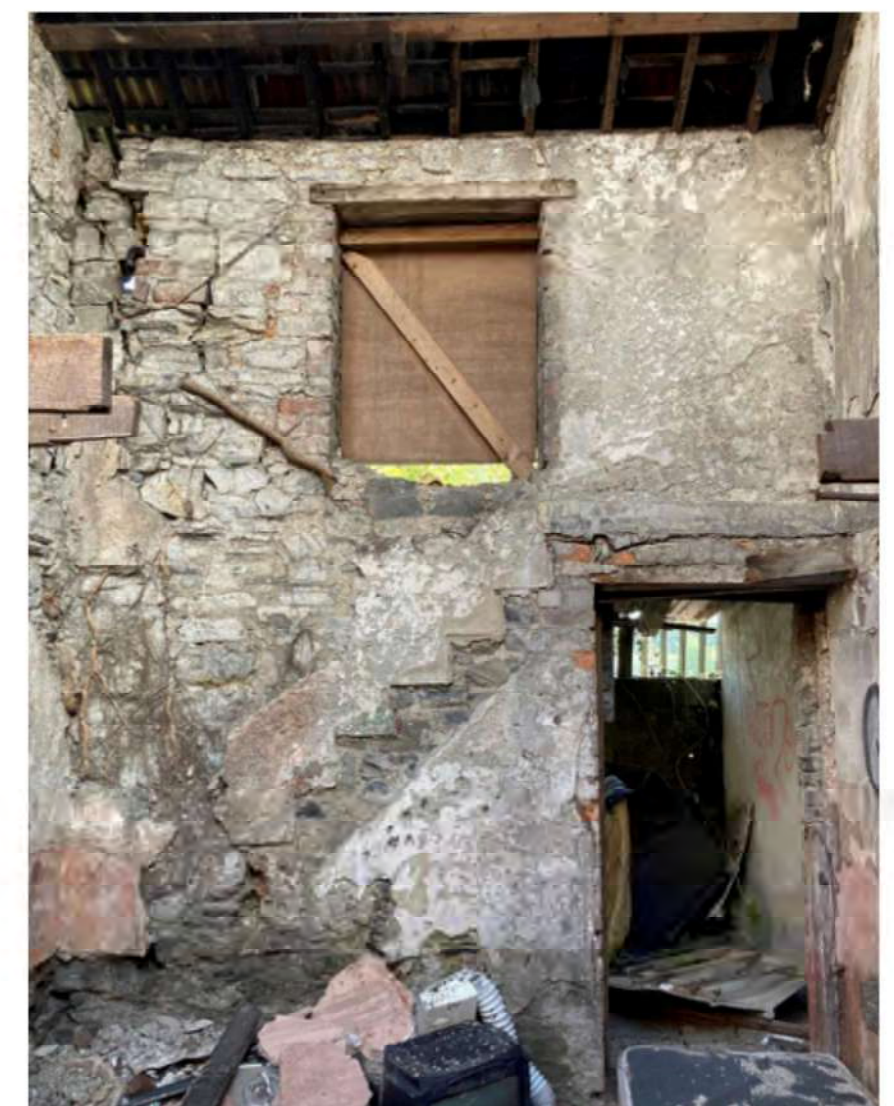
Plate 0.8
View towards east wall showing; significant cracks in north-east corner; root system within wall structure in north-east corner; outline of timber stairs in lime plaster; openings formed in red brick; timber heads to door and window; gypsum plaster at lower level to north wall and lime plaster to rear wall; windows and doors are lost.

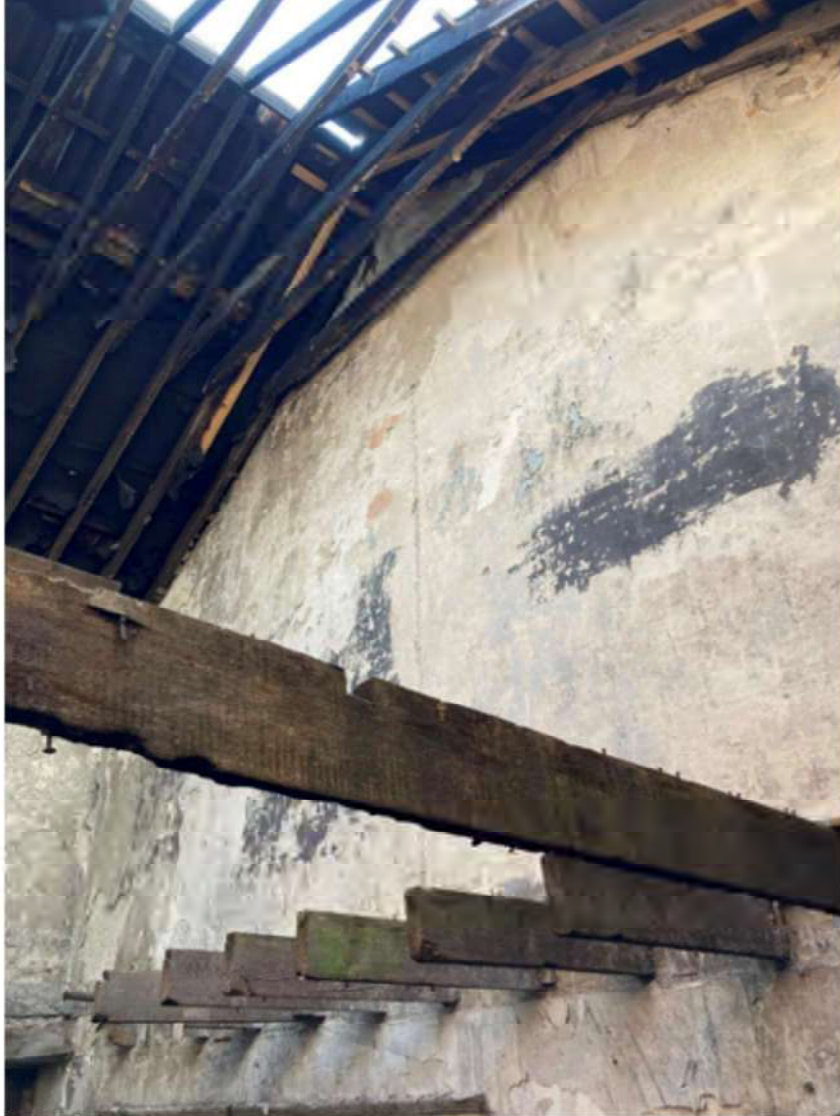
Plate 0.9
View towards ridge showing; charred rafters with collar beams covered to the east with corrugated iron and open to the west; A rafter along the party wall has been sistered and new timber purlins have been laid to provide support to roof cladding of adjacent building.

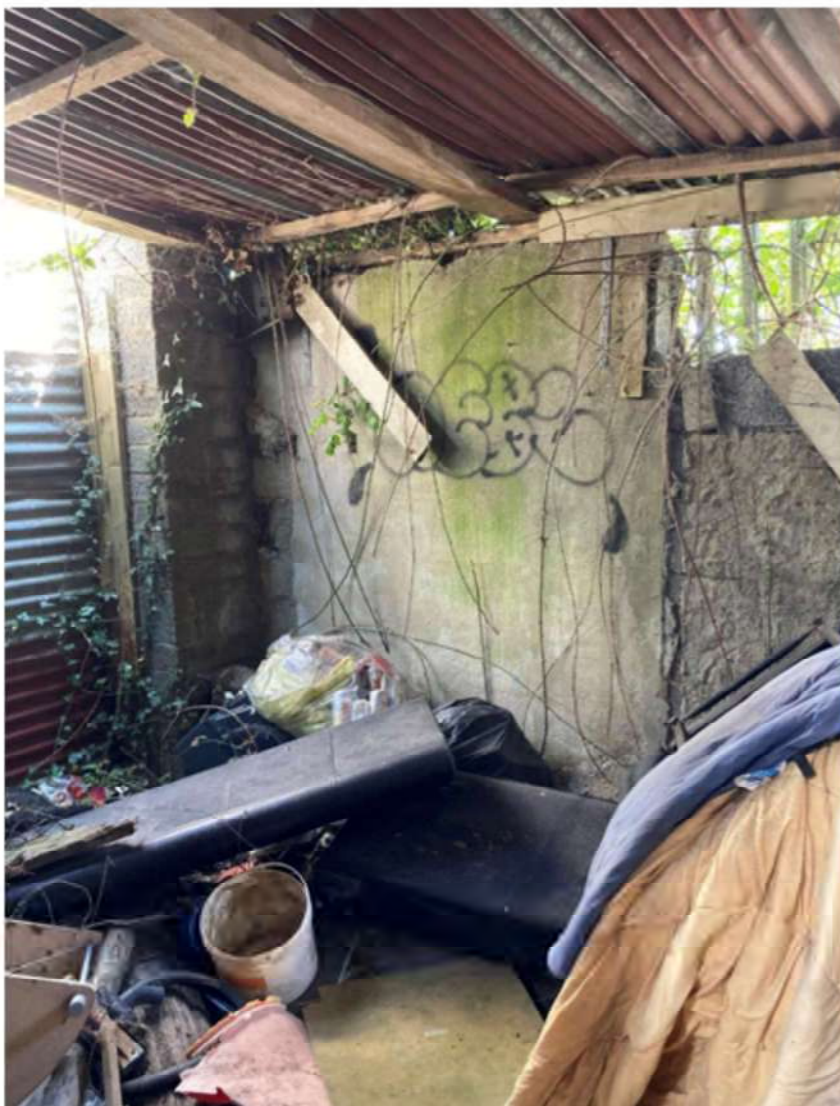
Plate 0.11
View within covered yard: Walls are constructed in a mix of stone, concrete block and corrugated metal cladding; a crude corrugated roof structure covers the yard.
