Submission to Draft Louth County Development Plan 2021-2027

BOYNE COTTAGE CONSERVATION APPRAISAL

**Conservation Appraisal
in respect of
Protected Structure Designation
of
Boyne Cottage
Cord Road
Drogheda
Co. Louth**

Architectural Inventory and Photographic Survey - Boyne Cottage

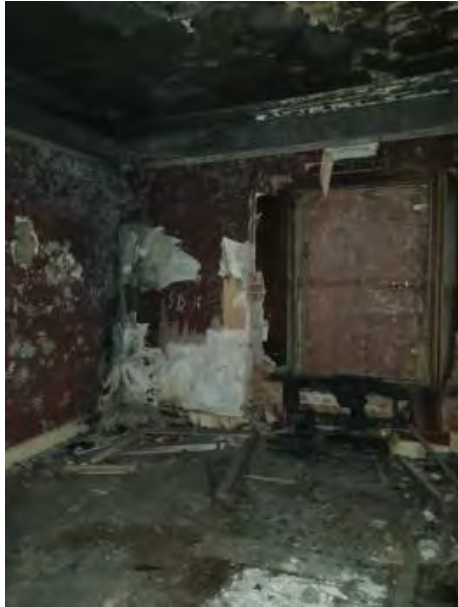
<p>GF Living Room (east)</p>

<p>Lath and plaster ceiling, decorative cornice in very poor condition Fragments of window casings (architrave) Lime plastered walls in poor condition. T&G floorboarding on suspended timber floor part decayed No fire surround</p>	<p>Fire damaged and in very poor repair.</p>
<p>GF Living Room (west)</p>

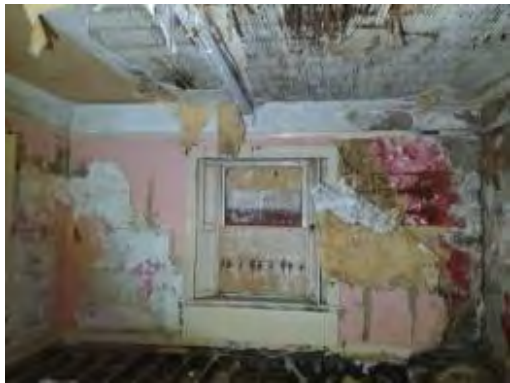
<p>Lath and plaster ceiling, decorative cornice in partial collapse. Cross beam inserted under ceiling. Window casings Lime plastered walls in poor condition. T&G floorboarding on suspended timber floor in partial collapse.No fire surround</p>	<p>In very poor repair.</p>

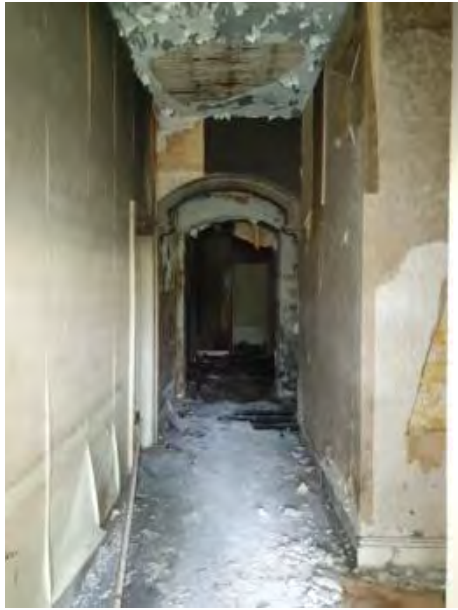
<p>GF Hall</p>

<p>Lath and plaster ceiling, in partial collapse. No cornice. Lime plastered walls Decorative plaster arch on brackets. Door architrave, lining and skirting board.</p>	<p>In very poor repair. Contains fireplace core of earlier cottage.</p>
<p>GF Porch</p>	<p>Lath and plaster ceiling Lime plastered walls Window casings.</p>	
<p>Stair hall</p>

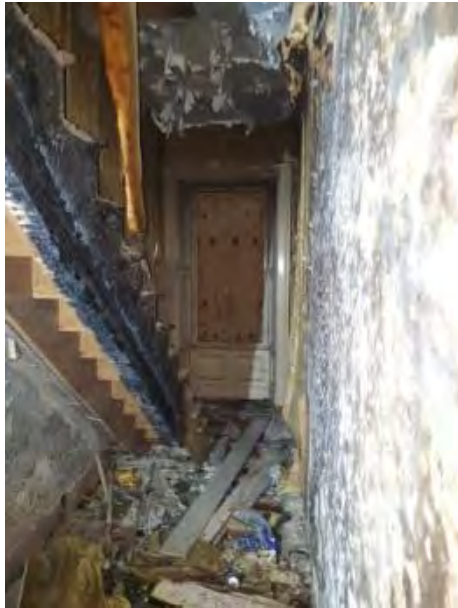
<p>Lath and plaster ceiling in partial collapse. Window casings Lime plastered walls in poor condition. T&G floorboarding on suspended timber floor in partial collapse. Stairs fire damaged, no balustrade.</p>	<p>In very poor condition. Stairs unsafe and beyond salvage.</p>

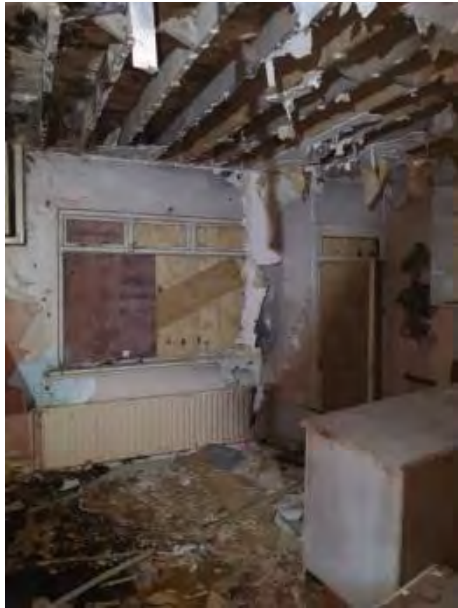
<p>GF Kitchen</p>

<p>20thC extension Gypsum plastered walls. Plaster slab ceiling collapsed. 20thC softwood windows and internal joinery.</p>	<p>In poor condition.</p>
<p>GF Back Room (north)</p>	<p>20thC extension Gypsum plastered walls. Plaster slab ceiling collapsed. 20thC softwood windows and internal joinery.</p>	<p>20thC of yard. In very poor condition containing no original material.</p>
<p>First Floor</p>

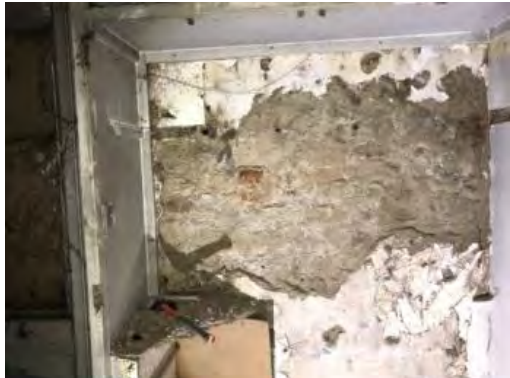
<p>3 no bedrooms and corridor to main house. Lath and plaster ceiling in partial collapse. Window casings Lime plastered walls in poor condition. T&G floorboarding on timber floor joists in partial collapse. Stairs fire damaged, no balustrade. 20thC return to rear (north) contains bedroom and bathroom in poor condition.</p>	<p>This area unsafe and inaccessible. Viewed from a distance.</p>

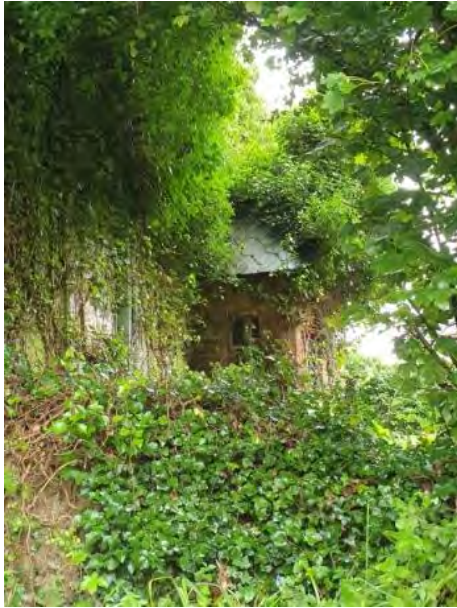
<p>Southern facade</p>

<p>Illustration from old sales brochure</p>	<p>Slated roof Timber fascias on twin masonry brackets. Walls are pebbledashed (20th C). Moulded plastered reveals to windows. Cast vermiculated quoins. Stone window cills. Replacement aluminium windows The entrance porch is in a cast terracotta brick and has a pitched roof with scalloped slates and a decorative barge. It retains its timber sliding sash windows.</p>	<p>This facade is overgrown and obscured. Information is taken from old sales brochure illustrations.</p>
---	---	--

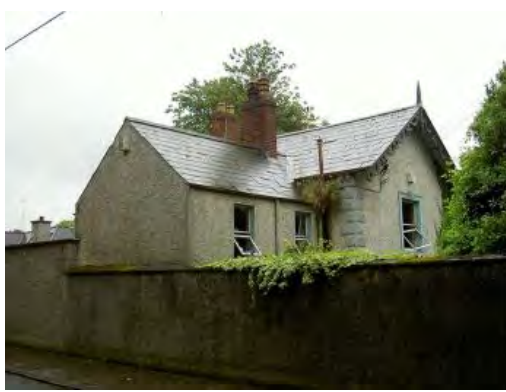
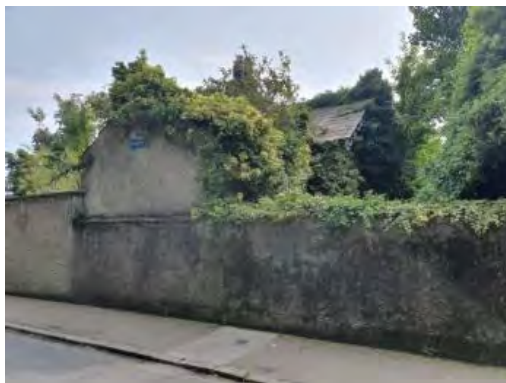
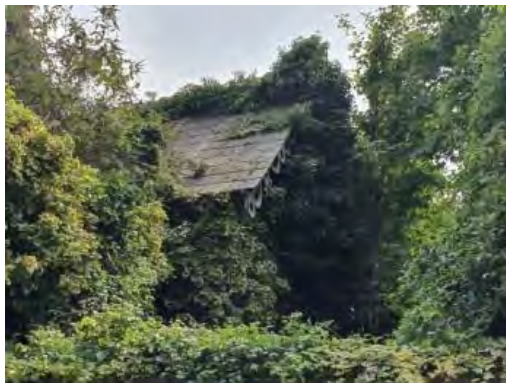
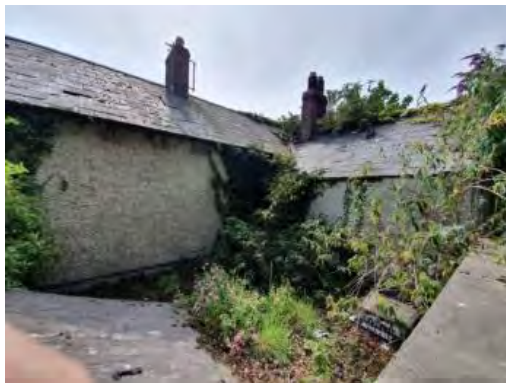
Northern Facade

Natural slate roof with rows of decorative scalloped slates. Brick chimneys. Timber fascias on twin masonry brackets. Pierced decorative barge boards to gables. Walls are pebbledashed (20th C). Moulded plastered reveals to windows. Cast vermiculated quoins. Stone window cills. Replacement aluminium windows. 20th C two storey return.

20th C single storey flat roofed garage and infill of yard.

This facade is overgrown and obscured. Information is taken from NIAH illustration.

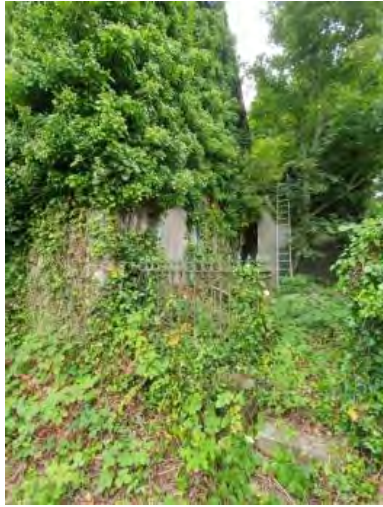
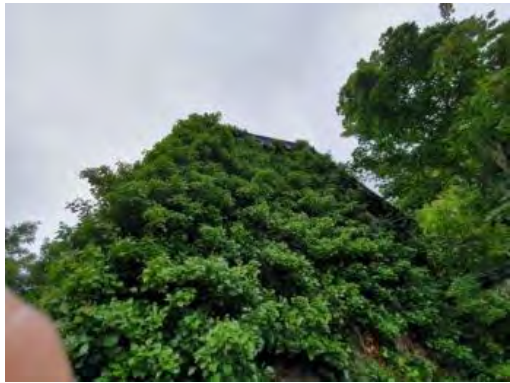
<p>Natural slate roof with rows of decorative scalloped slates. Brick chimneys. Timber fascias on twin masonry brackets. Pierced decorative barge boards to gables. Walls are pebbledashed (20th C). Moulded plastered reveals to windows. Cast vermiculated quoins. Stone window cills. Replacement aluminium windows 19th C cast iron railings on masonry base.</p>	<p>This facade is overgrown and obscured by ivy.</p>

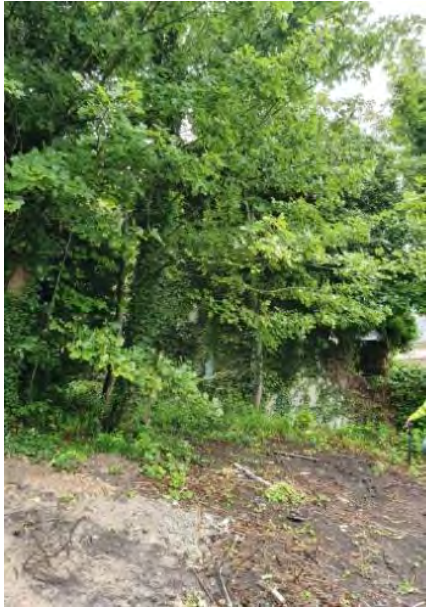
<p>Western Facade</p>

<p>This facade is overgrown and obscured by ivy.</p>
