Louth County Council

**Declaration In accordance with Part IV, Section 57 (2) of the Local Government
(Planning and Development) Act, 2000(as amended).**

REF: DB21-03
Applicant's Name: Pillardale Limited
Status: Owner occupied
Location: 8 and 9 St Laurence Street, Drogheda, Co. Louth

8 LAURENCE STREET, DROGHEDA, CO. LOUTH STRUCTURAL REPORT

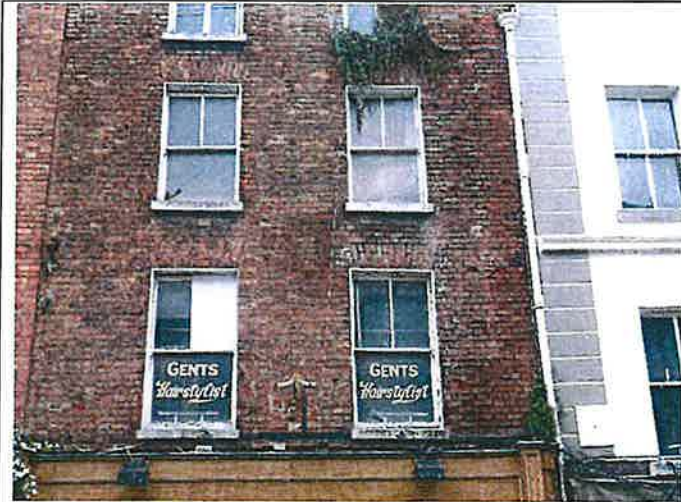
The front wall is of red brick construction. It appears to be straight with no sign of significant cracking or bulging. There are a number of areas where the pointing has deteriorated and it needs to be repointed. The Ground Floor wall is constructed as a shop front with circle steel columns evident. The make up of the head structure was not revealed.

FIGURE 1 FRONT ELEVATION REMOVE VEGETATION AND REPOINT

1. Remove vegetation and repoint the front wall.
2. Replace the rotten rafters ends and timber heads at Third Floor level.
3. Insert ridge purlin, if not present.
4. Expose the joint ends at all floors to check for rot.
5. Expose the First-Floor support mechanism for the party walls.

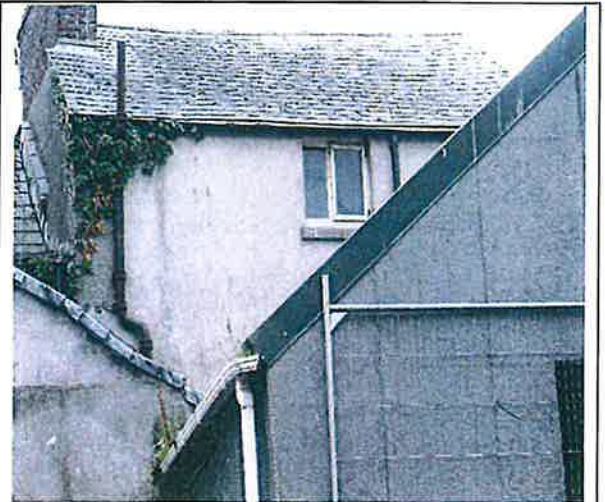
FIGURE 2 REAR ELEVATION SAG IN ROOF

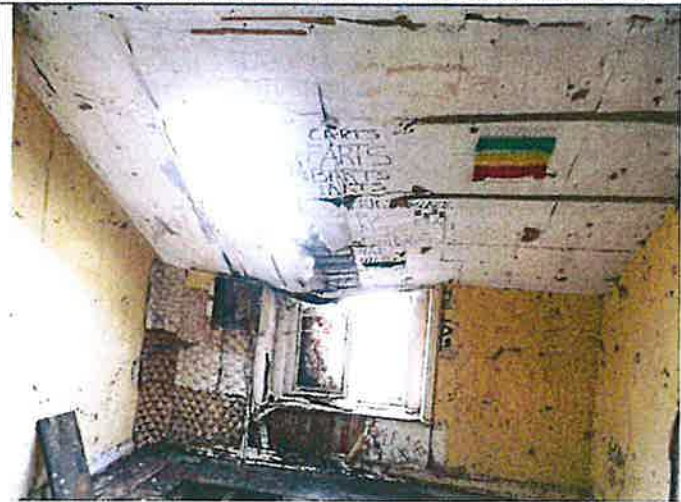
FIGURE 3 THIRD FLOOR ROTTEN RAFTERS AND HEAD

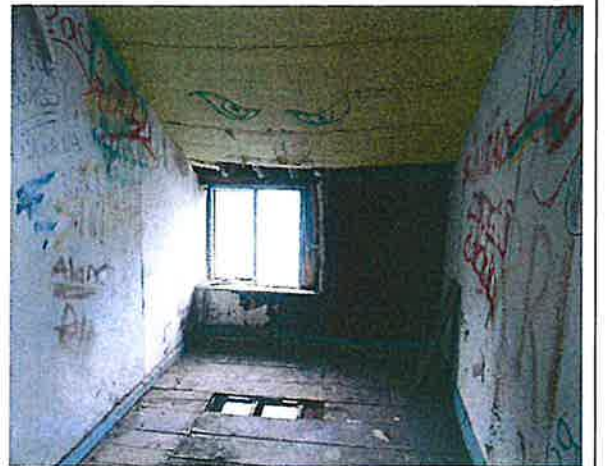
FIGURE 4 THIRD FLOOR ROTTEN RAFTERS AND HEAD

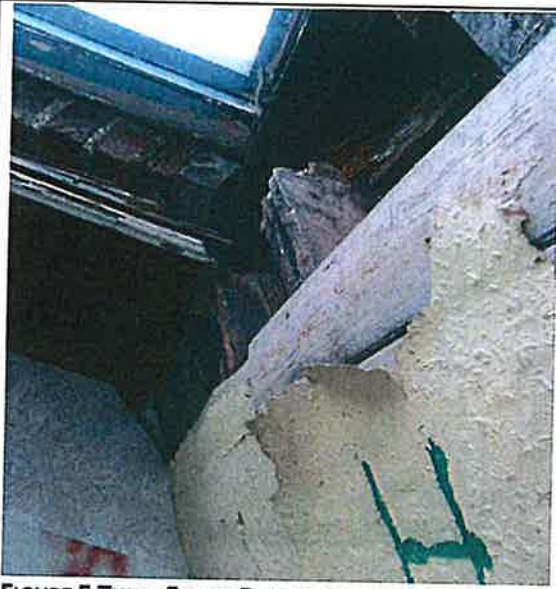
FIGURE 5 THIRD FLOOR ROTTEN RAFTERS AND HEAD

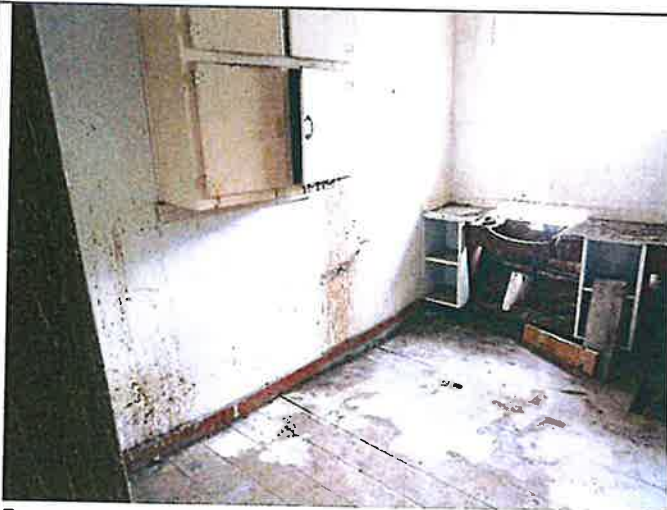
The stairs have worn threads but are generally straight and in sound condition. The floor at the stairs partition has sagged by c. 25mm at both the First and Second floors.

FIGURE 7 SECOND FLOOR PARTITION SAGGED

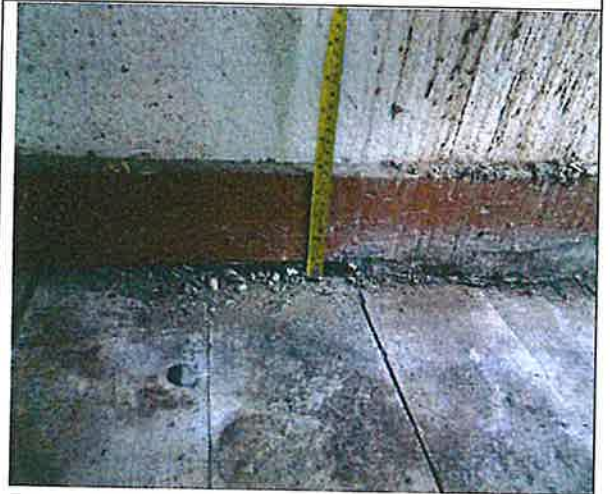
FIGURE 8 SECOND FLOOR PARTITION SAGGED 25MM

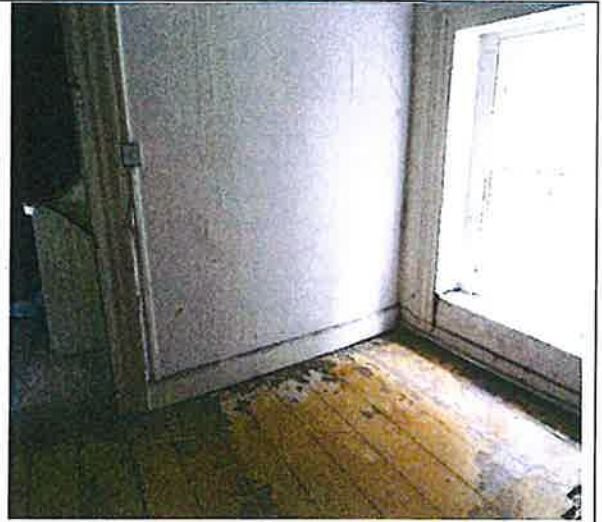
FIGURE 10 FIRST FLOOR PARTITION SAGGED

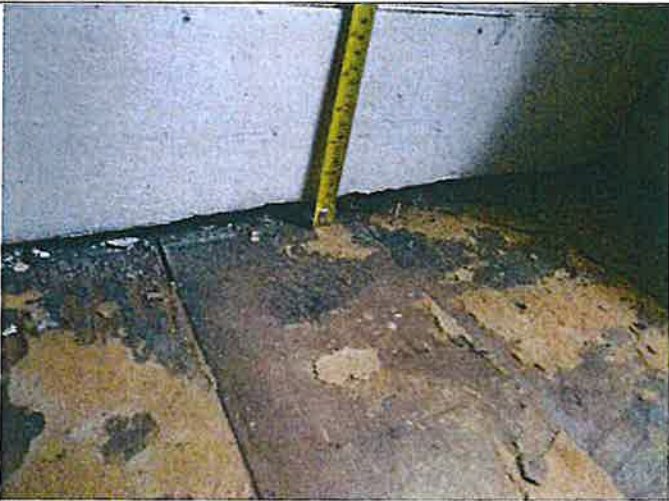
FIGURE 11 FIRST FLOOR PARTITION SAGGED 25MM

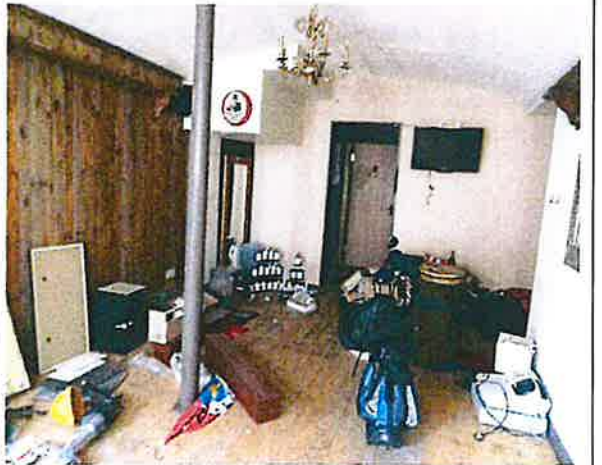
The spine wall is not present at Ground Floor level. It is replaced by a single steel circular column. We assume that there is a beam structure overhead but this was not visible during the time of our visit. This column appears to sit on a masonry wall in the basement.

FIGURE 12 GROUND FLOOR SPINE WALL REPLACED BY COLUMN

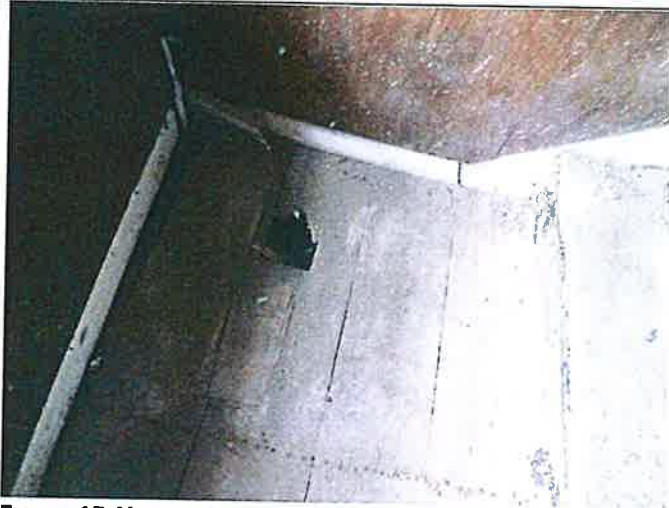
FIGURE 15 HOLE IN STAIRS FIRST FLOOR HALF LANDING

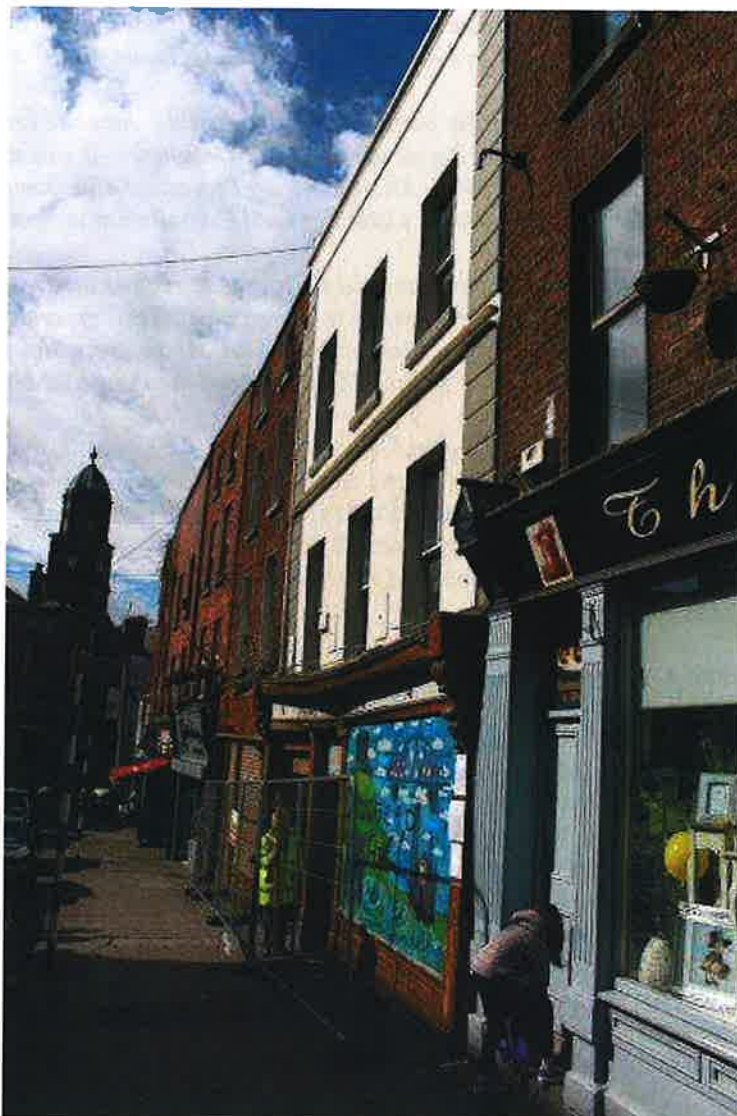
The buildings have been the subject of a dangerous building notice as the fascia of no. 9 sagged and was in danger of collapsing on to the footpath. The building was examined by the consultant structural engineer, the reports are available and show that major works are required to no. 9 to make the building safe, and works are required to no. 8 to repair the roof and floor joists resting on the front wall to prevent the building from being endangered.

Figure 6: Peter Mathew's Pub with its rendered front and fascia with a large deflection.

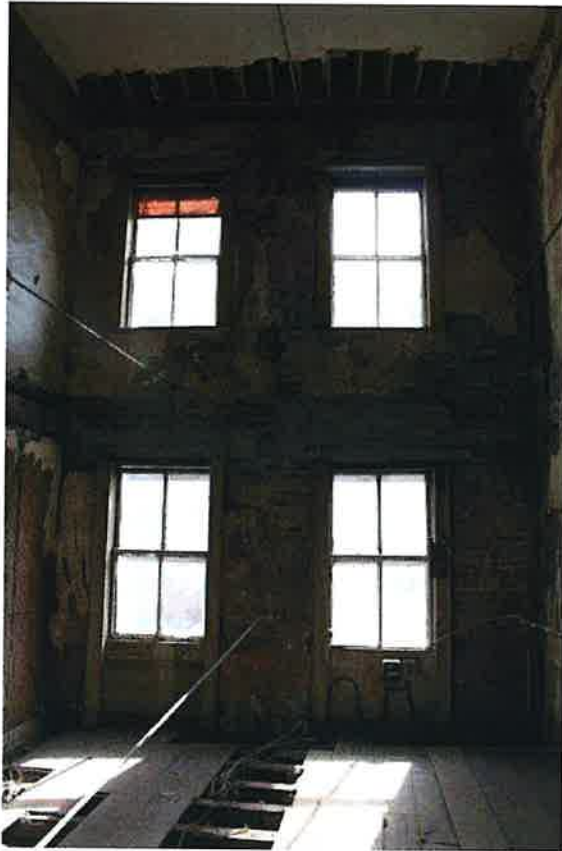
Figure 8: First and second floors and note the second floor is missing.(3754)

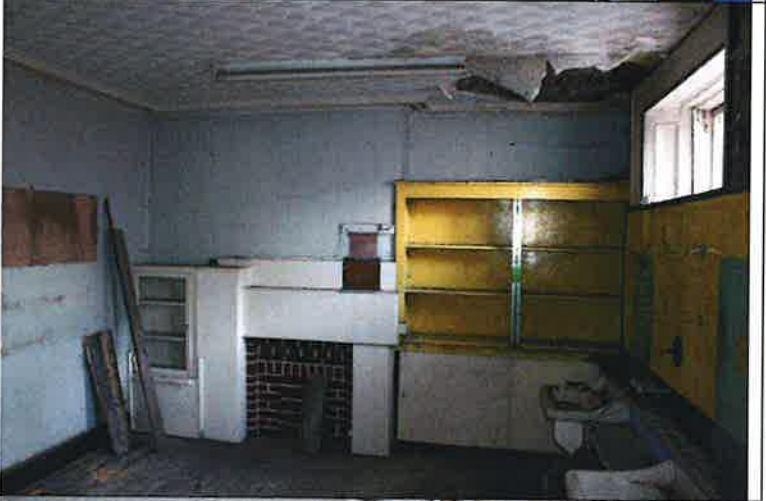
First floor front room ceiling. No plane run corners and perished ceiling. (5242)
