# NAVY BANK PROJECT, POINT ROAD, DUNDALK, CO. LOUTH

## ROAD SAFETY AUDIT STAGE 1 / STAGE 2

**NAVY BANK PROJECT AT  
POINT ROAD, DUNDALK, CO.LOUTH**

**ROAD SAFETY AUDIT  
STAGE 1 / STAGE 2**

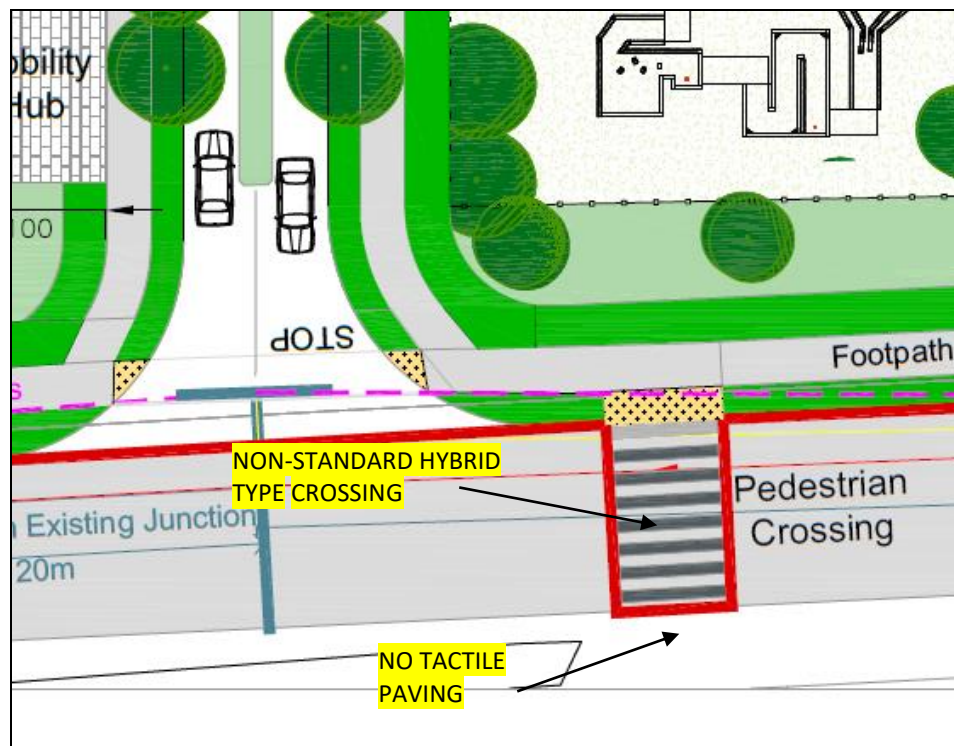
## 2.1 PEDESTRIAN CROSSING OF POINT ROAD

The crossing type as shown is a non-standard hybrid of a controlled and uncontrolled crossing.

If an uncontrolled crossing; then the provision of zebra stripes is non-standard

If a controlled zebra crossing; then either flashing belisha beacons or alternative signage as TSAN-2024-01 is required

The tactile configuration is incorrect for either case

A Zebra Crossing Type A or Type B should only be installed in locations where 85% speed is < 50km/hr

Observations during the site visit would indicate operational speeds exceed this level

A speed survey would be required to 'prove' that a zebra crossing is appropriate.

Decide on appropriate crossing type (controlled or uncontrolled)

Apply correct design features for the selected crossing type.

If uncontrolled – omit zebra stripes

If controlled –select either a Type A or Type B configuration as per TSAN-2024-01 (

If a controlled crossing is to be provided; a traffic light controlled crossing would represent a better choice.

| <b>Item Ref.</b> | <b>Identified Problem</b> | <b>Designers Response</b> |
|---|---|---|
| 2.1 | Pedestrian Crossing of Point Road | Uncontrolled Crossing Point now provided with dropped kerb and tactile paving on each side of road<br>Refer to Drg. No. LCC-NVY-DRG-3.0 (29/04/26) |

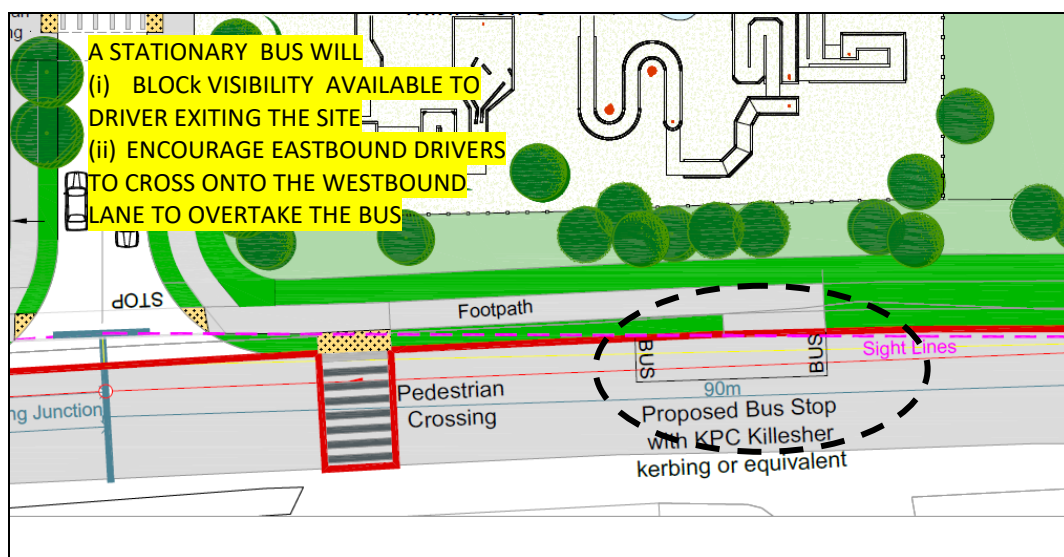
## 2.2 BUS STOP

The 'on-line' Bus Stop configuration, with the bus stop occupying the east bound lane of the Point Road, is sub-optimum for the following reasons:

- (i) A parked bus will obstruct the required 49m x 2.4m visibility splay in this direction for drivers exiting the recreational facility.
- (ii) Drivers shall drive onto the opposing lane in order to 'pass' a stationary bus with resultant risk of collision with an oncoming vehicle.

Avail of the wide grass verge along the north side of the Point Road to create an 'off-line' bus stop or bus lay-by.

If this is not possible then shift the bus stop circa 10m to the east so that it lies outside of the 49m visibility splay

| <b>Item Ref.</b> | <b>Identified Problem</b> | <b>Designers Response</b> |
|---|---|---|
| 2.2 | Bus Stop | On-line Bus Stop now replaced by a Bus Lay-by<br>Refer to Drg. No. LCC-NVY-DRG-3.0 (29/04/26) |

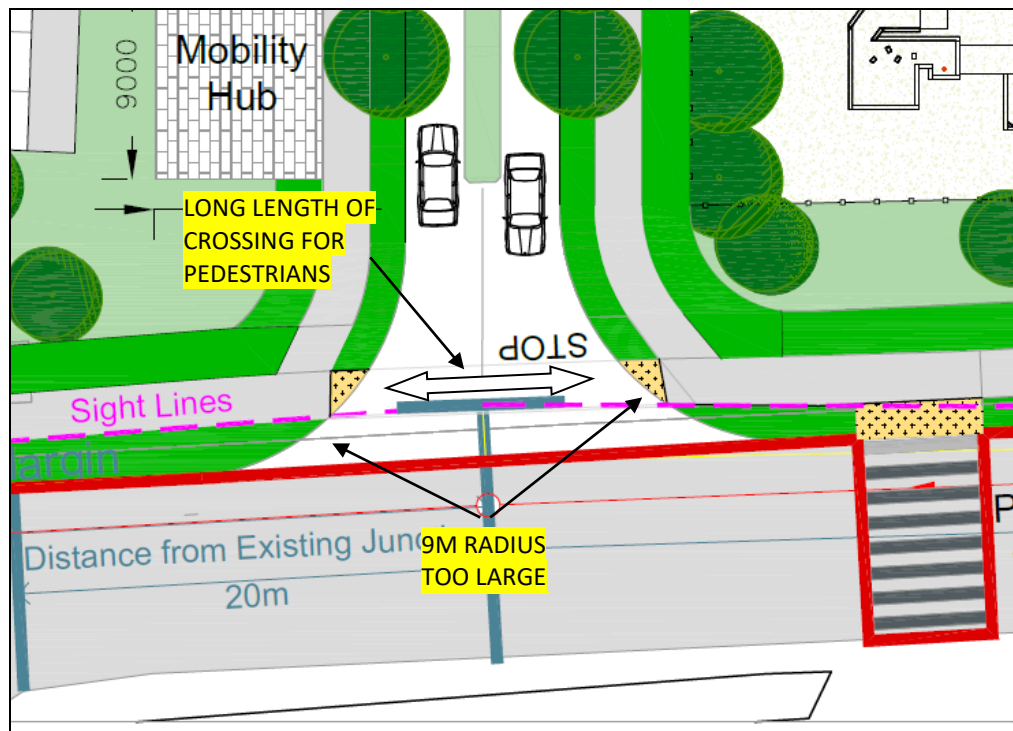
## 2.3 SITE ENTRANCE

The 9m entry/exit radius is excessive for an urban location. The large radius shall:

- (i) Encourage excessive entry and/or exit speeds.
- (ii) Increases the road width to be crossed by pedestrians (13m) with increased exposure to the risk of a collision between a pedestrian and a vehicle entering/exiting the site.

Decrease the entry/exit radius to a maximum of 4.5m

| <b>Item Ref.</b> | <b>Identified Problem</b> | <b>Designers Response</b> |
|---|---|---|
| 2.3 | Site Entrance | Entry and Exit radius at entrance reduced at 4.5m<br>Refer to Drg. No. LCC-NVY-DRG-3.0 (29/04/26) |

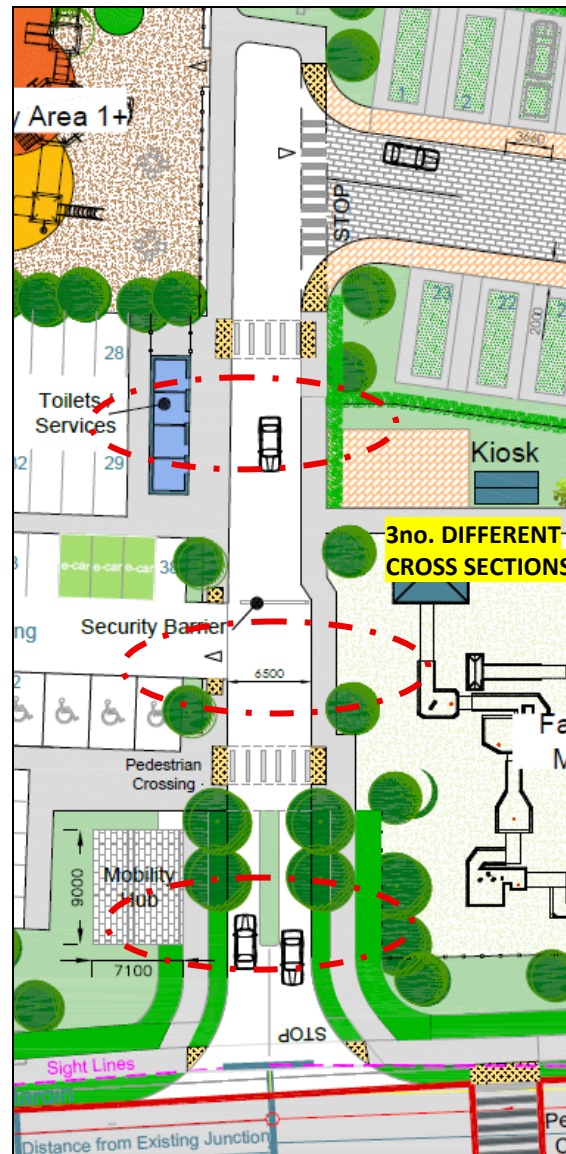
## 2.4 INTERNAL ACCESS ROAD – CROSS SECTION

The site access road has a variable cross section with a mix of divided and undivided carriageways and a carriageway width switching from 6.5m to 5.5m.

The inconsistent cross section shall confuse drivers and lead to inconsistent driver behavior.

The 6.5m wide carriageway is inappropriate for a low speed environment

Retain a consistent road cross section/carriageway width along the entire length of the access road.

It is the view of the Audit Team that a 5.5m undivided carriageway represents the optimum choice.

| <b>Item Ref.</b> | <b>Identified Problem</b> | <b>Designers Response</b> |
|---|---|---|
| 2.4 | Internal Access Road – Cross Section | Standard 5.5m wide undivided carriageway cross section provided along the entire length of the Access Road. Refer to Drg. No. LCC-NVY-DRG-3.0 (29/04/26) |

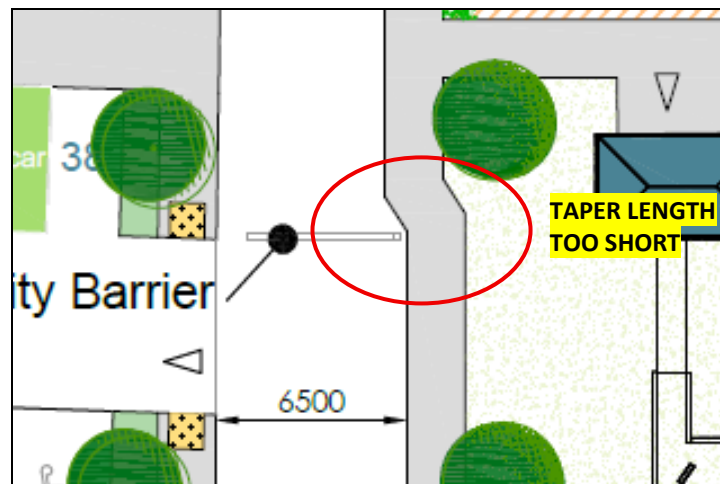
## 2.5 ROAD WIDTH TRANSITION / TAPER LENGTH

The proposed transition between a 6.5m carriageway width to a 5.5m carriageway width occurs over too short a taper (1m)

Drivers shall not be able to adjust their line of travel within this short distance

Taper should be at least 5m long ( 1 in 5 taper)

*Audit Team Note:* The recommended selection of a consistent carriageway width (Item 2.4) shall eliminate this problem.

| <b>Item Ref.</b> | <b>Identified Problem</b> | <b>Designers Response</b> |
|---|---|---|
| 2.5 | Road Width Transition/Taper Length | Design Response to Item 2.4 eliminates need for taper<br>Refer to Drg. No. LCC-NVY-DRG-3.0 (29/04/26) |

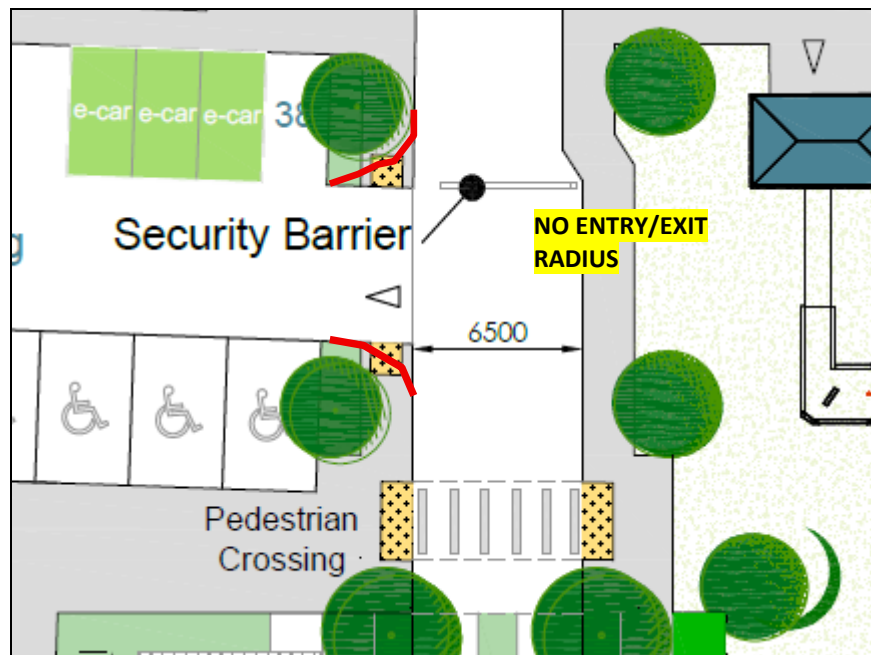
## 2.6 CAR PARK ENTRANCE

No entry /exit turning radius are provided at the car park entrance.

Drivers entering the car park will have to encroach onto the car park exit lane in order to enter the car park with resulting risk of a collision between a car entering and a car waiting to exit the car park

Provide entry and exit radius of 2m – 3m

| <b>Item Ref.</b> | <b>Identified Problem</b> | <b>Designers Response</b> |
|---|---|---|
| 2.6 | Car Park Entrance | Entry / exit radius now provided at car park entrance<br>Refer to Drg. No. LCC-NVY-DRG-3.0 (29/04/26) |

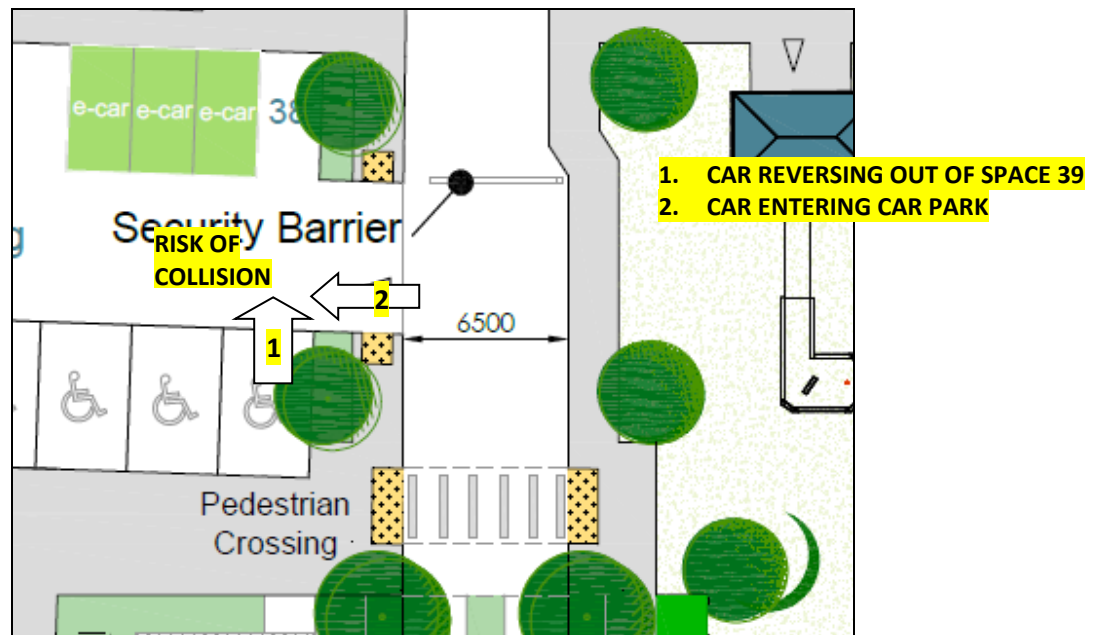
## 2.7 PROXIMITY OF PARKING SPACES TO CAR PARK ENTRANCE

Car park spaces 38 and 39 are located within 3m of the car park entrance/exit.

There is a resulting high possibility of a collision between a vehicle reversing into/out of these spaces and a vehicle entering/exiting the car park.

Omit car park spaces 38 and 39 and replace with small landscape areas/bioretention areas

| <b>Item Ref.</b> | <b>Identified Problem</b> | <b>Designers Response</b> |
|---|---|---|
| 2.7 | Proximity of Car Park Spaces to Car Park Entrance | Car Park Spaces 38 & 39 now omitted and replaced by landscape area<br>Refer to Drg. No. LCC-NVY-DRG-3.0 (29/04/26) |

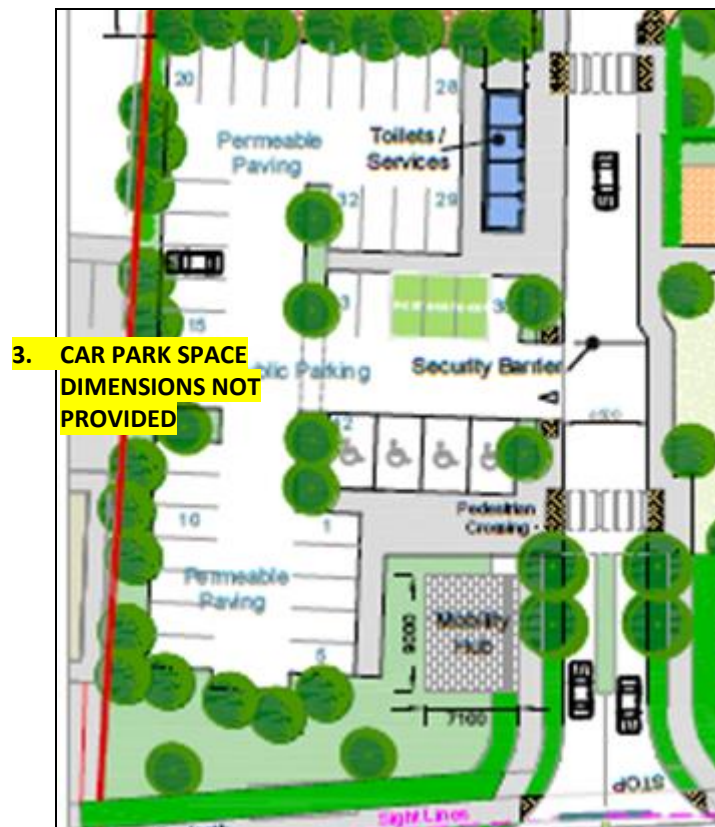
## 2.8 CAR PARK SPACES – DIMENSIONS

No dimensions are provided for the width or depth of the car parking spaces (standard, e-charging and mobility impaired type). It was not possible to accurately determine the dimensions by scaling off the design drawing.

It is therefore not possible to confirm whether the dimensions comply with the design standards set out in Table 13.9 of the Louth County Development Plan 2021-2027.

Ensure that all parking space types have the appropriate dimensions

| <b>Item Ref.</b> | <b>Identified Problem</b> | <b>Designers Response</b> |
|---|---|---|
| 2.8 | Car Park Spaces - Dimensions | All car park spaces comply with standards set out in Table 13.9 of the LCDP 2021-2027<br>Refer to Drg. No. LCC-NVY-DRG-3.0 (29/04/26) |

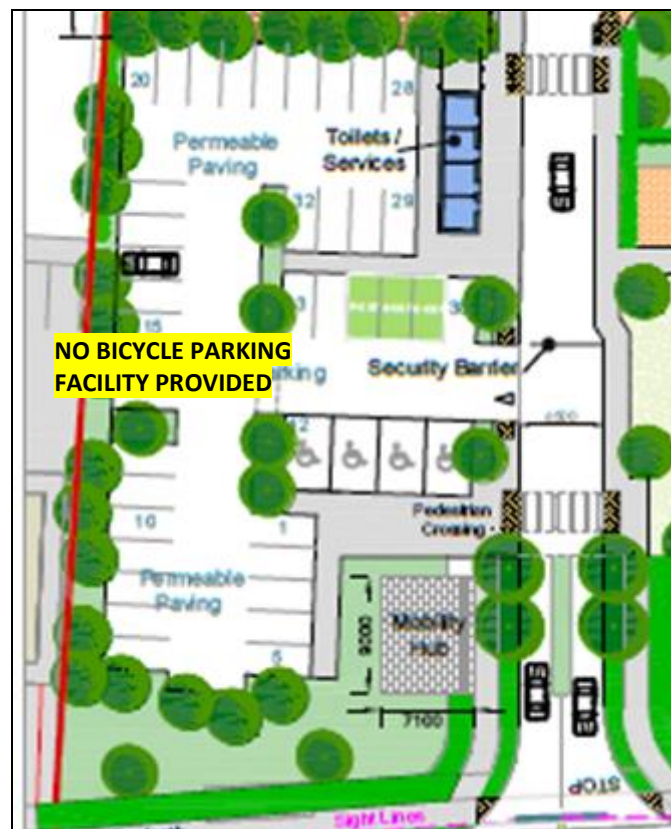
## 2.9 BICYCLE PARKING

No facility is shown on the design drawing for bicycle parking.

It is Louth Co. Co policy to promote active travel and it is considered that a significant number of persons shall cycle to the facility.

The absence of a cycle parking area shall result in cyclists parking their bike in haphazard fashion and in inappropriate areas blocking pedestrian routes and being a trip hazard

Provide a cycle parking facility is provided within the site.

| <b>Item Ref.</b> | <b>Identified Problem</b> | <b>Designers Response</b> |
|---|---|---|
| 2.9 | Bicycle Parking | Designated bicycle parking area now provided within car park area Refer to Drg. No. LCC-NVY-DRG-3.0 (29/04/26) |

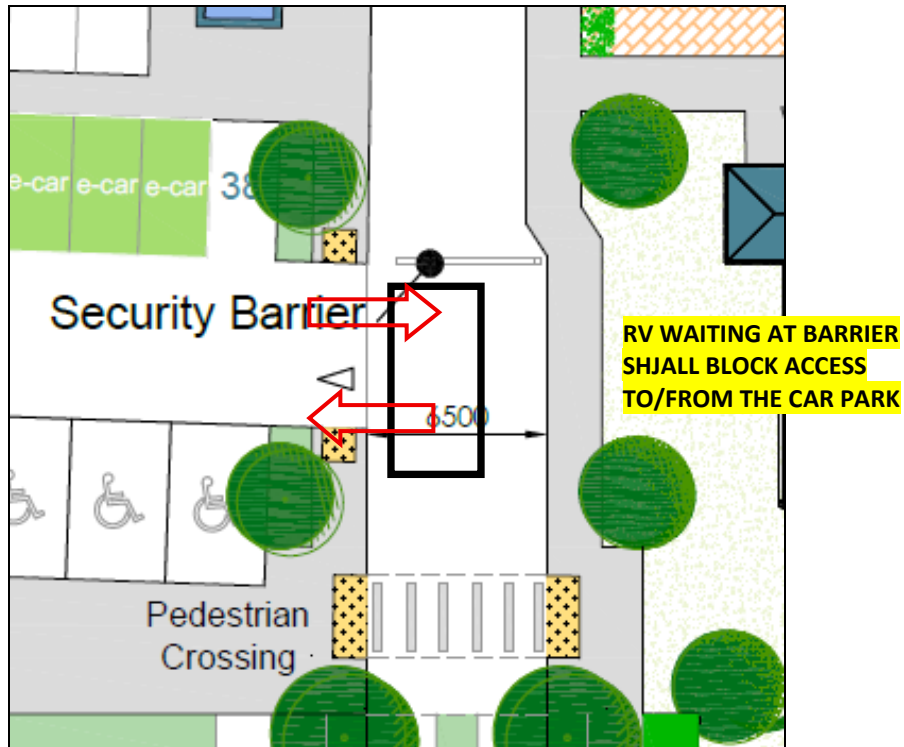
## 2.10 LOCATION OF ACCESS BARRIER TO RV PARKING AREA

The barrier is located very close to the car park entrance.

A RV waiting for barrier to open will block entry/exit to the car park

Move barrier at least 10m to the north so that a waiting RV shall not block the car park entrance

| <b>Item Ref.</b> | <b>Identified Problem</b> | <b>Designers Response</b> |
|---|---|---|
| 2.10 | Access Barrier to RV Area | Access Barrier re-located to avoid clash with car park entrance<br>Refer to Drg. No. LCC-NVY-DRG-3.0 (29/04/26) |

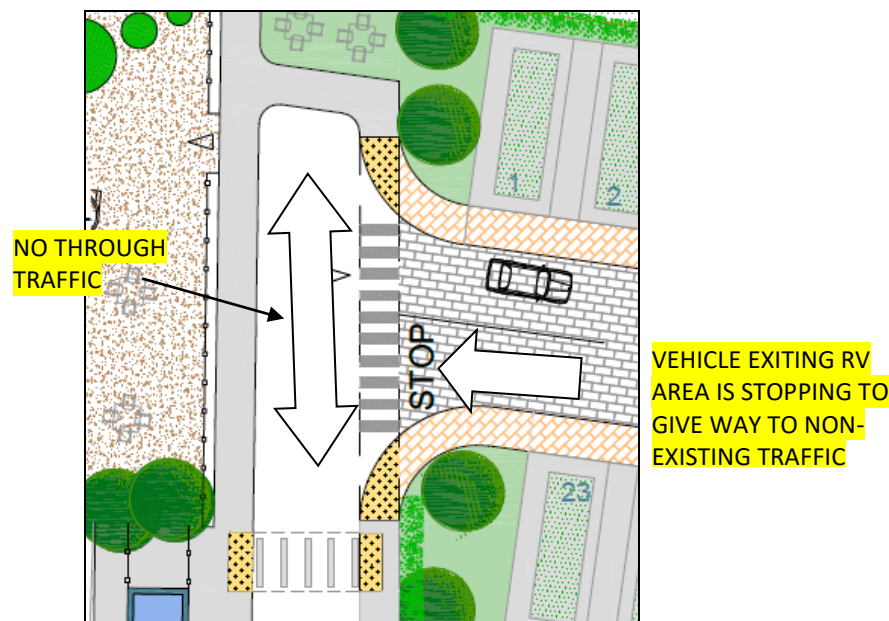
## 2.11 ENTRANCE TO RV PARKING AREA

The entrance configuration matches that of a non-priority T type between a main road and a minor road. In this case the main road is the Site Access Road and the minor road is the RV Access Road.

The protocol at a simple priority junction is for minor road traffic to stop at the junction and wait for a gap in main road traffic before proceeding to turn onto the main road.

However, this protocol is not applicable in this case as the main road terminates immediately after the junction (i.e. no through traffic) while the traffic flow is exclusively between the access road (main road) and the RV access road (minor road).

In other words, the current configuration creates an ineffective T junction with traffic entering/exiting the RV parking area required to give way to non-existent traffic on the main access road.

Drivers shall, under these circumstances, fail to follow the standard T junction protocol and shall instead enter/exit the RV area in a continuous movement with no stopping

The junction entry/exit turning radius (6m) is not large enough to cater for this 90° turning movement except at very low speeds. There is a risk of a RV overturn if a driver attempts to make this turn at too high a speed.

Omit the T junction entrance to the RV Parking Area.

Link the main access road and the RV parking access road with a small radius horizontal curve to provide a direct route into/out of the RV Parking Area .

Ensure that the radius of the horizontal bend is large enough for the driver of a RV to negotiate without undue steering effort when travelling at an appropriate speed (20km/hr) – i.e. min. radius (centreline) to be 13m.

| <b>Item Ref.</b> | <b>Identified Problem</b> | <b>Designers Response</b> |
|---|---|---|
| 2.11 | Entrance to RV Parking Area | T-Junction configuration now replaced,<br>Main Access road now links to RV access road via short horizontal bend (R = 13m) Refer to Drg. No. LCC-NVY-DRG-3.0 (29/04/26) |

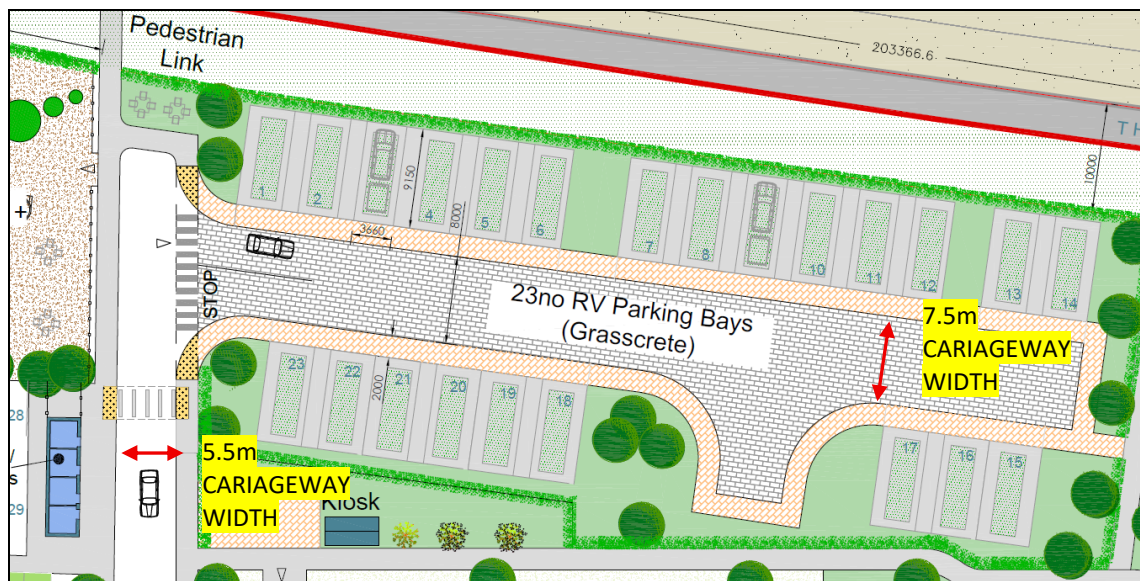
## 2.12 RV PARKING – CARRIAGEWAY WIDTH

It is not clear why carriageway width within the RV parking area is 7.5m in comparison to the 5.5m width of the main access road.

The use of inconsistent carriageway widths throughout the same development is poor design and will confuse drivers.

The 7.5m carriageway width shall encourage inappropriate high speeds along this section of road.

*Audit Team Comment* - the value of running a footpath along both sides of the RV Access Road is questionable given that each footpath shall require dropped kerbing along its entire length to allow a RV access a parking area.  
The need for a footpath along both sides of the RV access road should be re-assessed given the low traffic volume within this enclosed area

Reduce the carriageway width to 5.5m to offer consistency with the remaining sections of the access road.

It may be that the 7.5m width has been provided to provide sufficient road width to allow a RV reverse into/out of the parking bay. If this is the case; then increase the depth of each parking bay by 1m and run a 1m buffer strip along the front of each parking bay to compensate for the loss of reversing space due to reducing the carriageway width to 5.5m

| 2.12 | Carriageway Width – RV Parking | Carriageway width reduced to 5.5m<br>1.0m buffer zone provided in front of each RV parking bay<br>Refer to Drg. No. LCC-NVY-DRG-3.0 (29/04/26) |

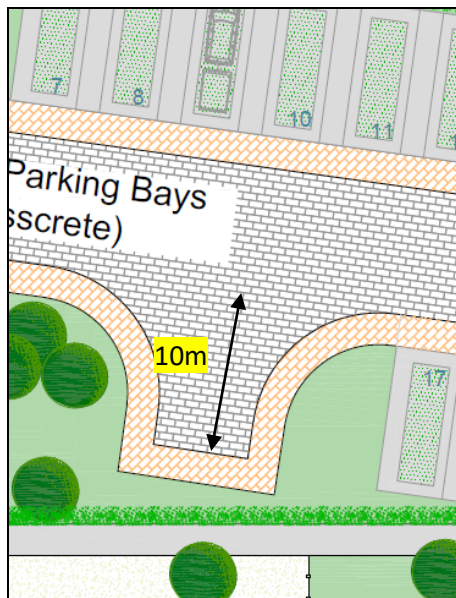
*Proposed Turning Head*

The turning bay as shown is a non-standard variant of Turning Head Type (ii). In particular, the depth (10m) of the turning arm is too short to accommodate the turning movement of a large vehicle (including a RV)

- (i) Increase depth of the turning head to 11.5m , or
- (ii) Consider an alternative option of providing a Type (i) Turning Head at the east end of the RV access road

| 2.13 | Turning Head – RV Parking Area | Type (i) turning head now provided at eastern end of RV Access Road<br>R Refer to Drg. No. LCC-NVY-DRG-3.0 (29/04/26) |
