## Declaration

In accordance with Part IV, Section 57 (2) of the Local Government (Planning and Development) Act, 2000 (as amended).

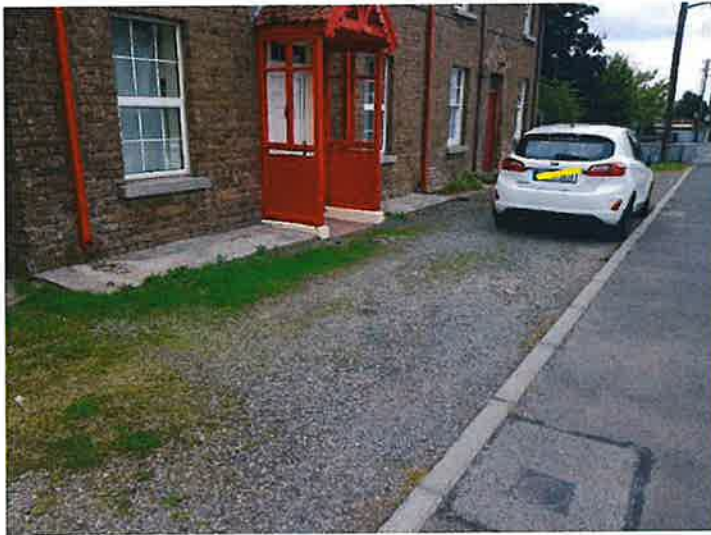
If the boundaries don't match up or if they are unsure about the map, we can be instructed to carry out an evaluation and / or provide new maps if necessary. A fee will apply for this service.

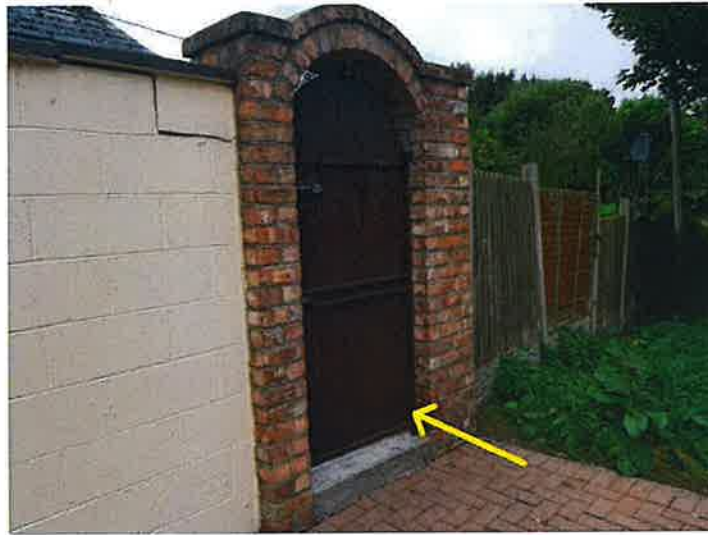
Likely right of way to back left of property.

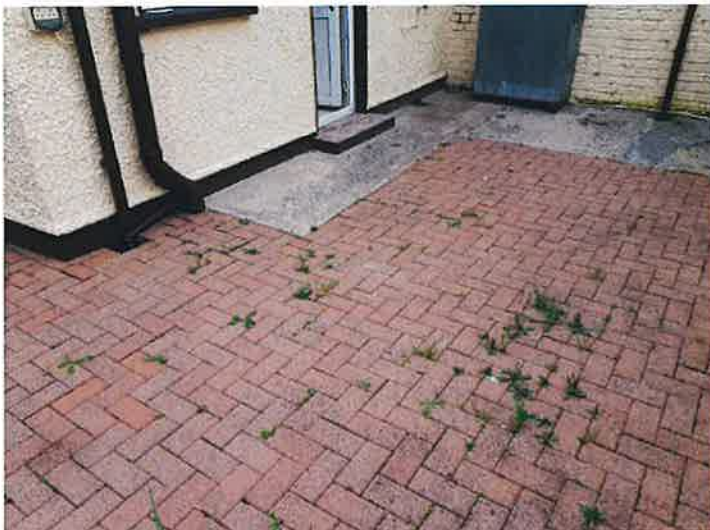
Inadequate access to drains, no visible inspection chambers.

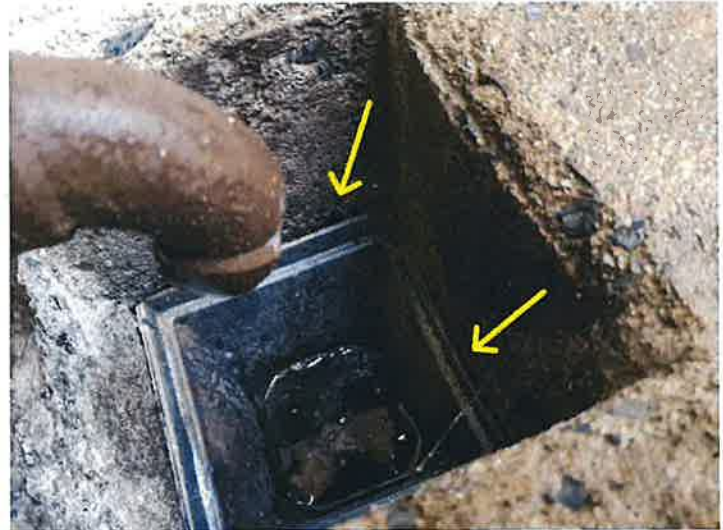
Gaps present which can allow water seep into the ground around the walls of the property. Repair.

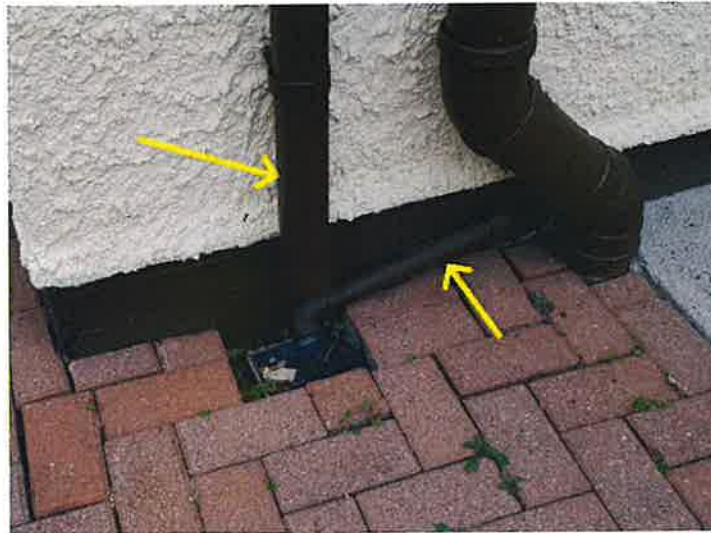
Foul and rain water discharging into same drain.

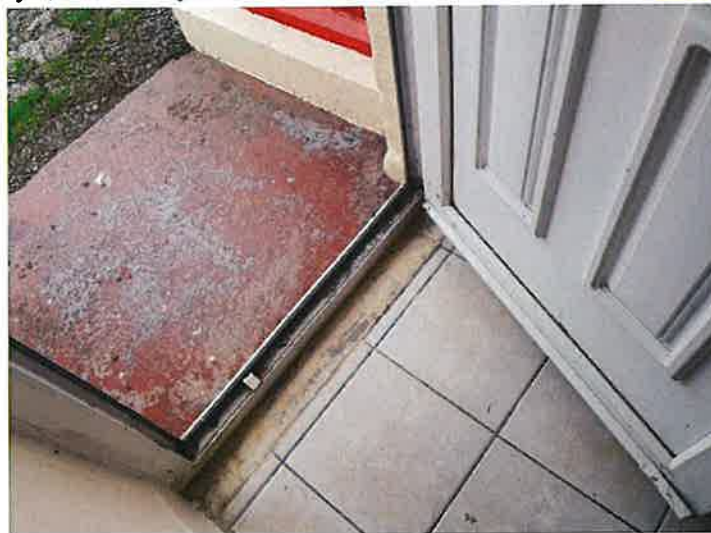
The floor level inside the property is below/ level with the outside ground level. See Dampness in Walls section of report.

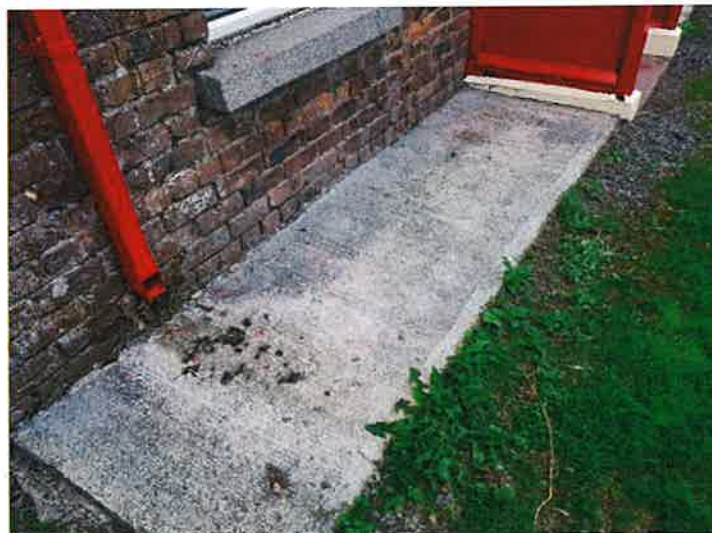
6.1. The **footpath/s** are in a reasonable condition.

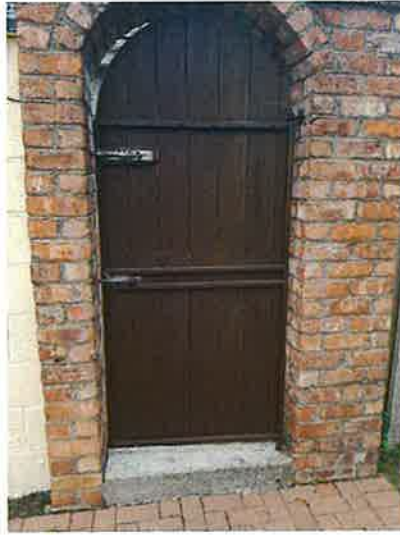
- 7.1. The **timber gate** is in a reasonable condition.

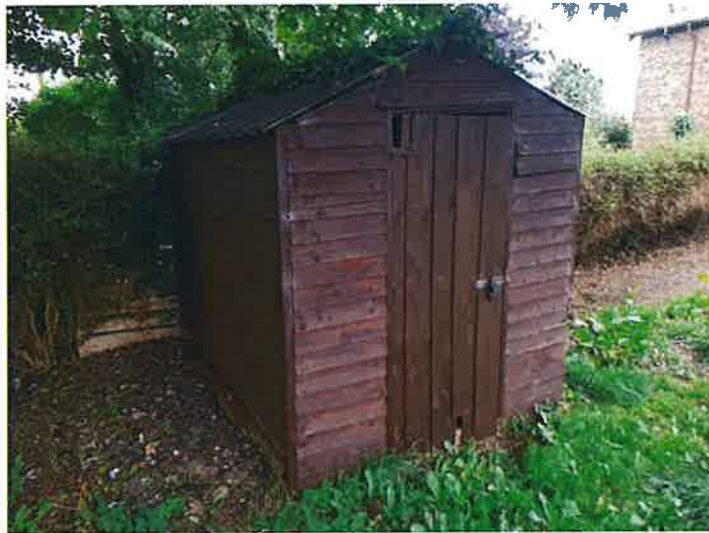
- 8.1. Timber shed is in a poor condition.

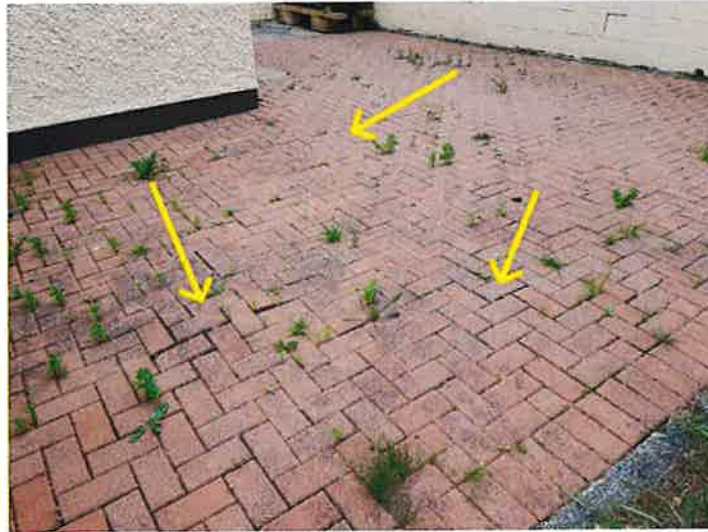
Uneven paving slabs should be secured / re bedded as they can provide a trip hazard.

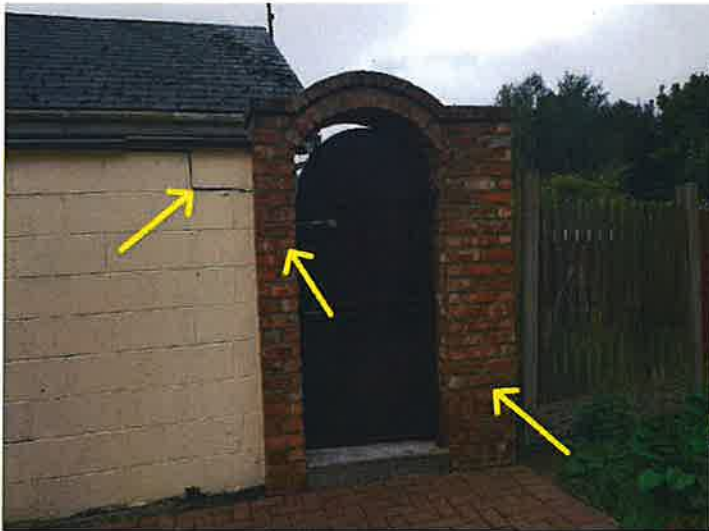
Sample of settlement in back left boundary wall/ arch.

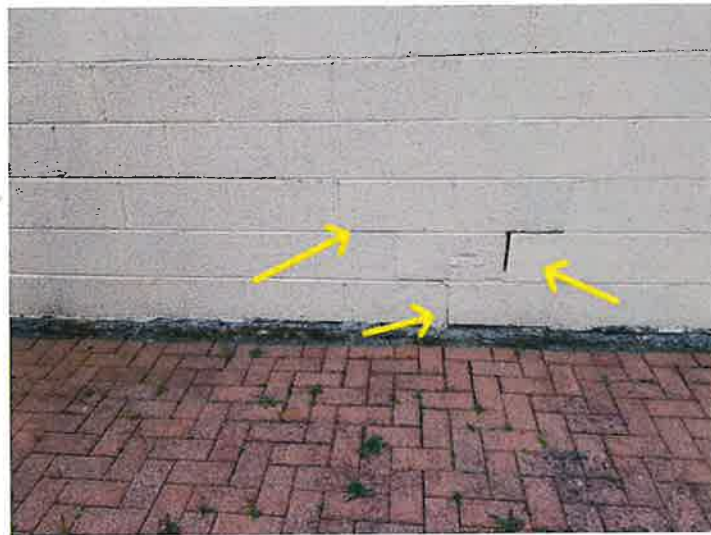
Sample of crack/s in back left boundary wall.

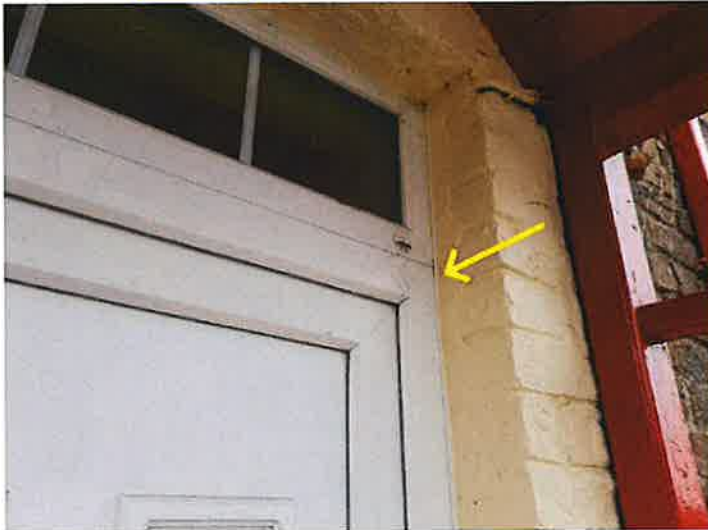
Re-seal around door frame/s.

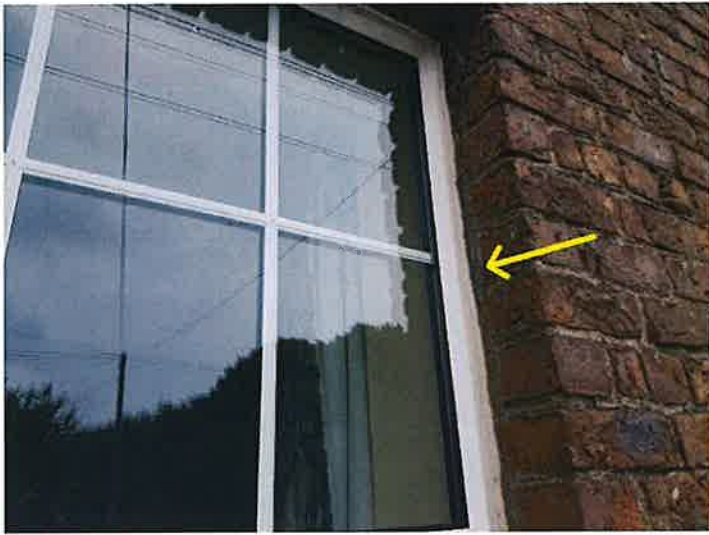
Re-seal around window frames to walls.

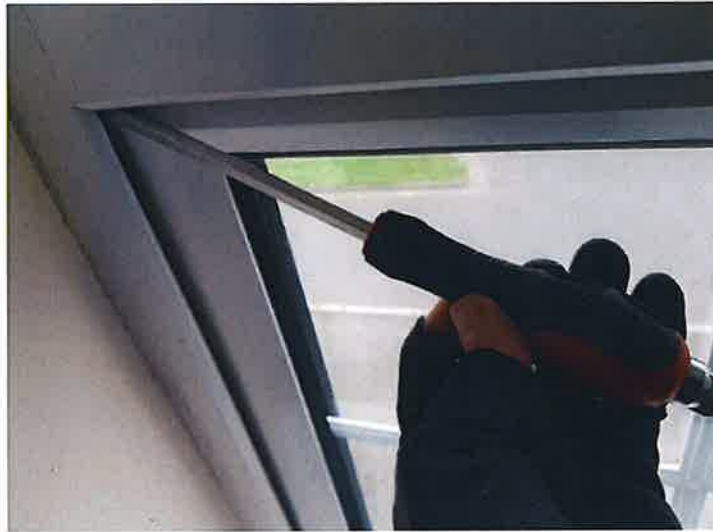
The windows are in a fair condition, repairs / maintenance recommended. Window hinges and hardware will require regular lubrication and maintenance.

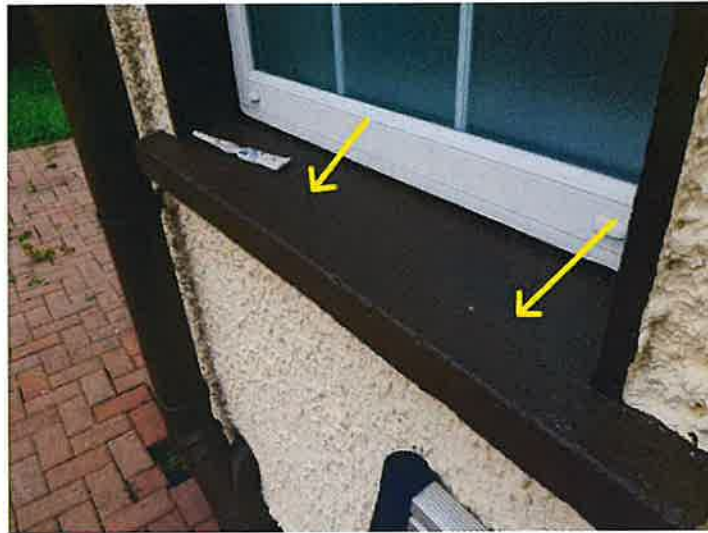
Repair cracked / damaged window sills.

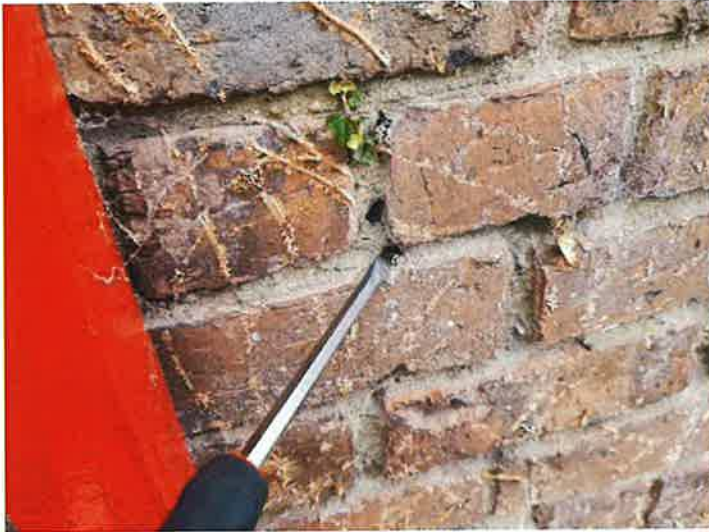
Sample of failing pointing between brickwork.

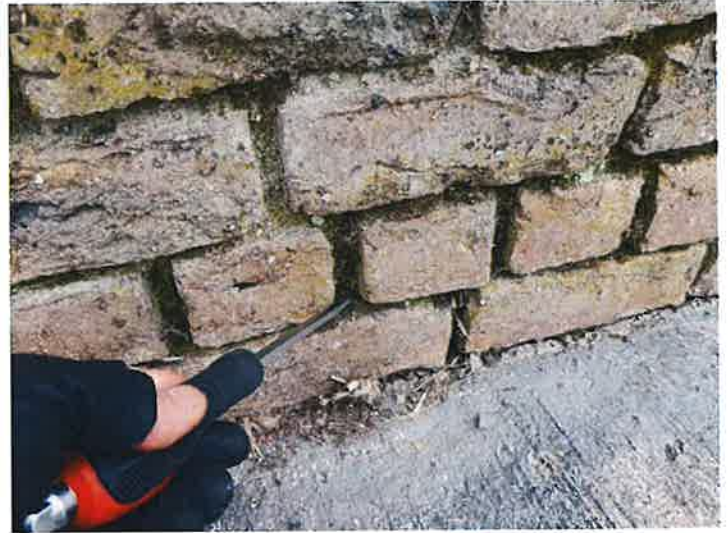
Sample of failing pointing between brickwork.

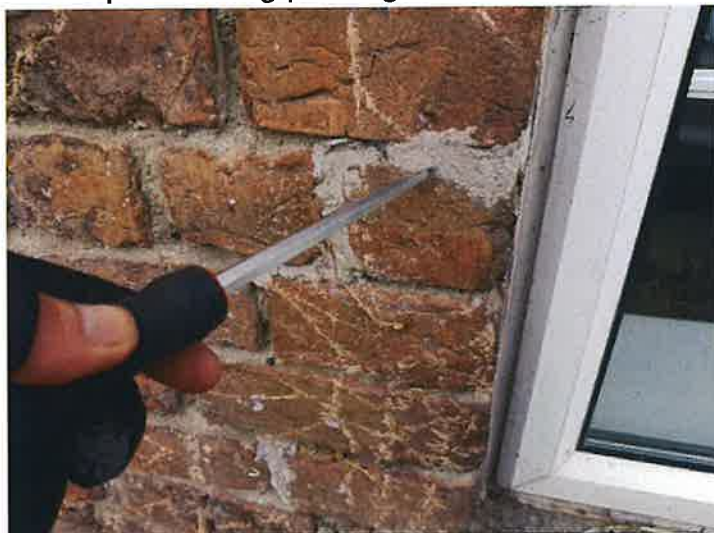
Sections of brickwork walls have been repointed with a cement based mortar, a lime based mortar should have been used.

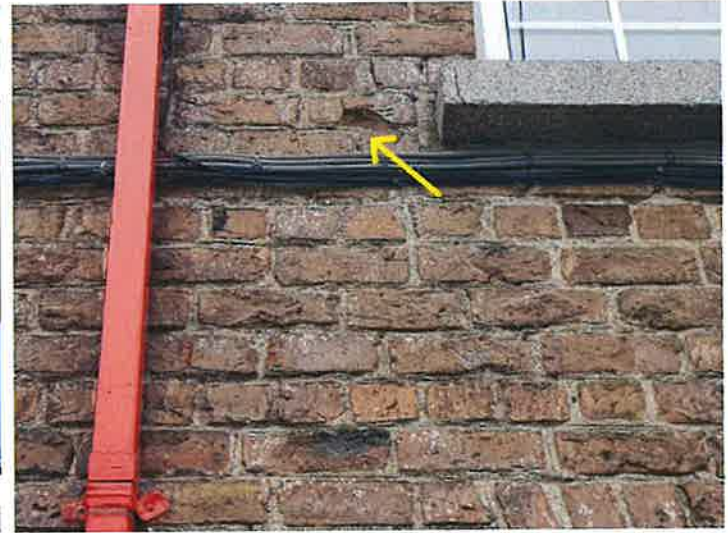
Sample of damaged bricks.

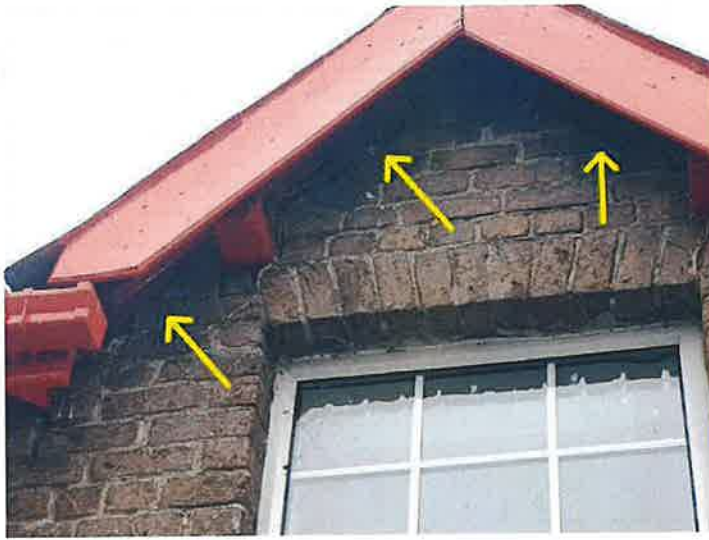
Remove vegetation and seal gaps between brickwork walls and soffits

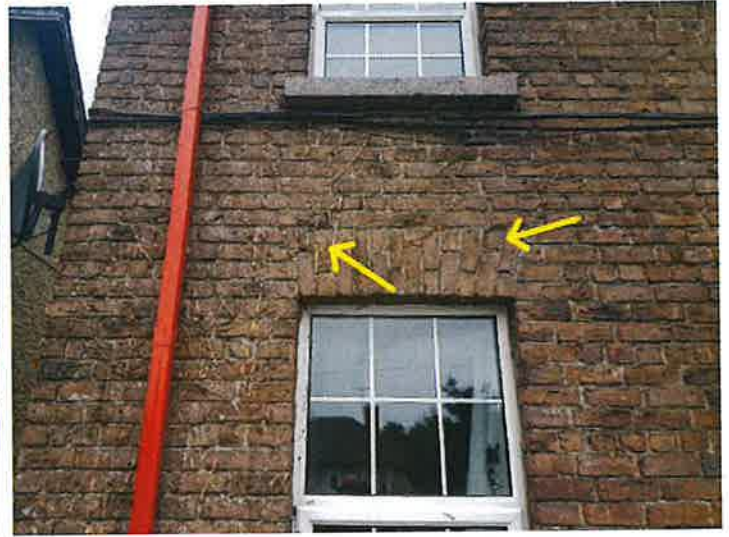
Sample of crack/s in front wall.

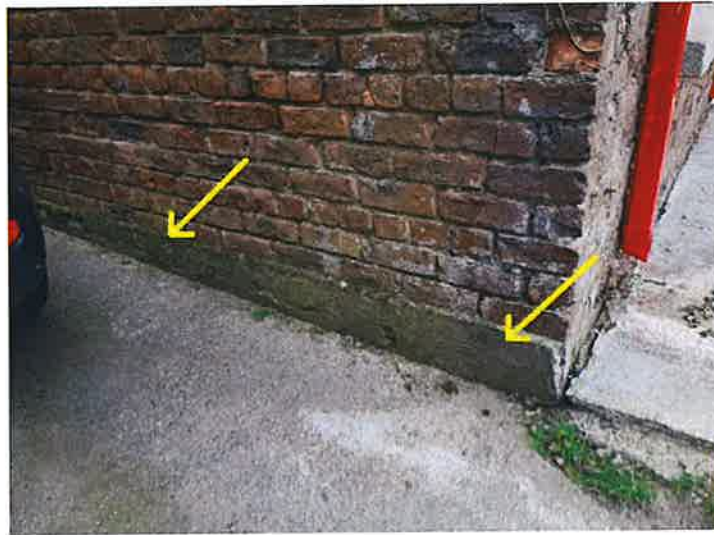
The sand and cement render plinth finish to the left external wall/s is not original.

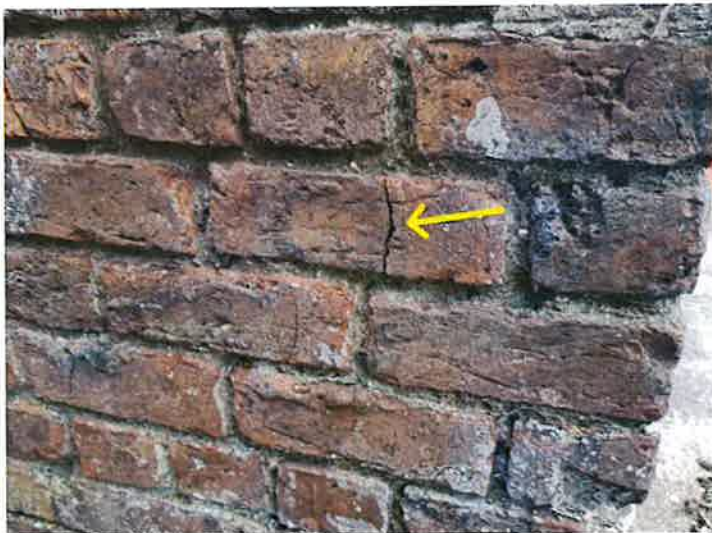
Sample of cracked brickwork in left wall.

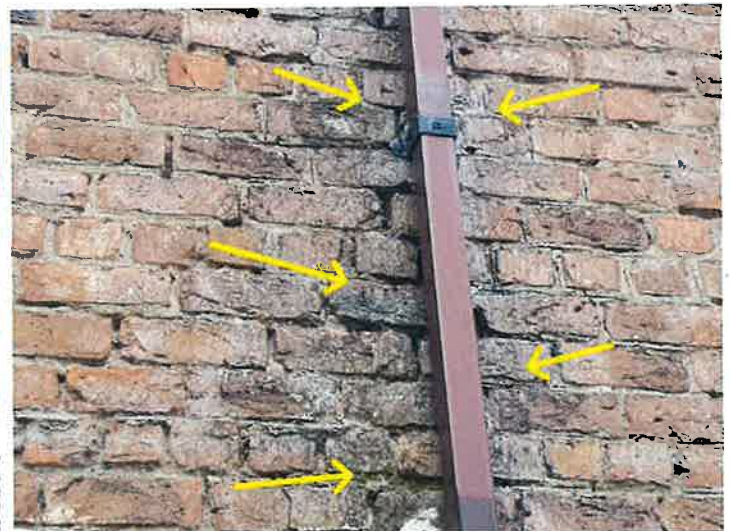
Sample of failing pointing between brickwork.

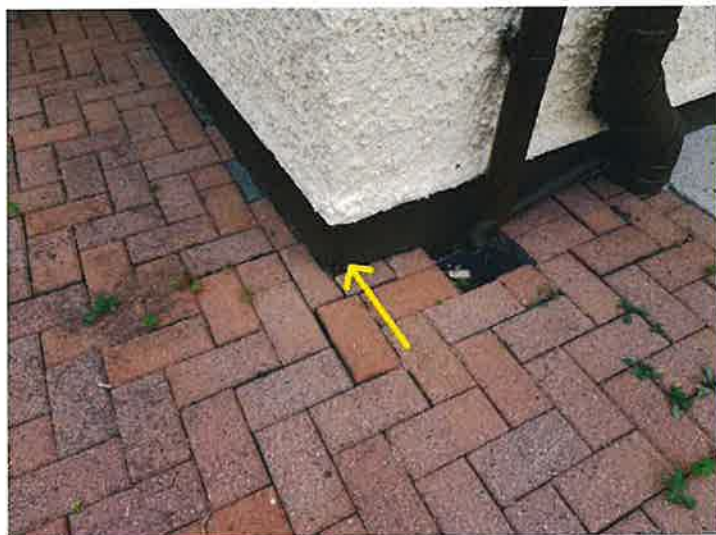
Sample of chipped render in back wall.

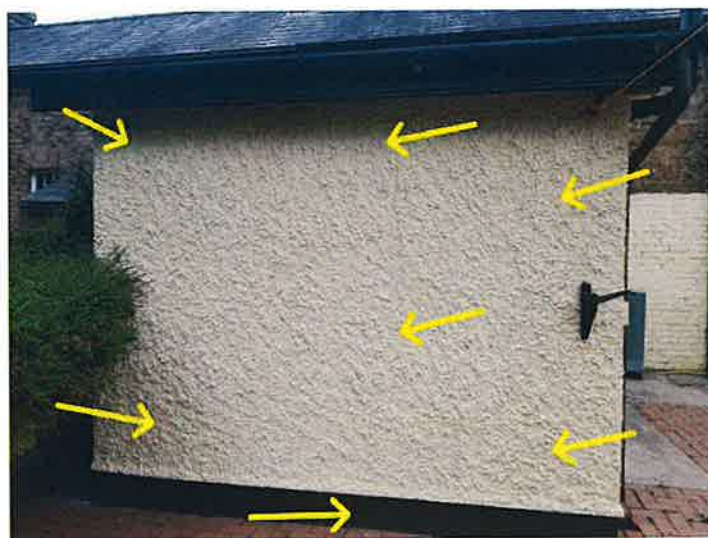
Sections of dashing (hollow sound with some cracking) not fully bonded to masonry walls, will require local repairs.

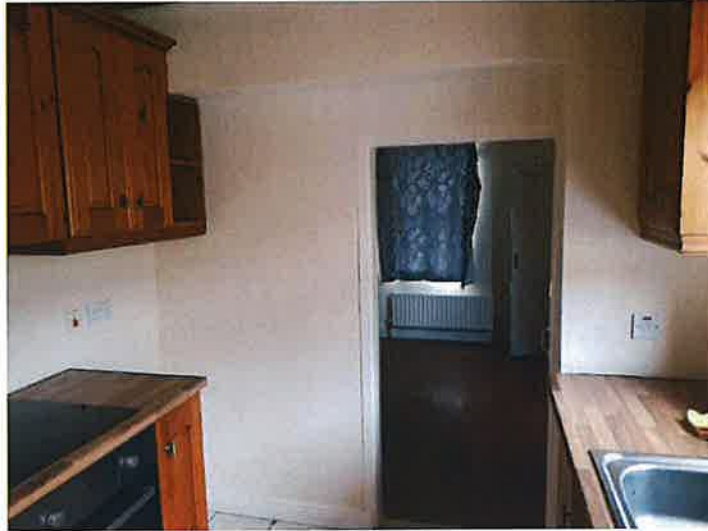
Wall removed / widened between original house and rear extension.

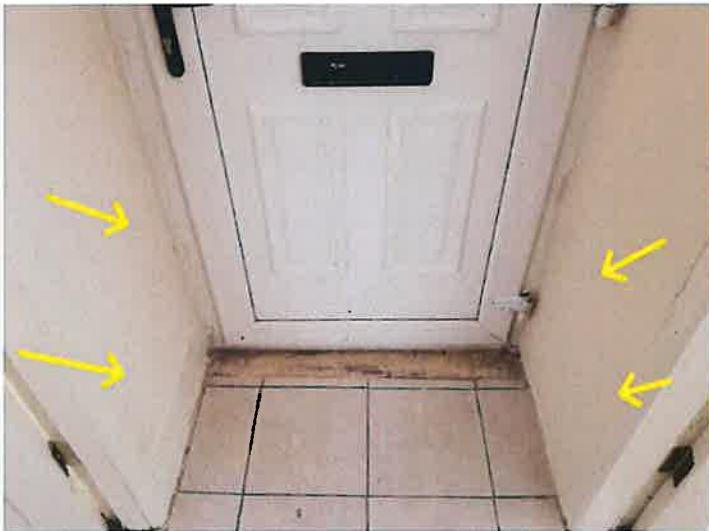
High moisture readings noted to front/ internal walls of property.

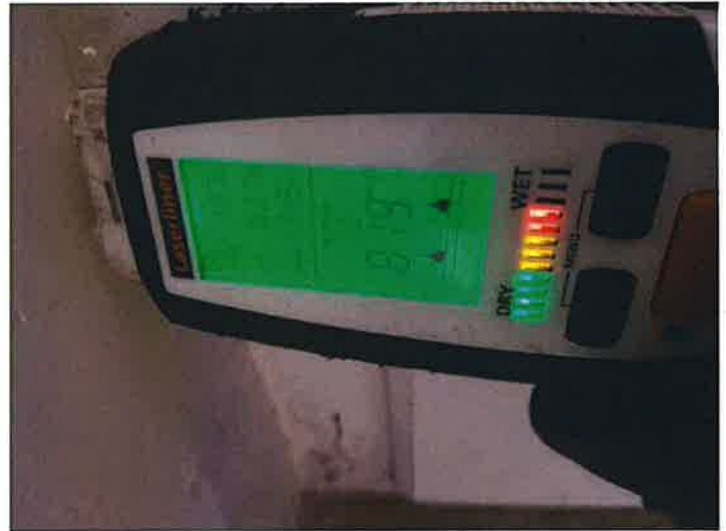
High moisture readings noted to front/ internal walls of property.

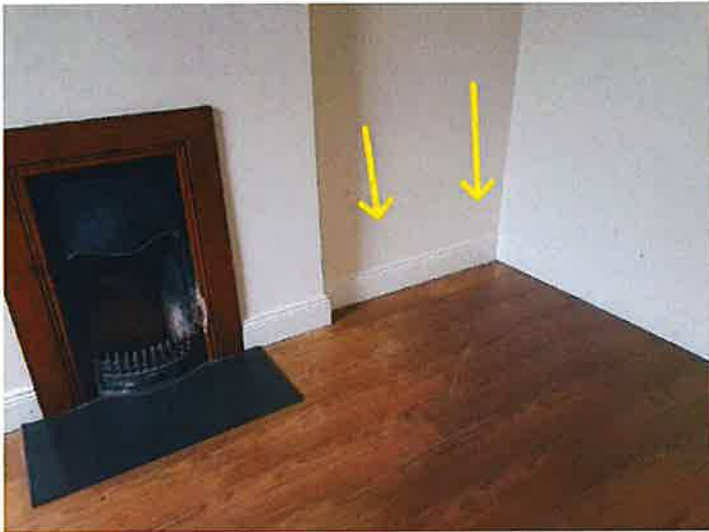
High moisture readings noted to left wall of property.

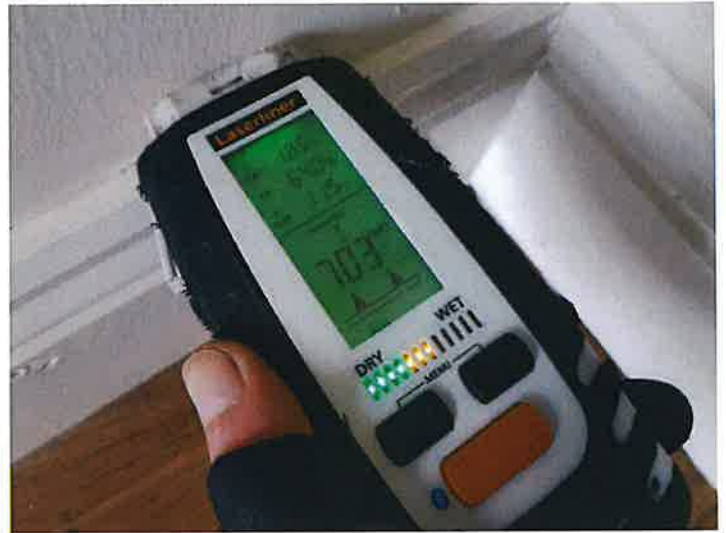
High moisture readings noted to left wall of property.

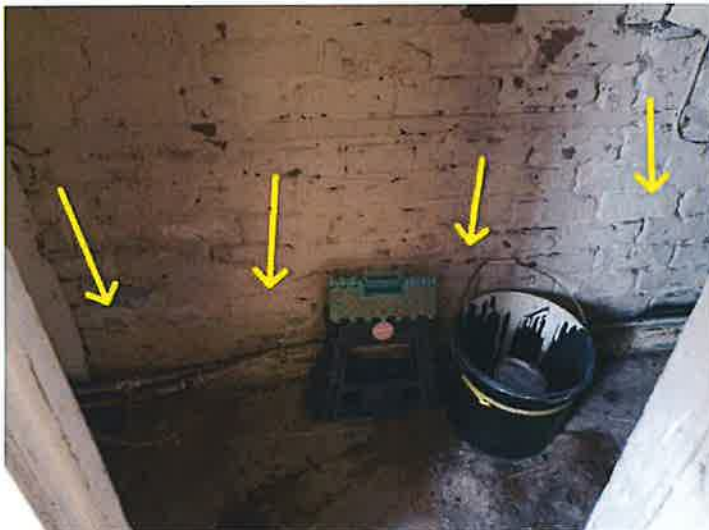
High moisture readings noted to internal wall of property.

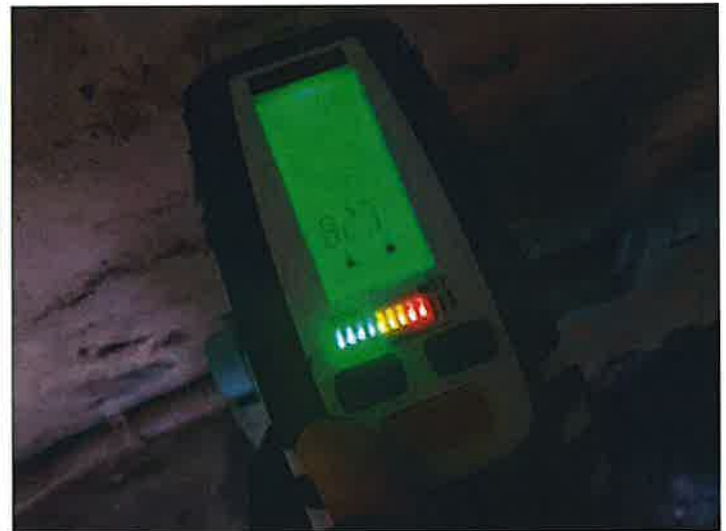
High moisture readings noted to internal wall of property.

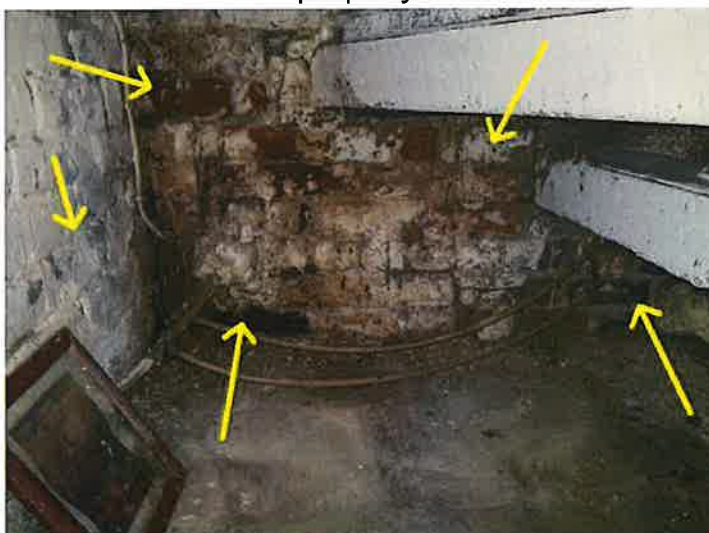
High moisture readings noted to back wall of property.

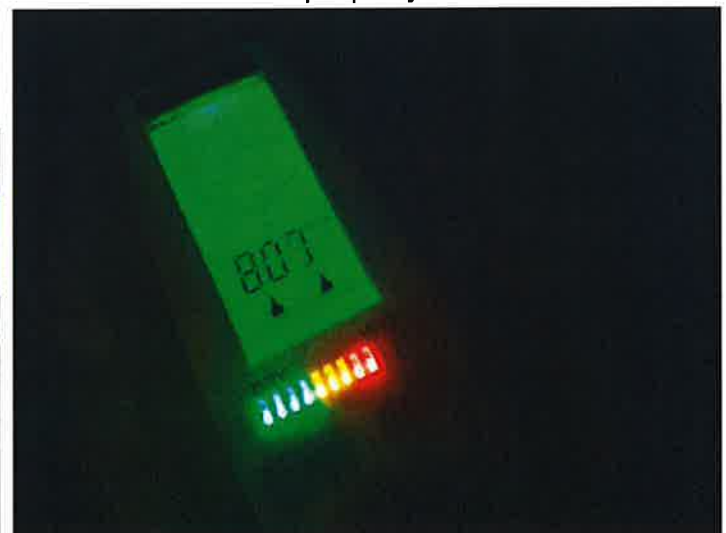
High moisture readings noted to back wall of property.

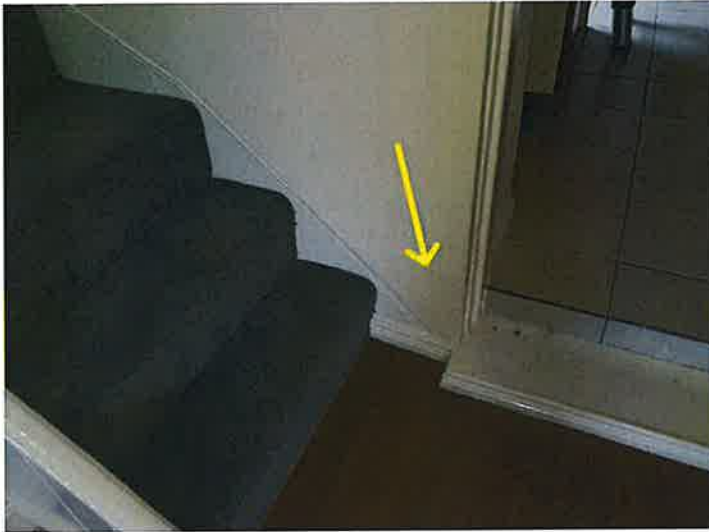
High moisture readings noted to internal wall of property.

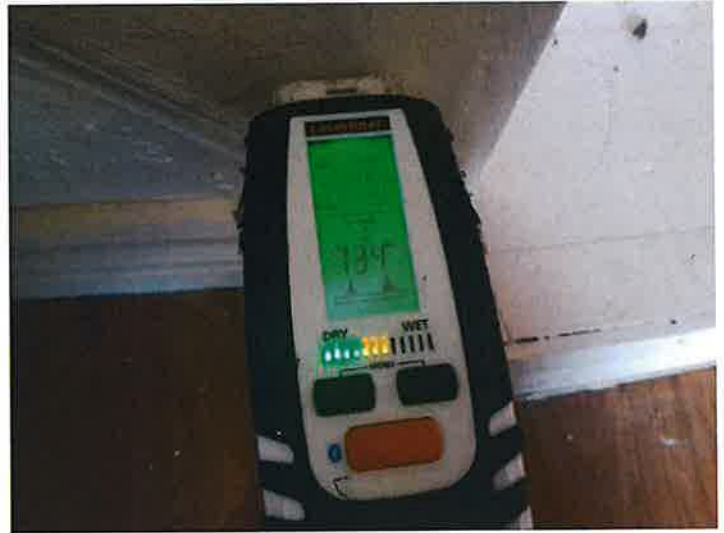
High moisture readings noted to internal wall of property.

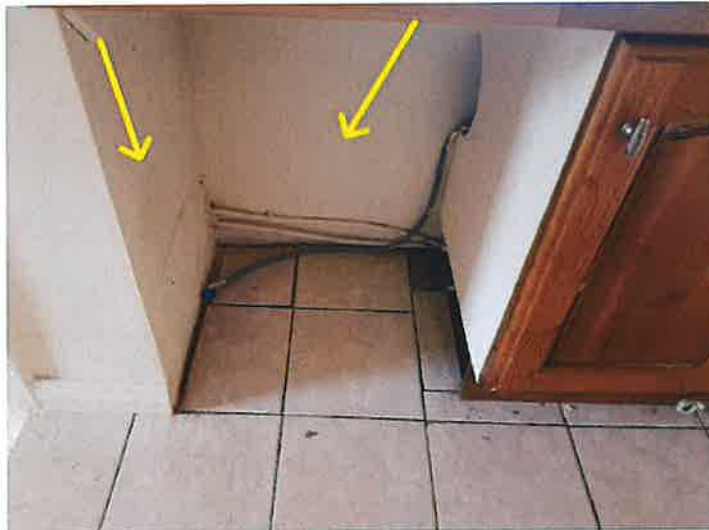
High moisture readings noted to back left wall of property.

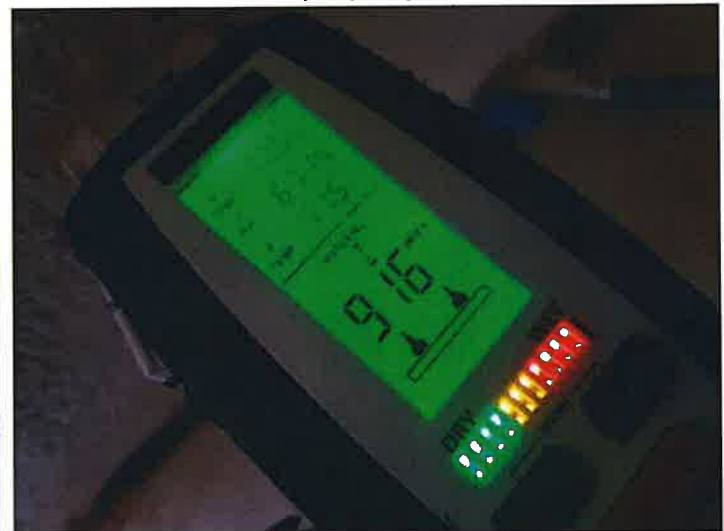
High moisture readings noted to back left wall of property.

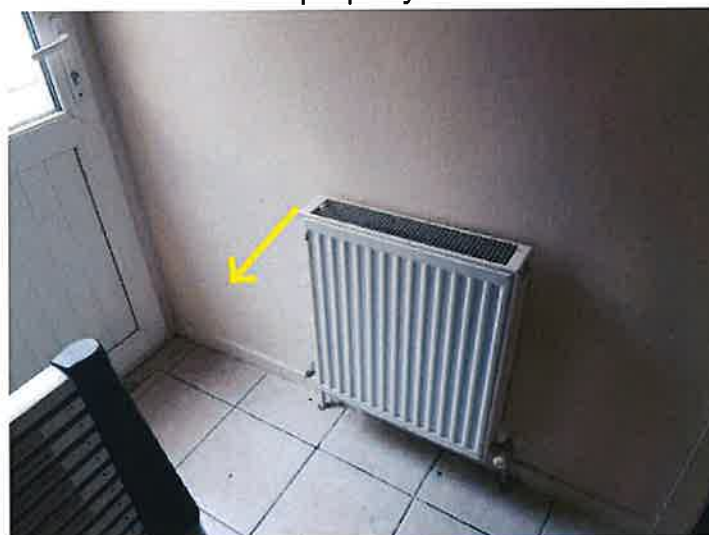
Normal moisture level reading taken at internal wall of property.

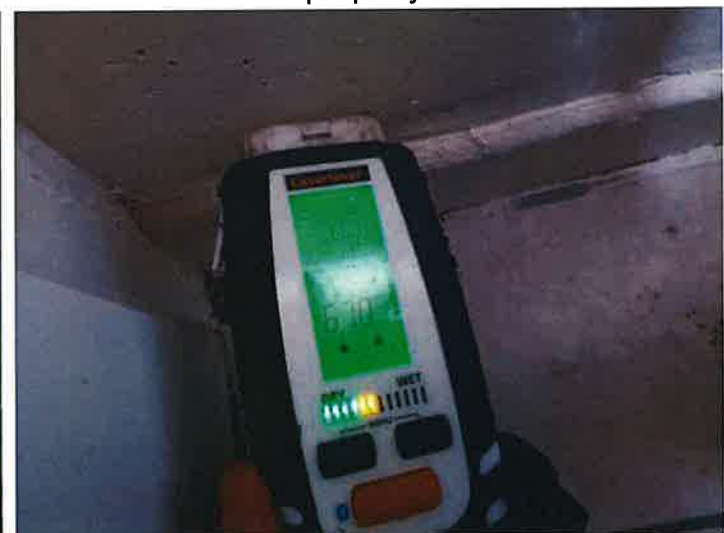
High moisture readings noted to internal wall of property.

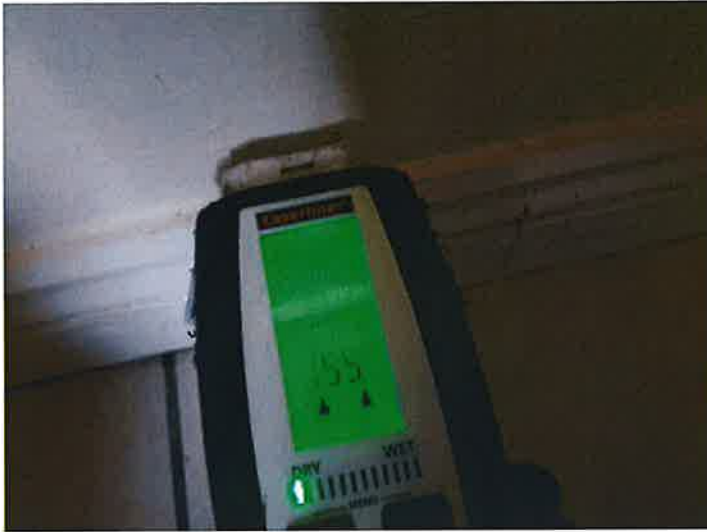
Normal moisture level reading taken at right wall of property.

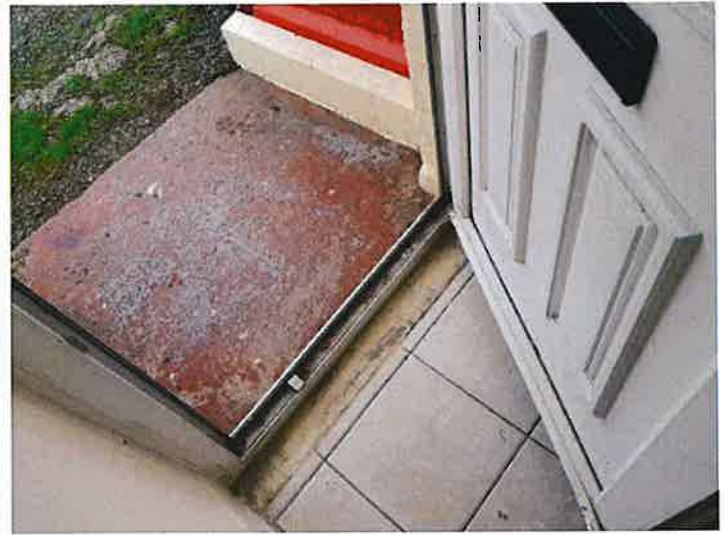
The floor level inside the property is below/ level with the outside ground level.

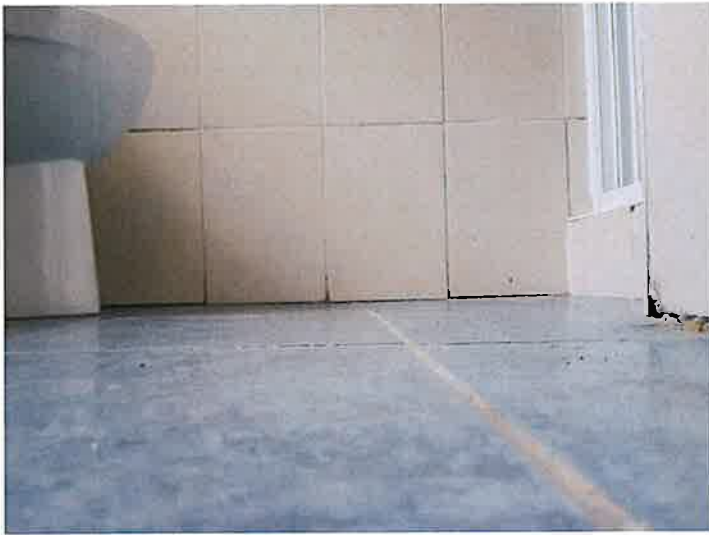
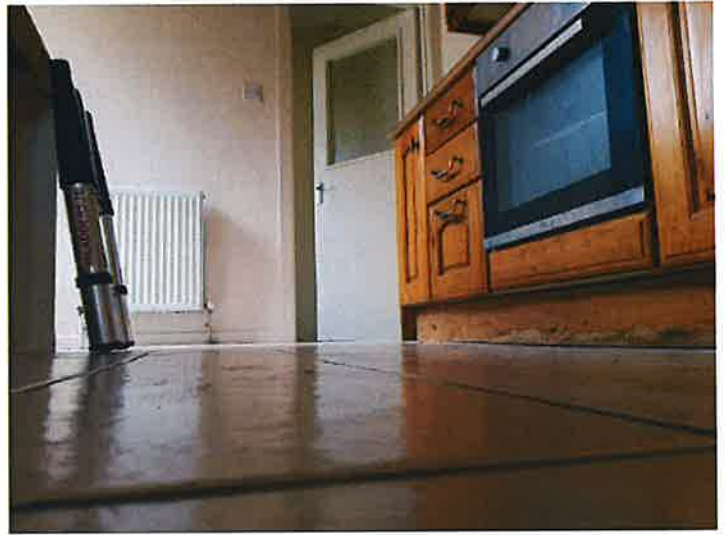
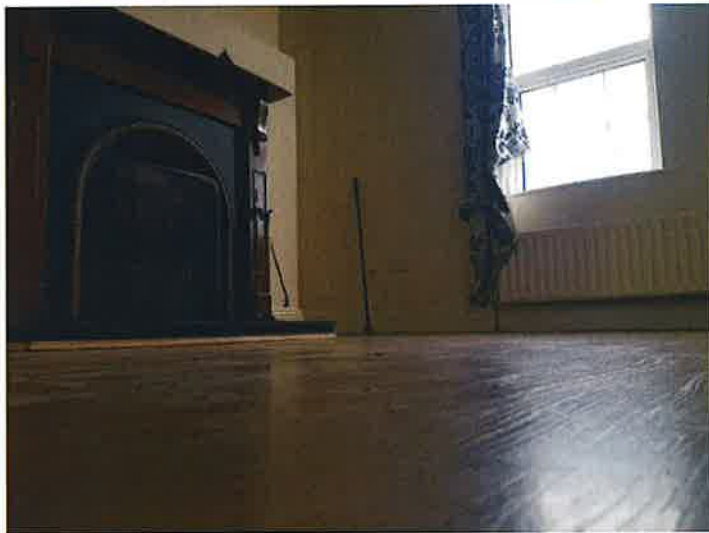
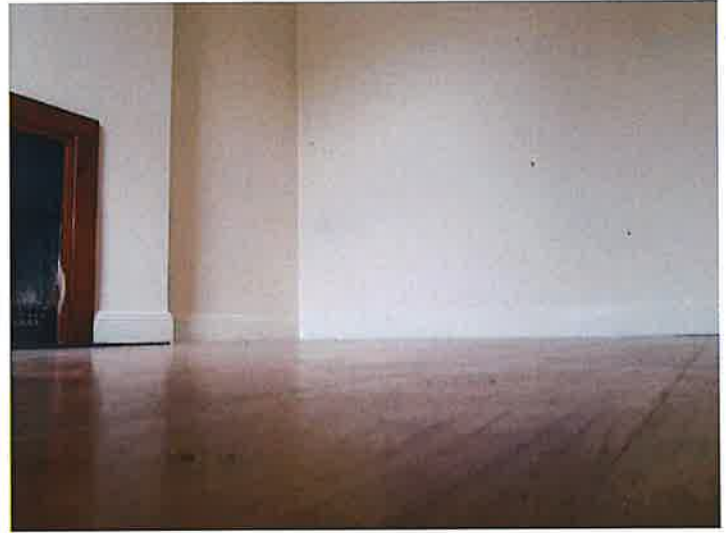
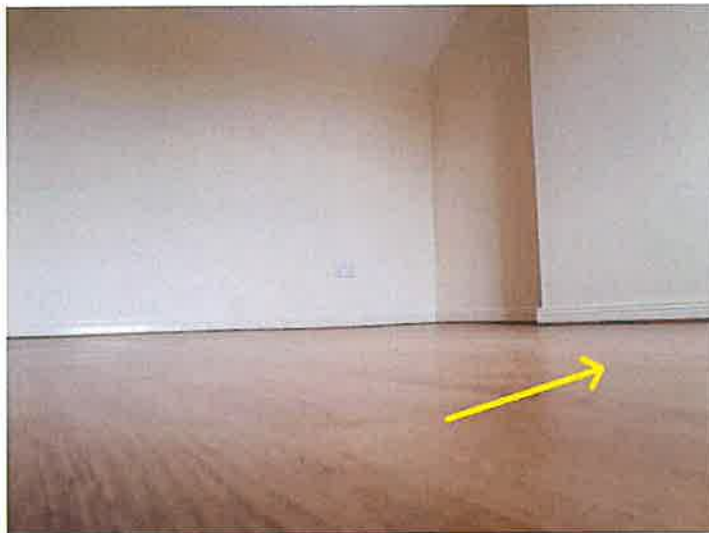
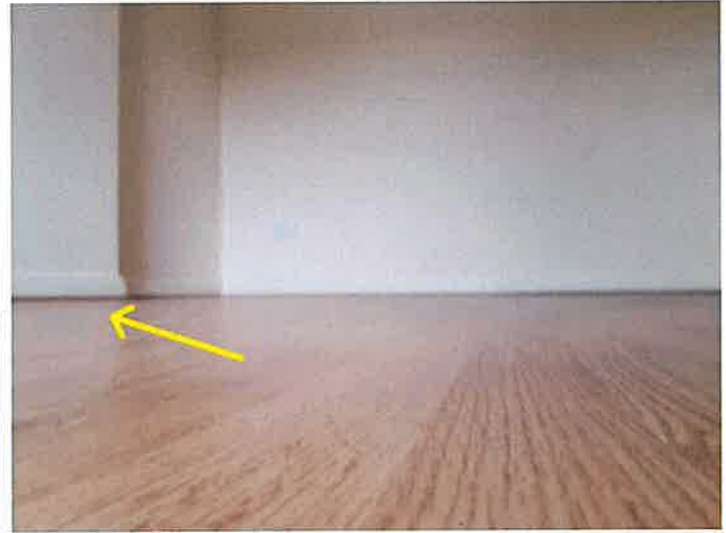
Sample of sloping / unevenness in the right bedroom floor at the time of inspection.

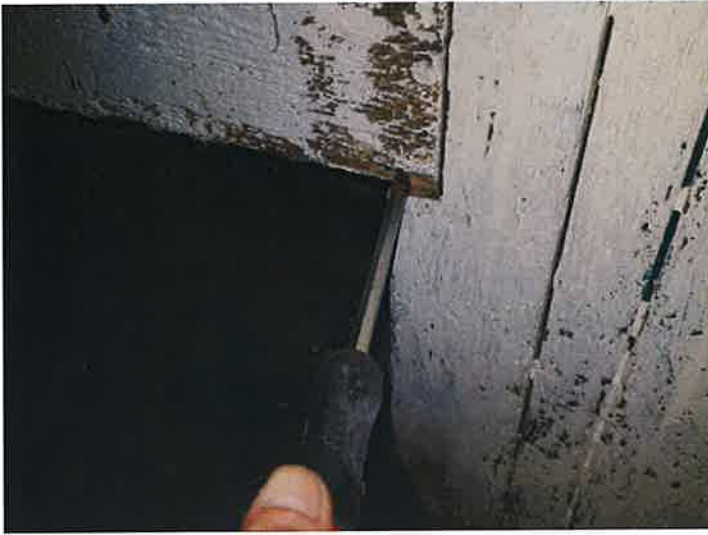
Rotten timber noted supporting stairs.

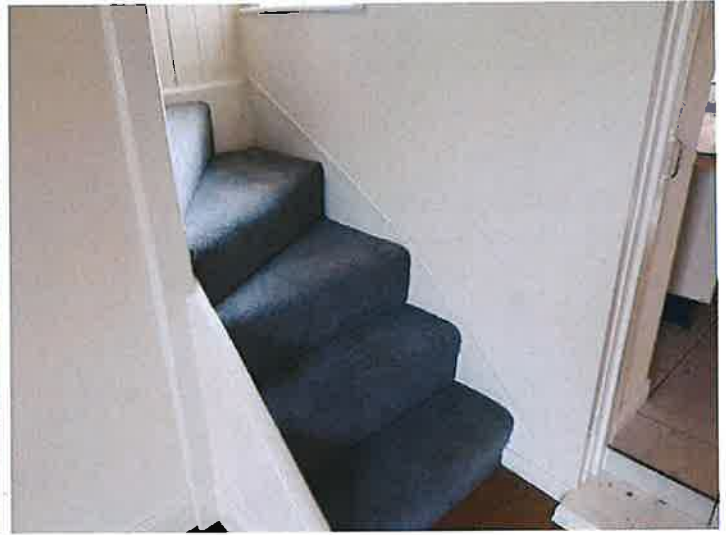
No hand rail fitted to bottom section of stairs.

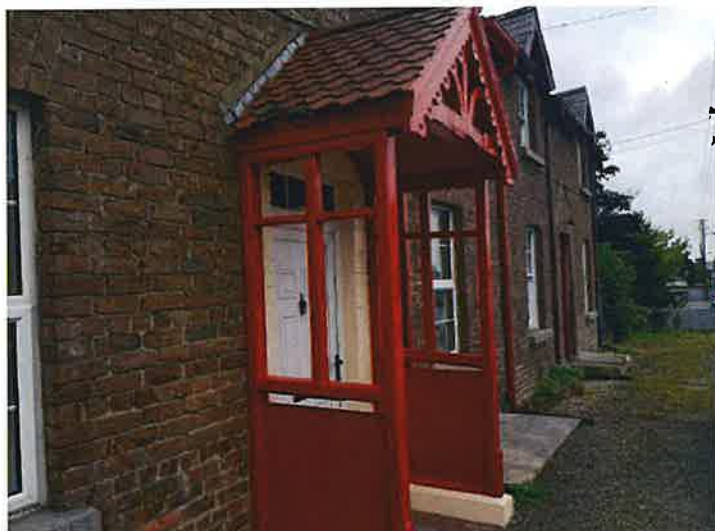
From a visual inspection the roof structure to the front canopy is in a poor condition.

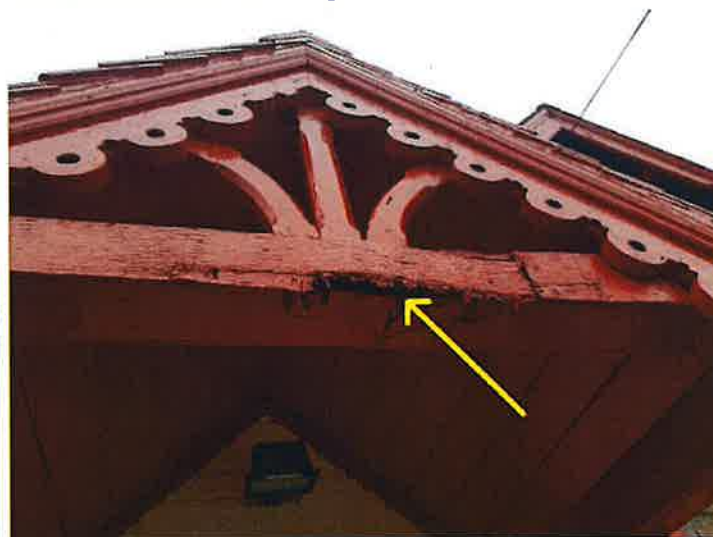
Rotten timbers supporting canopy

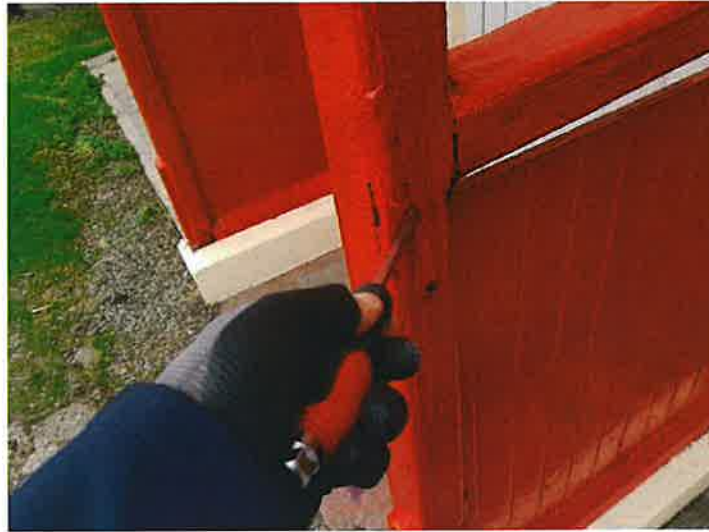
Rotten timbers supporting canopy

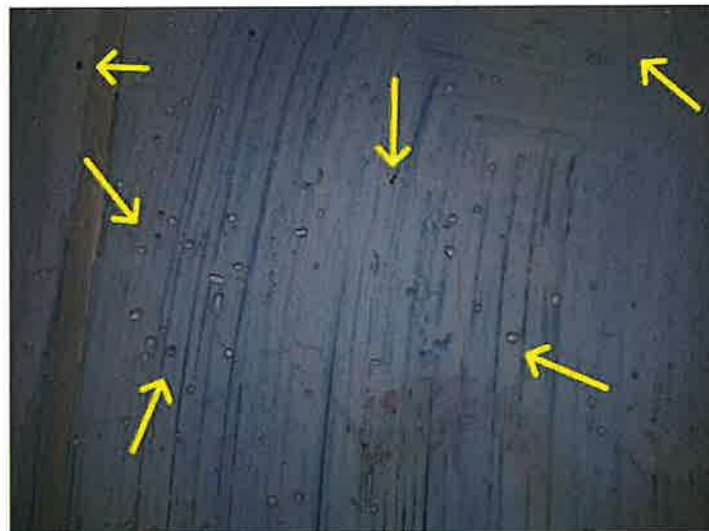
Sample of active woodworm in stairs timbers.

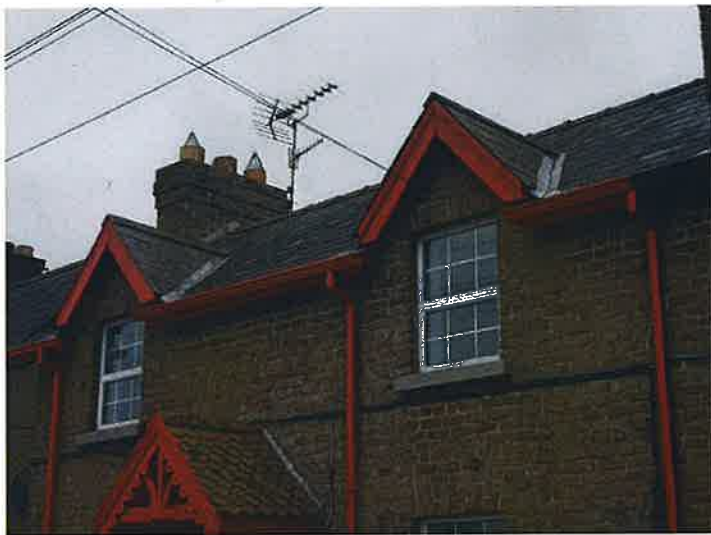
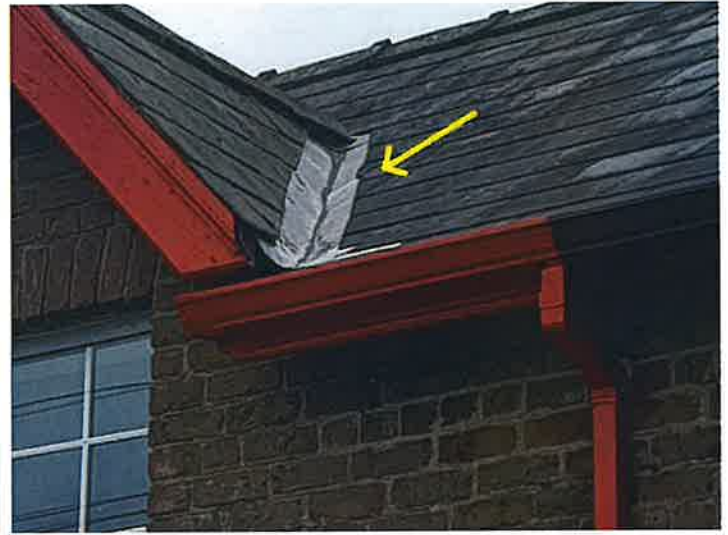
Sample of slipped roof covering.

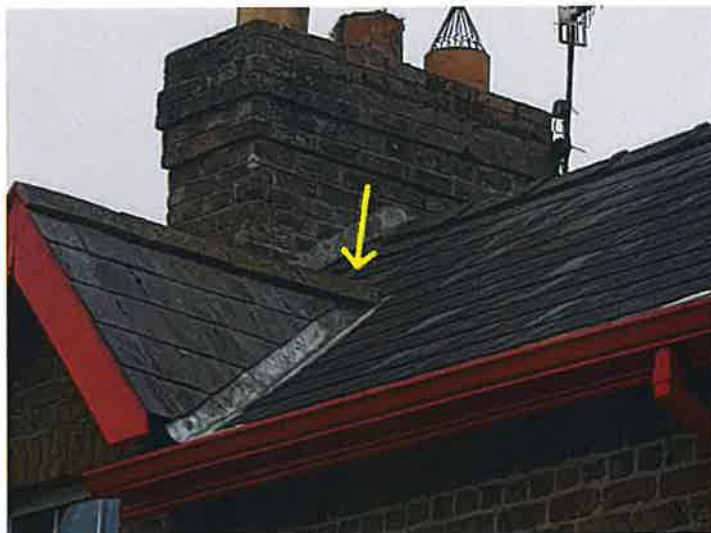
Sample of cracked / damaged roof covering.
