## Declaration

In accordance with Part IV, Section 57 (2) of the Local Government (Planning and Development) Act, 2000 (as amended).

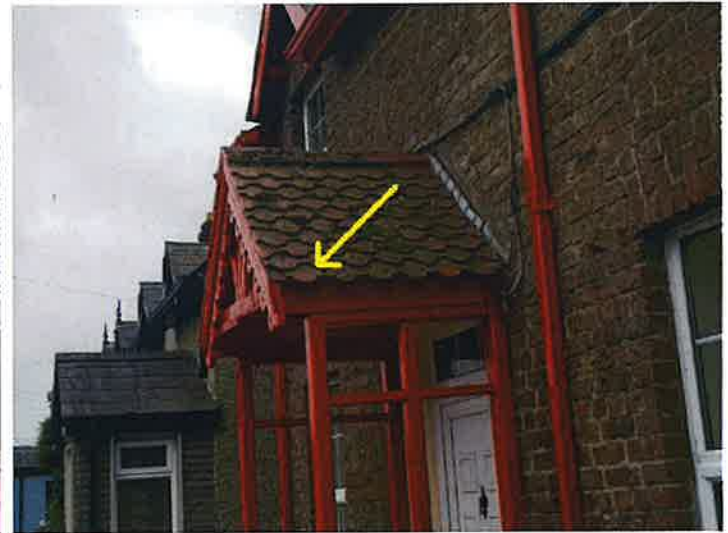
Sample of missing roof covering.

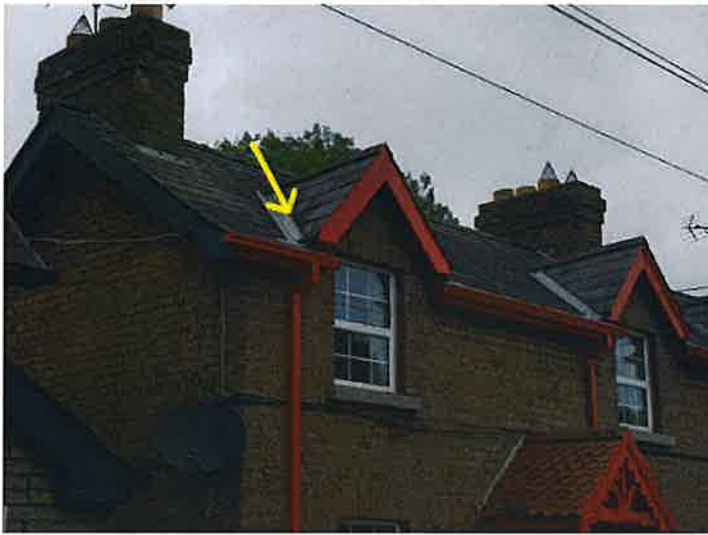
Sample of slipped roof covering.

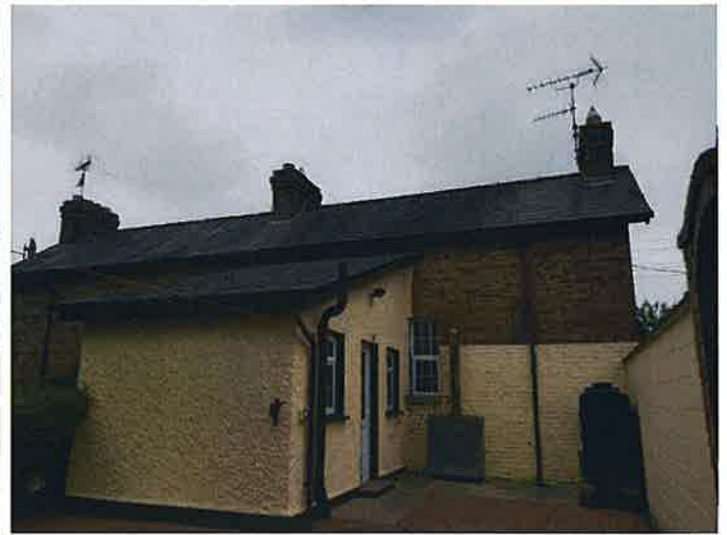
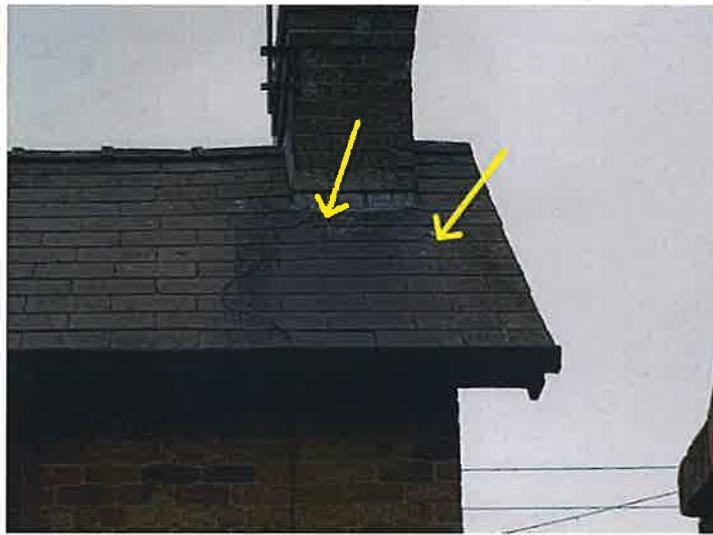
Sample of cracked / damaged roof coverings.

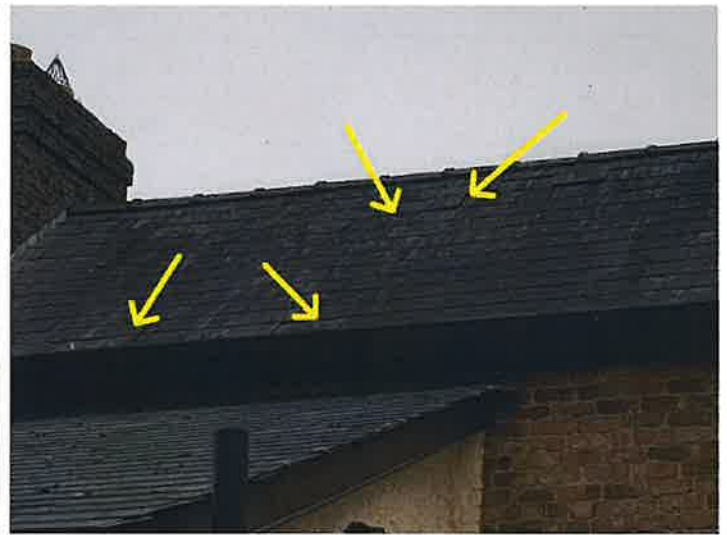
Sample of slipped/ lifted roof covering.

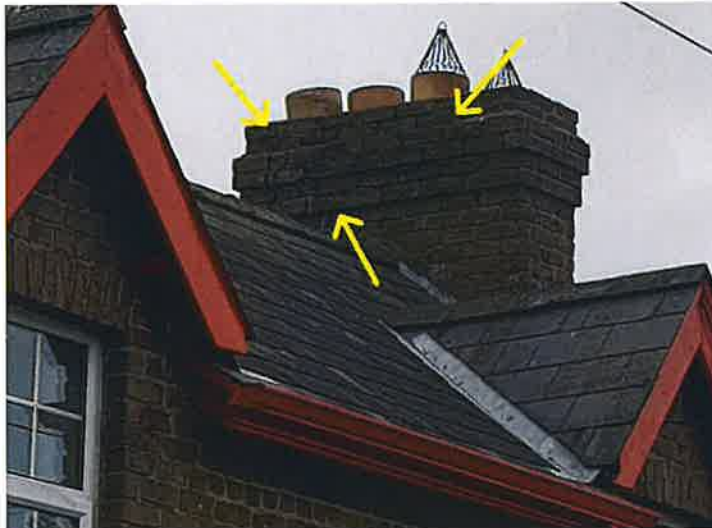
Repoint brick chimney. Brick and mortar deterioration observed; repair advised.

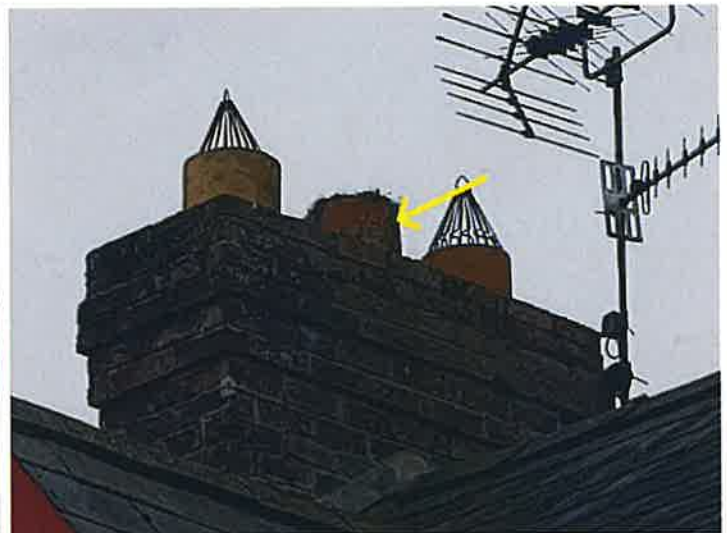
Replace / repair chimney capping / pot/s.

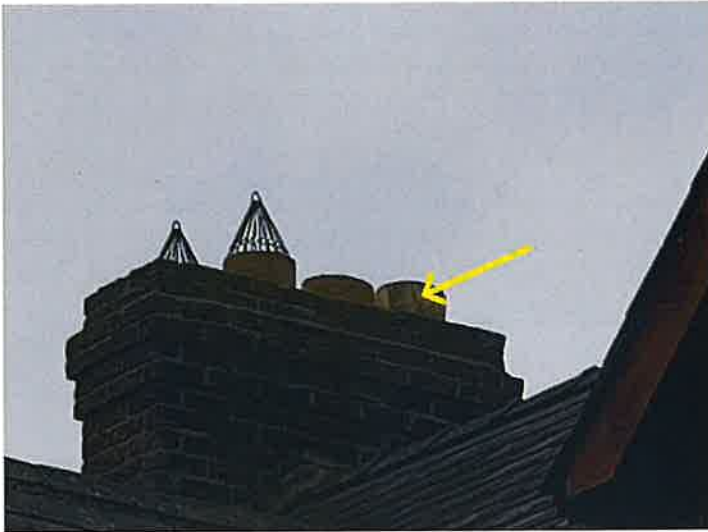
Replace / repair chimney capping / pot/s.

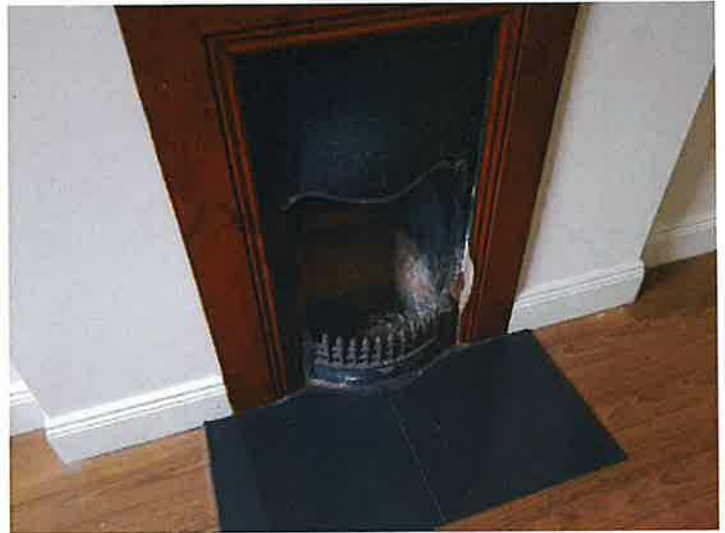
The fireplace/s would appear to be in a fair condition where visible.

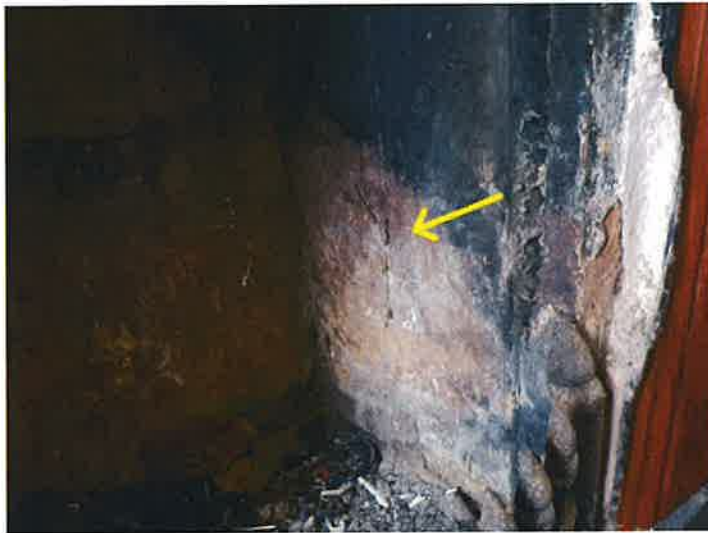
Repair damaged firebrick in fireplace.

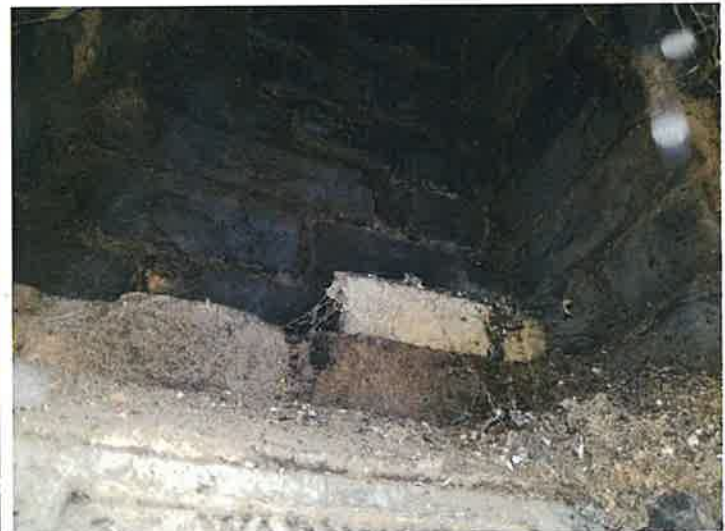
Chimney flue, should be cleaned out before use.

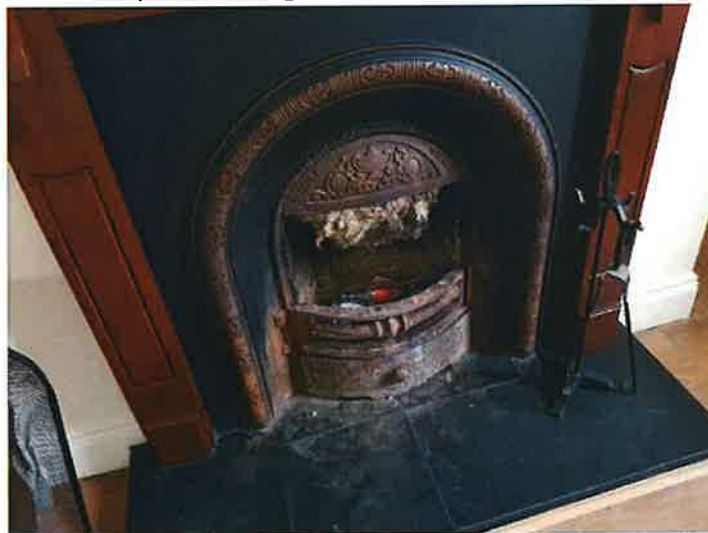
The fireplace/s would appear to be in a fair condition where visible.

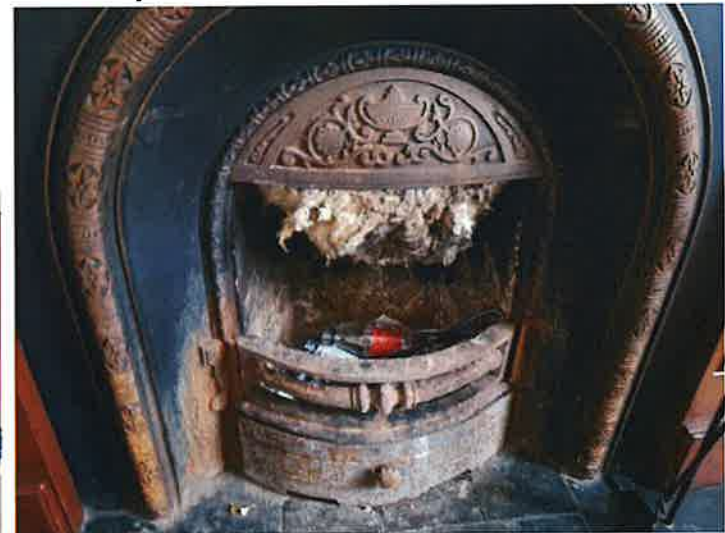
Treat rusted fireplace

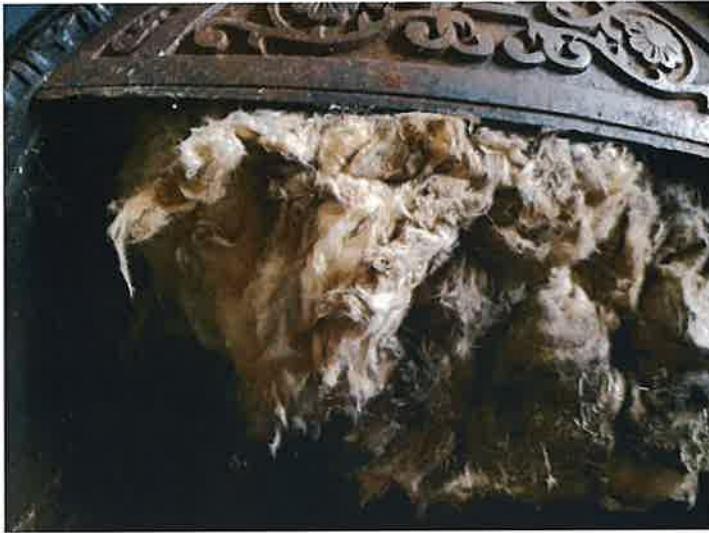
Chimney flue, should be cleaned out before use.

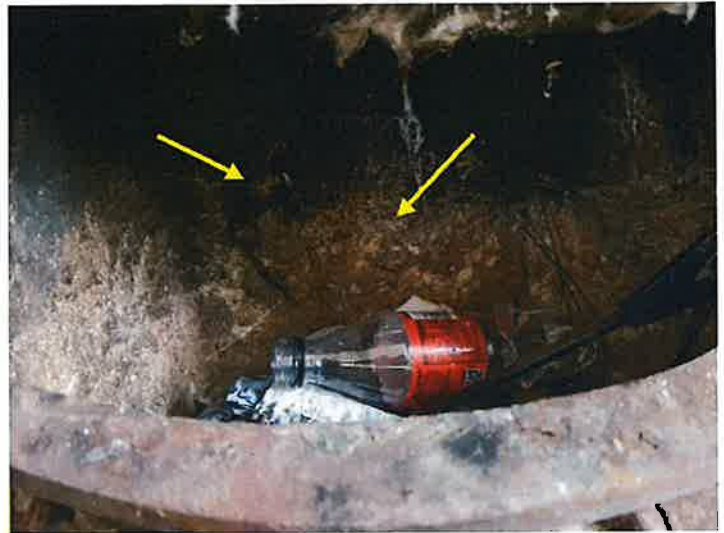
Repair/ replace damaged firebrick in fireplace.

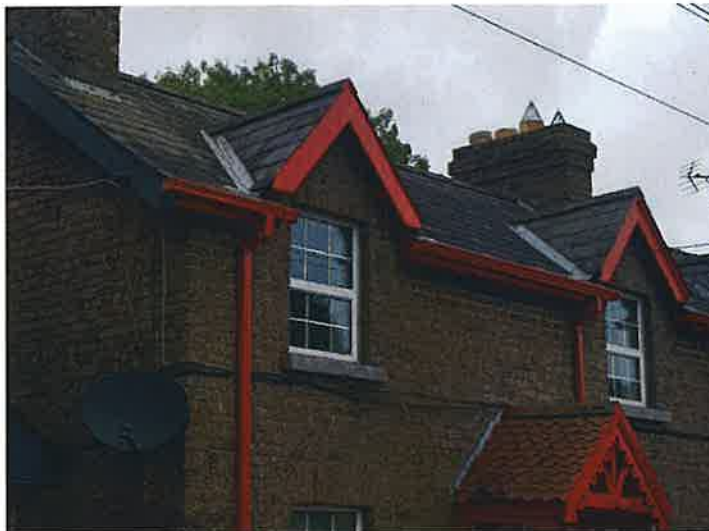
Roof flashings / valleys are prone to leak during strong wind driven rain, monitor. Normal maintenance required.

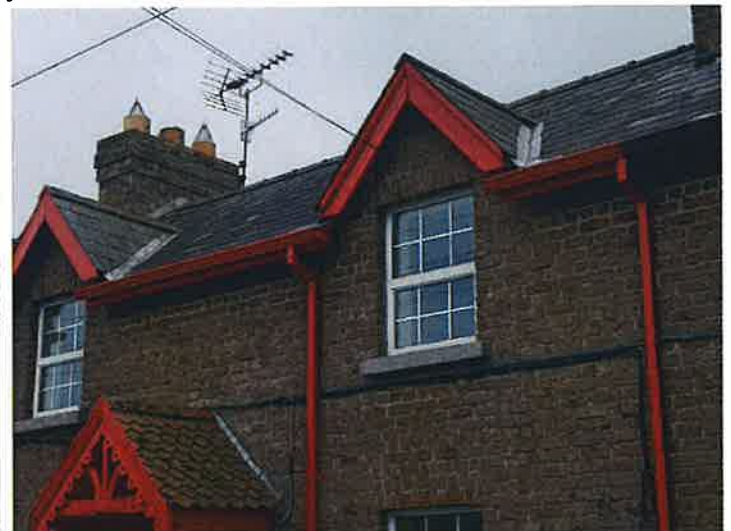
Roof flashings / valleys are prone to leak during strong wind driven rain, monitor. Normal maintenance required.

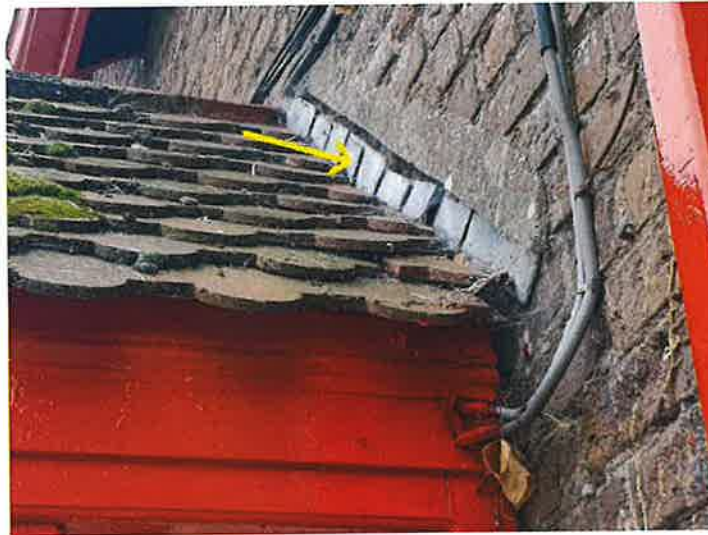
Re-secure / repair flashing to front canopy.

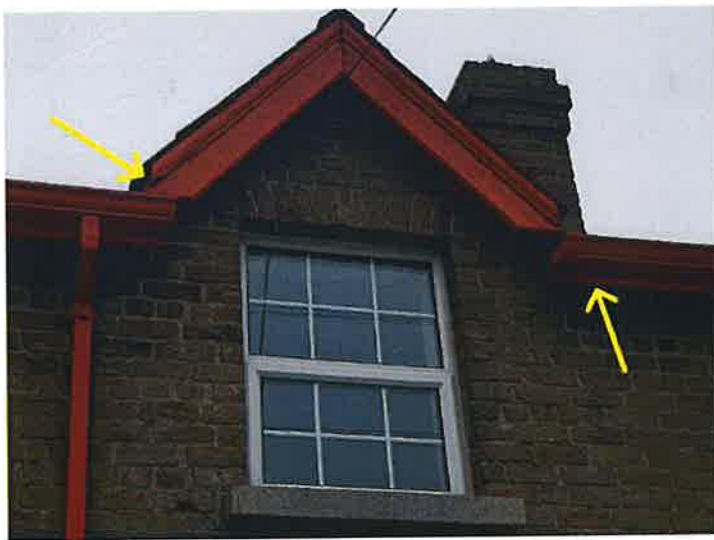
Sample of rotting sections of timber fascia and soffits.

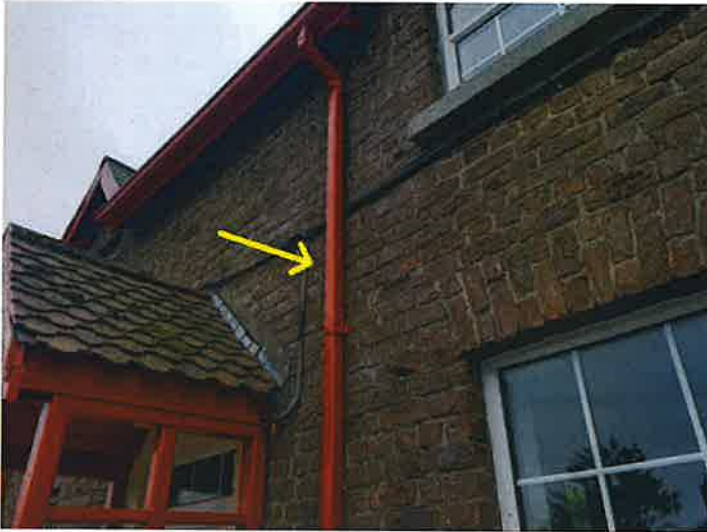
Secure loose downpipes to property.

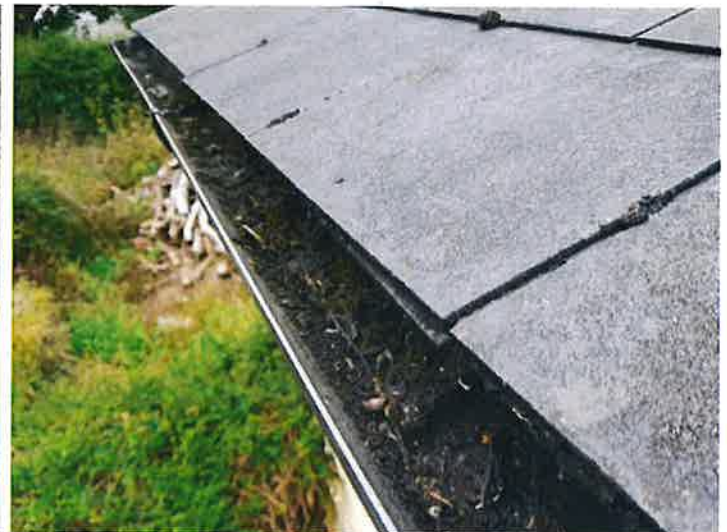
Remove debris from gutters.

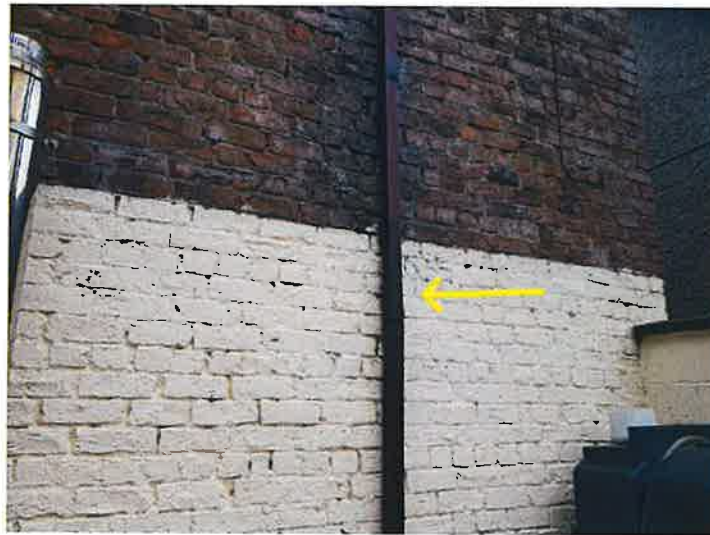
Secure loose downpipes to property.

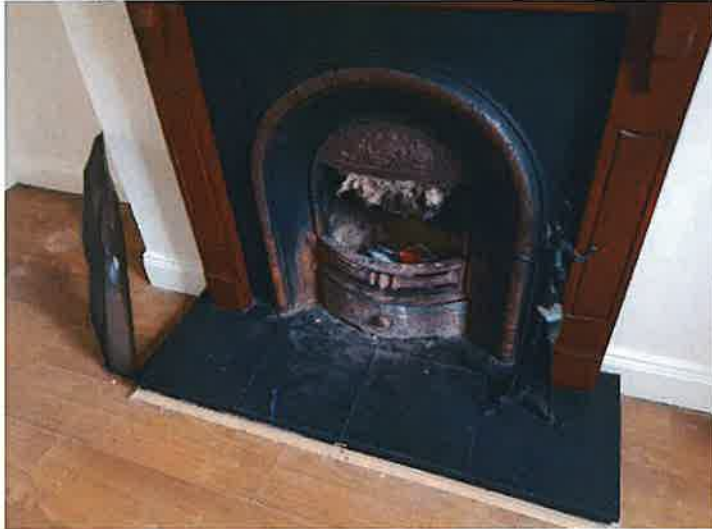
Chimneys providing ventilation to rooms.

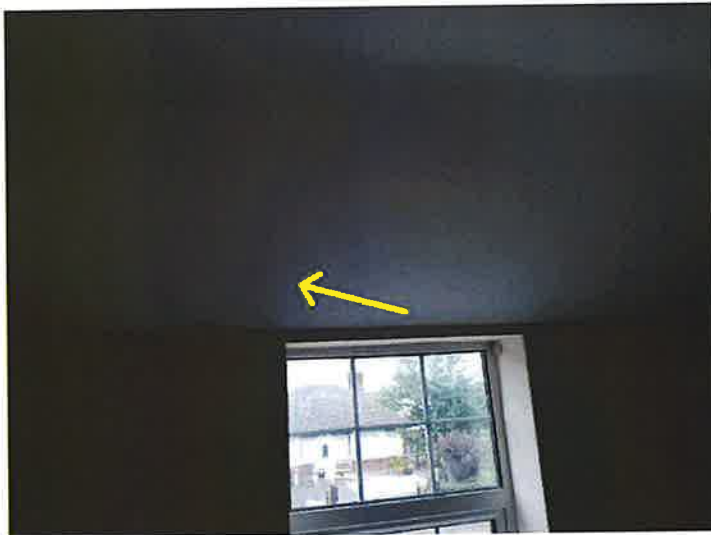
Sample of crack/s in ceilings.

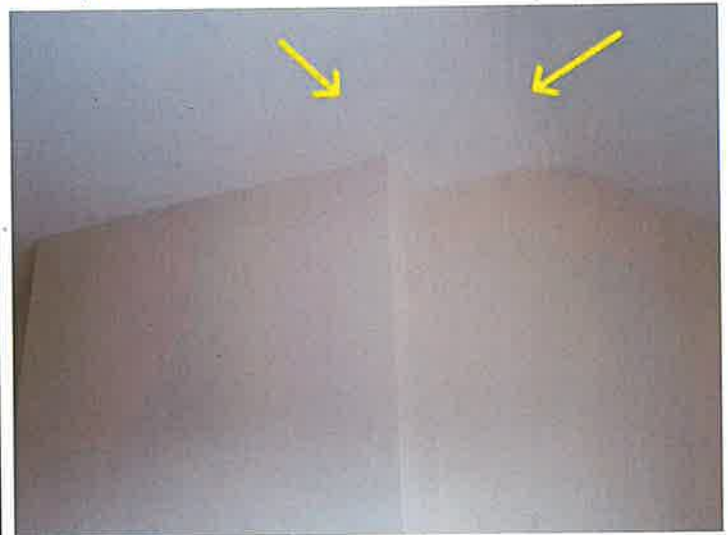
Moisture stains/ patched repairs in right bedroom ceiling adjacent to chimney. Dry at the time of inspection, further investigation / repairs required.

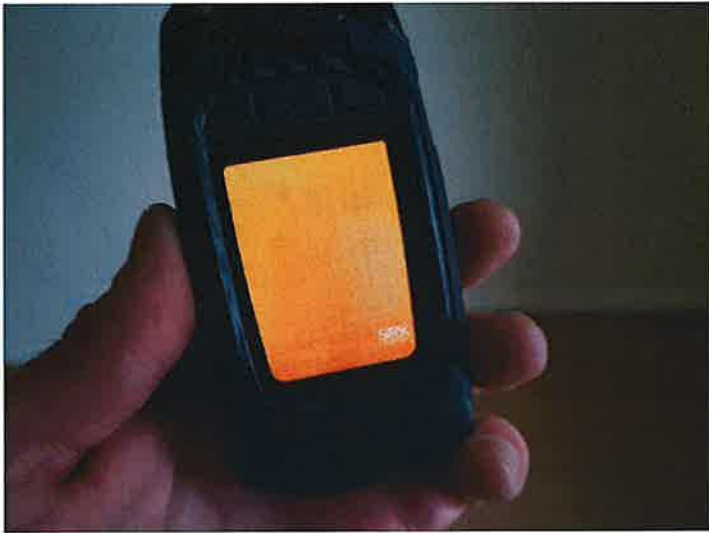
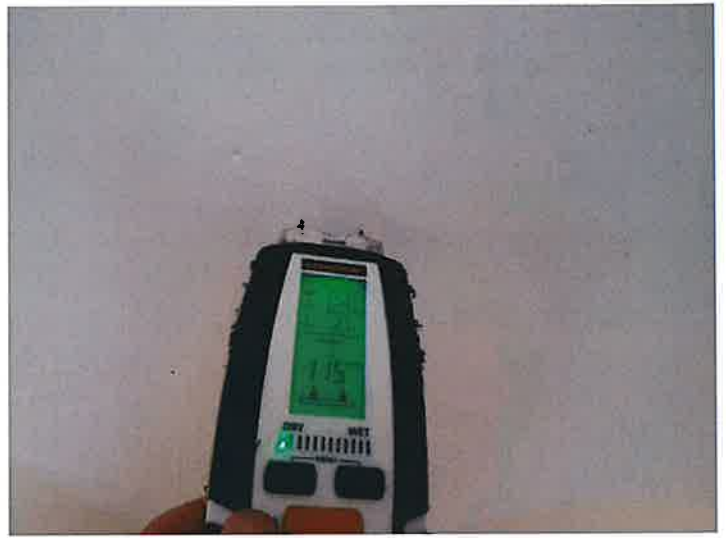
Moisture stains/ patched repairs in right bedroom ceiling adjacent to chimney. Dry at the time of inspection, further investigation / repairs required.

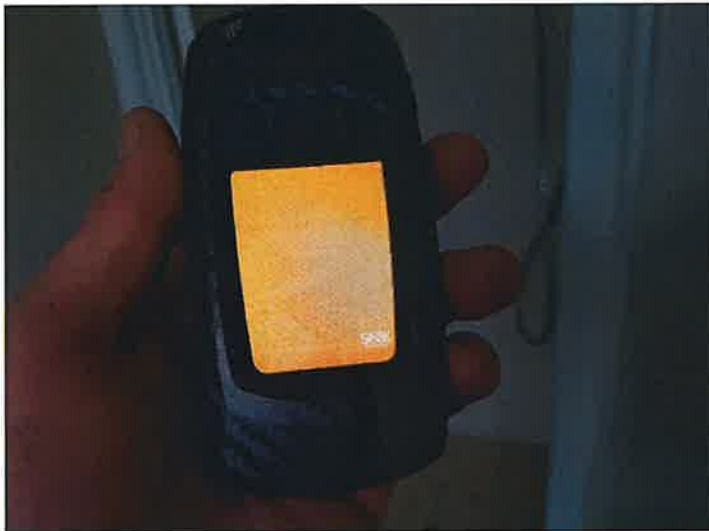
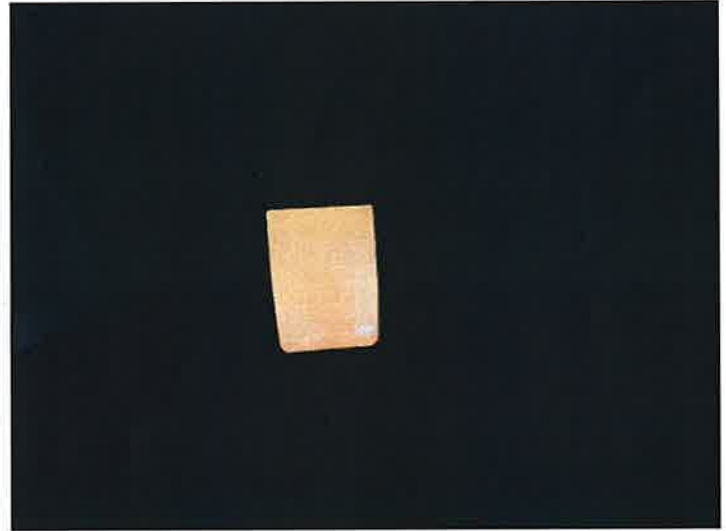
Ceiling dry at time of inspection.

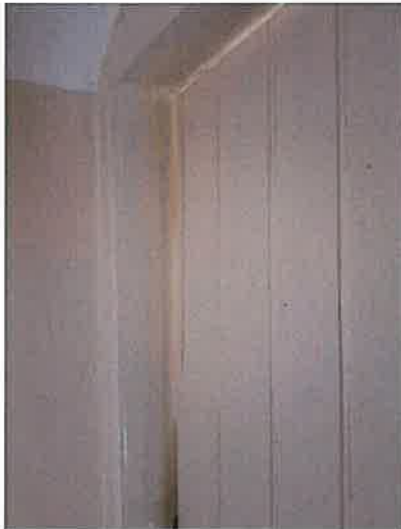
Doors to bedrooms not sitting square on door frames.

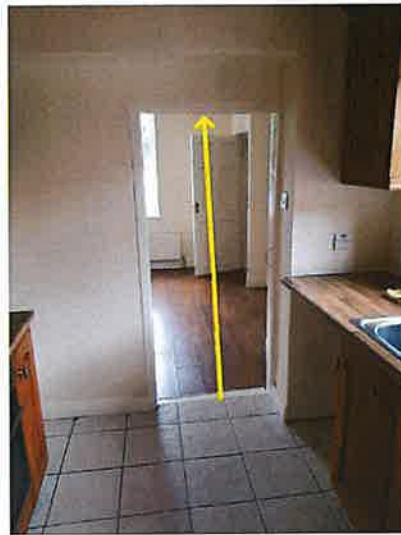
1.780mm door height to kitchen, below recommended 2.030mm. Hazard.

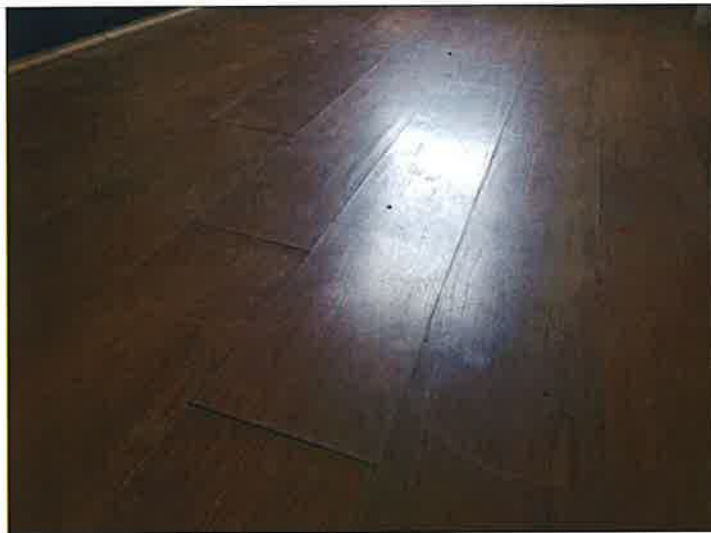
Sample of detached laminate flooring

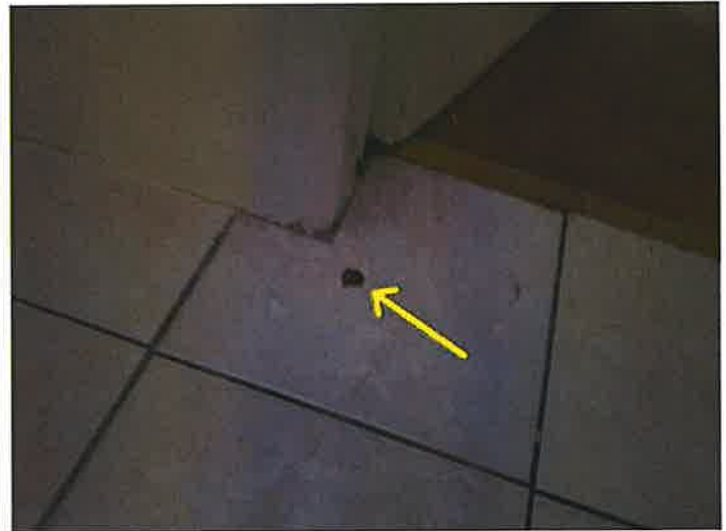
Sample of floor tiles damaged in hallway.

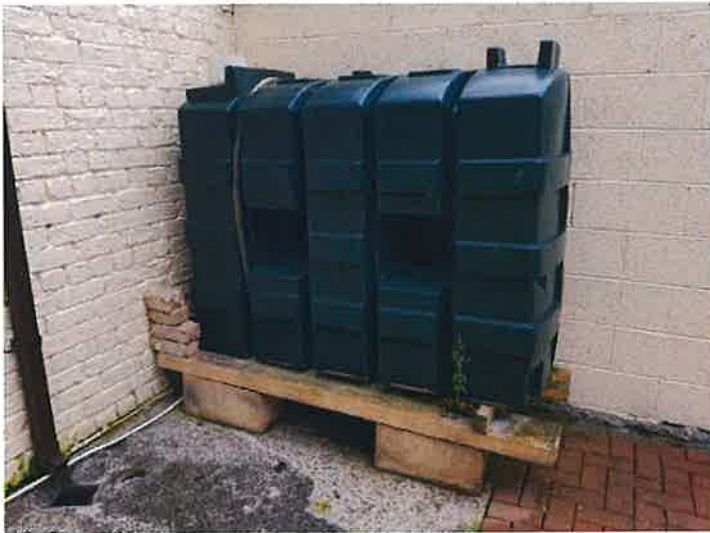
No power to system at the time of inspection.

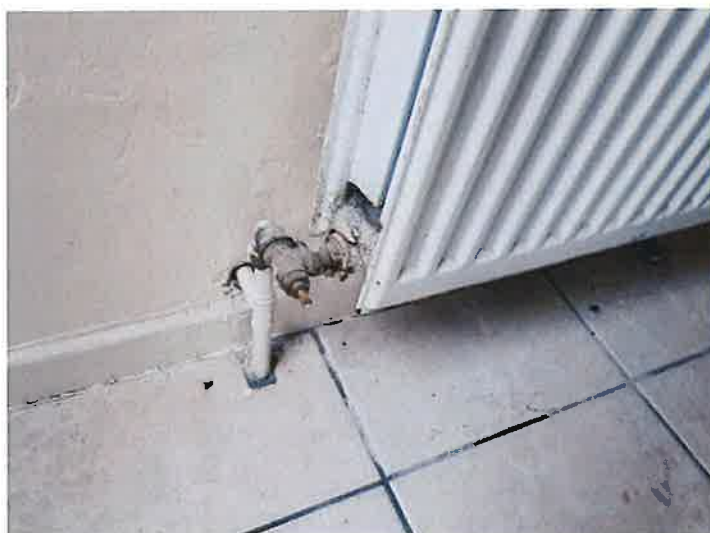
Sample of valve covers missing to radiator pipes.

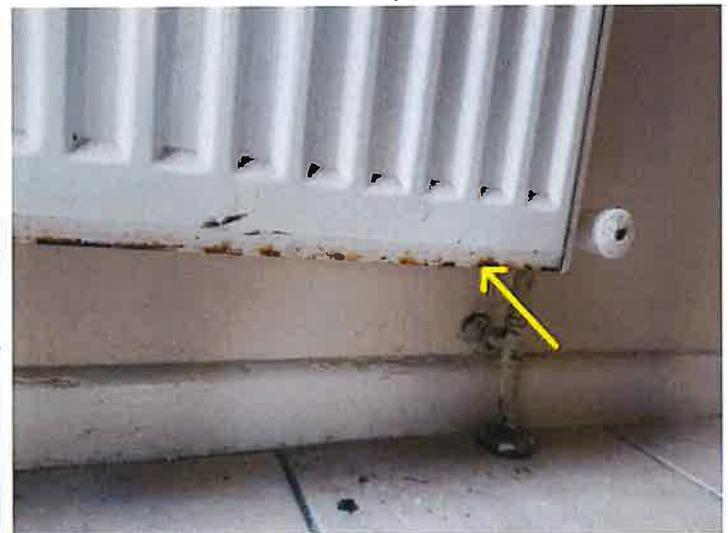
Sample of corrosion in radiator to property.
