# Carlingford

Historic Town Walls  
County Louth

Conservation & Management Plan

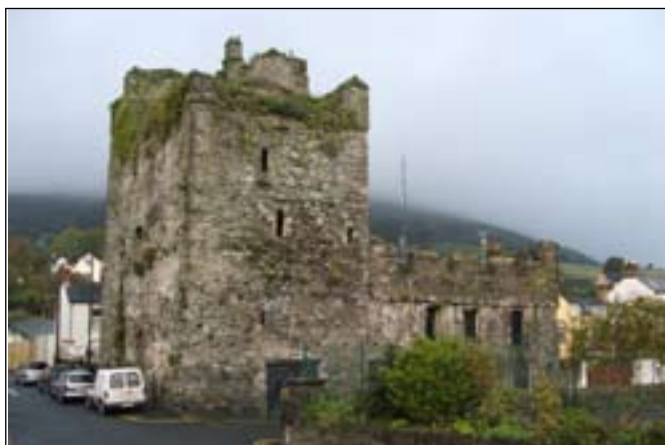
Substantial remains of a c16th century four storey fortified tower house with a later 16th century two-storeyed north annexe.

There are several conservation issues/threats including adjacent development work, current development work on the building and vegetation and water damage.

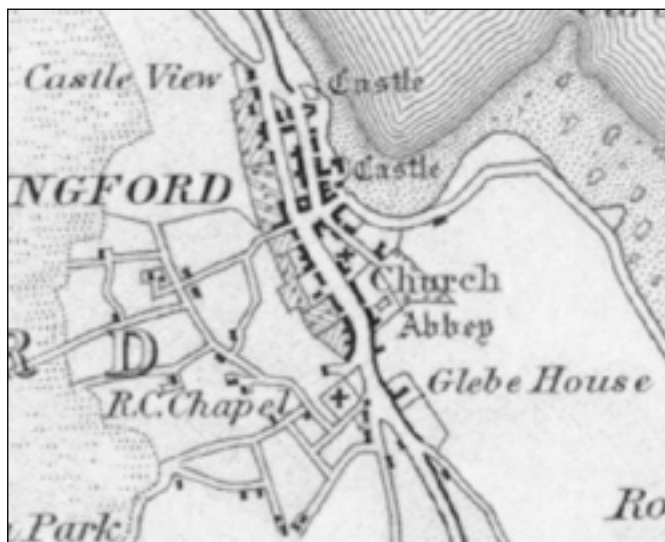
The ground floor contains a passage along the west side entered by the present door and formerly by the now blocked west door. The passage leads to spiral steps in the north-west corner accessing the first floor. The main ground floor room is not accessible from the passage and must have had a separate door or doors in the north and/or east wall where there are now modern doorways.

The first floor has a barrel vaulted ceiling. It also has a small chamber to the west above the lower passage but this is off the main room and separated from the spiral stairs which continue up in the north-west corner to the second floor. There is a mural garderobe chamber in the north-east corner which has the ogee headed slit mentioned above and a fireplace in the north wall.

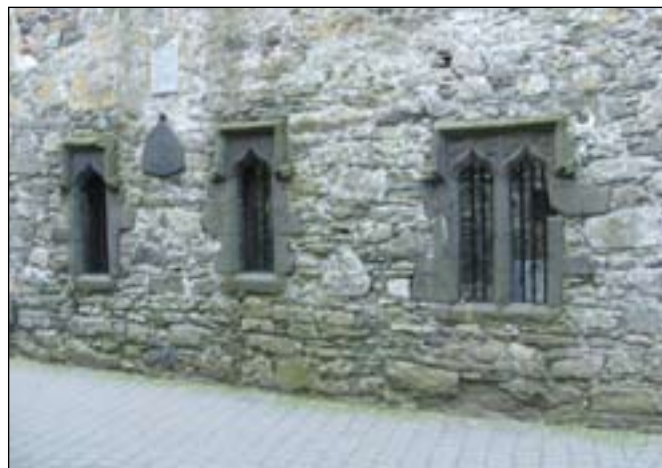
There is a large machicolation, c.1.2 m wide, resting on double sandstone corbels directly over the doorway and extending down from the battlements to about 2 m

above the top of the doorway. The door has a rough stone surround excepting for the lower north jamb which is of dressed chamfered jamb stones with punched geometric designs.

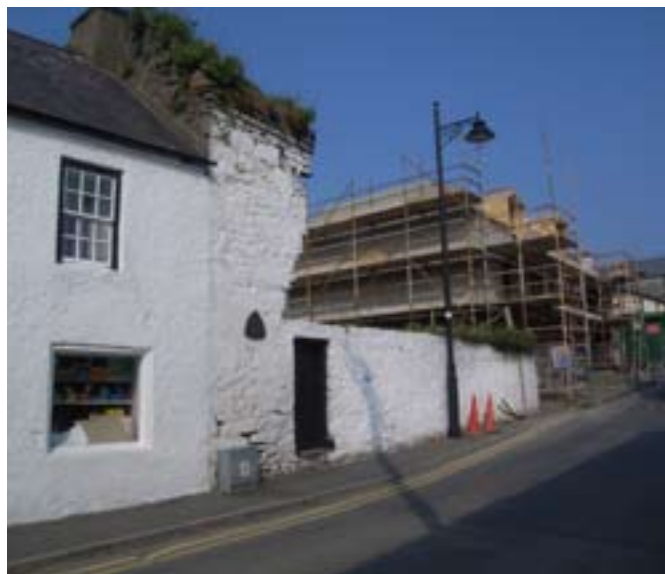
Urban tower houses are not as common as those in rural settings so the Watch House is significant for this reason. Its full significance is uncertain because the interior has not been seen and the exterior has been rendered and painted, therefore it is not known what early or interesting features may survive in the fabric and indeed how much of the early fabric survives and how

much is later alteration. As a former lifeboat house and watch house it is obviously also of historical and social significance to the town and its maritime heritage.

The 'medieval house' is a ruin and some of the upper stones of the gable and east return look a little precarious and perhaps in need of consolidation to prevent any decay of the structure. The east face of the east wall is whitewashed but the gable is unpainted stone.

- There is currently new development occurring immediately north of the ruined house with scaffolding adjacent to the north wall which may be part of the medieval gable.
- There is heavy vegetation on the top of the South gable which may be loosening the stonework and some of the upper stonework appears in need of stabilisation/consolidation.
- This site may be under threat of development, some archaeological work has been undertaken in this area in advance of development and it is likely that some significant below ground deposits survive in the vicinity of the ruined house.
- The Watch House might look more in keeping with its historic origins if without the present surface treatments but this is a conservation issue which would need expert advice and of course discussion and cooperation with the owner.

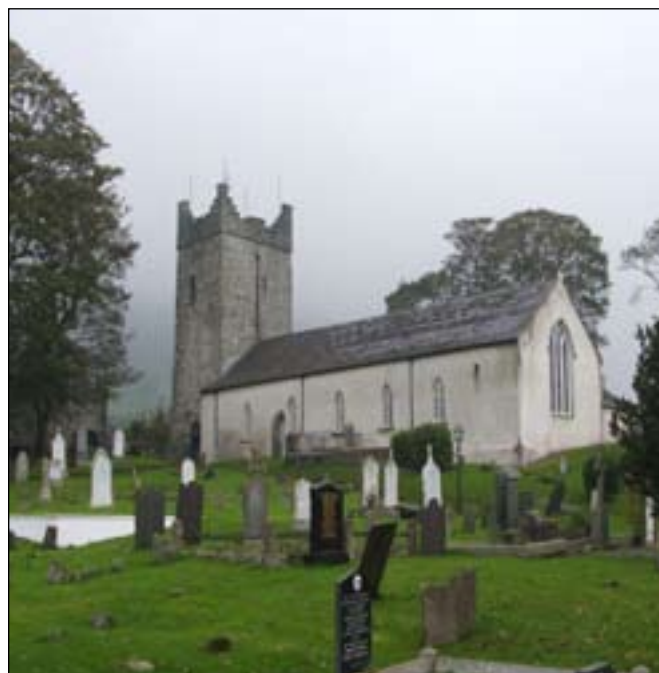
The building consists of a square west tower and rectangular nave extending east from it, there is no distinct chancel section.

The nave has a pitched roof clad in slates and the walls are rendered. There is a large round headed window in the east end with a dripmould and label stops. The window is divided into three pointed lights and glazed with modern stained glass. There are five regularly spaced pointed arched windows in either side, these have stone sills but the surrounds are rendered like the walls. The windows have wooden frames and Y shaped wooden mullions bars imitating stone tracery and are glazed with small diamond panes. All these windows were probably inserted in the c1804 restorations. The second window from the west in the south wall cuts an earlier stone door surround which has been left exposed. This has a chamfered two-centred arch which Gosling dates to the 16th or 17th centuries but which looks earlier, being medieval and probably of the 14th or 15th centuries. The church is currently entered by a round headed door in the south wall of the tower, the arch consists of numerous stone voussoirs. The doorway is fitted with a later wooden frame and door, with a radially-glazed fanlight in the tympanum of the arch, all perhaps dating from the c1804 works.

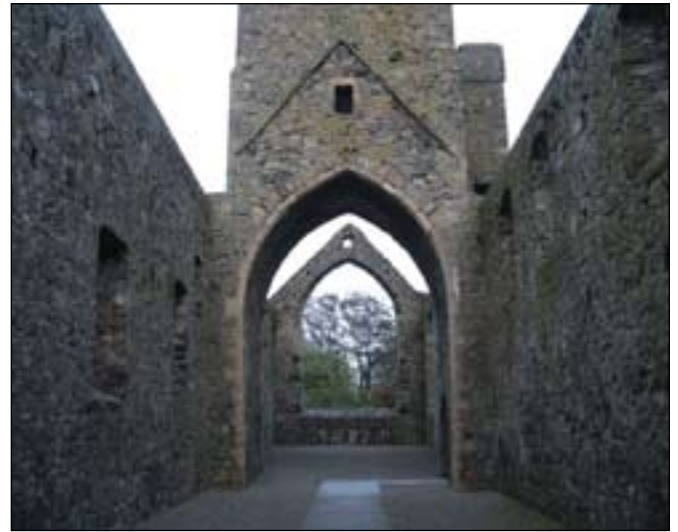
The chancel has a large east window, three windows in the north wall and one in the south wall. The east window has a two centred arch and no surviving tracery. The north win-

dows are largely blocked, two have pointed arched heads the other has been altered to a flat arch. The south chancel window has a flat arch, matching that on the north.

The tower is a later addition thought to be of the first half of the fourteenth century. It is a standard friary tower, a narrow rectangle in plan, and has a stair turret in the south-east corner. The large tower arches are two-centred and the pitch line of the roof is visible on the east and west tower walls. The upper floors of the tower were accessed from the south range via a now blocked doorway in the south wall of the tower.

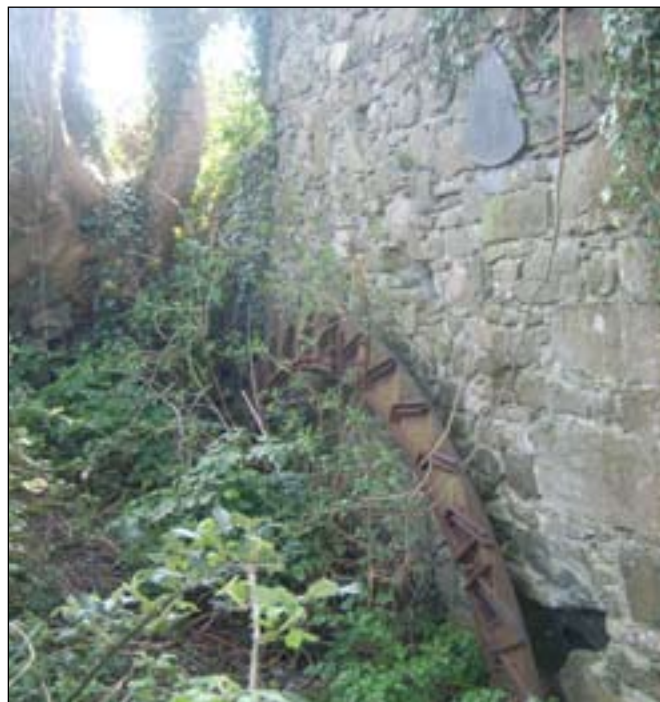
The remains of the mill are situated 50 m east of the Friary church adjacent to a path and built into a slope, as is common with watermills, to achieve the drop of water to power the wheel. The building is overgrown and roofless and consists of a small, rectangular plan structure of random stone rubble with large, roughly-squared quoins. The east and west walls have gables for a ridge roof. Adjacent to the east gable is the half buried cast-iron rim of the wheel with forged grooves for the wooden buckets and wheel spokes.

South of the Friary is the overgrown and recently infilled and remnant of the mill pond and adjacent to it a stone lined channel where a stream still runs for part of the length, fed by the stream and culvert coming from under the road to the west.

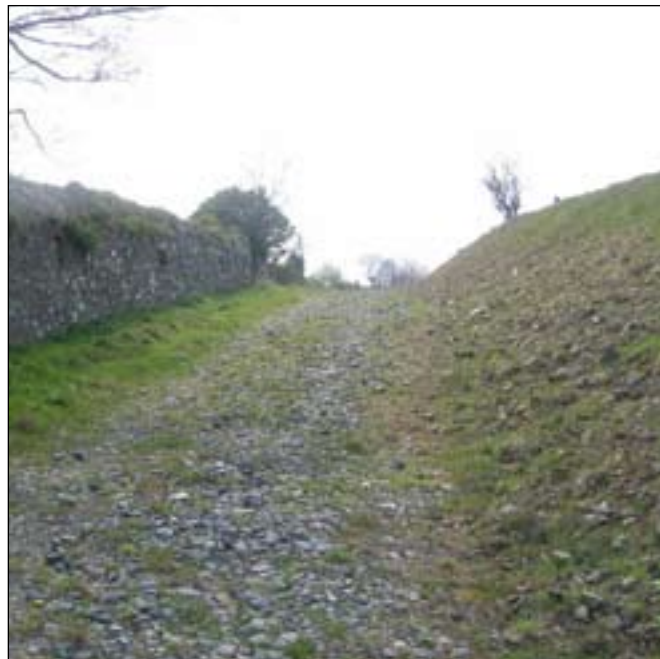
continues for over 2 m (at the north end) to ground level with 2 or 3 lesser irregular offsets. If the west face of the wall continues below ground without offsets the wall would be about 1.5 m thick at inner ground level.

Both ends of the surviving fragment are roughly broken showing the wall once continued in both directions. There are two separate builds represented in this wall. Approximately 6m from the southern end is a straight joint and slight offset. The 20m northern section of wall has large quoins at this end and is offset slightly to the west. The southern section (c. five metres long) does not have quoins on the west side and appears to be later, having been built against the existing terminus of the northern section.

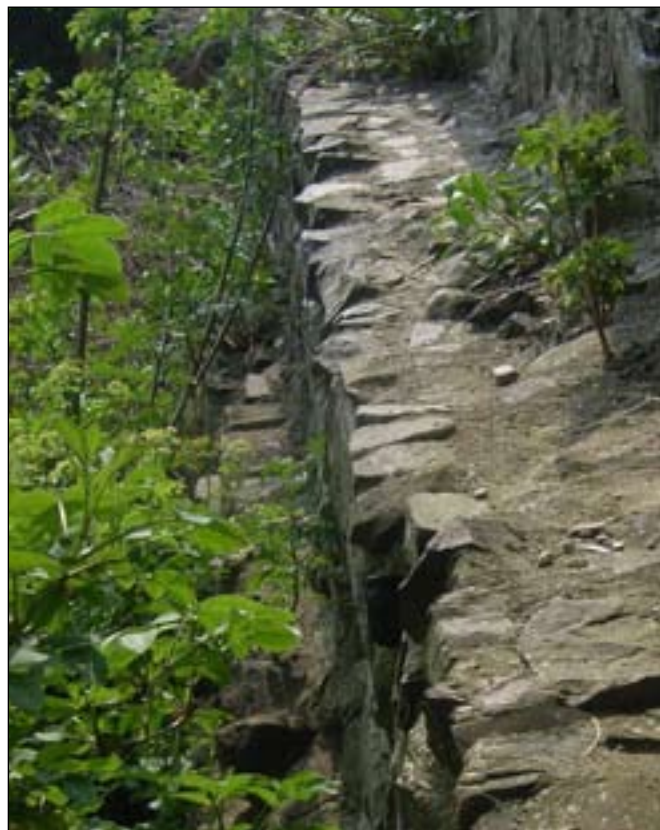
The Condition of the wall is generally good although some repointing has occurred. Apparently the wall was repaired as part of the FAS scheme about nine years ago (pers. comm. Ann Hrugb). There are frequent patches of lichen on the stones on the west face of the wall and some vegetation rooting into crevices in the stones particularly in the coping at the north end. On the east side the wall fabric is not particularly affected by gardening activities. The end of the garden at the north is largely left alone but the wall is free of vegetation excepting a large established tree which has partly grown over the foot of the wall but does not appear to have caused any disturbance to the wall fabric itself.

- The current adjacent residents respect the wall and their activities do not appear to have affected it adversely; however future change in use or ownership and residents could potentially affect the condition of the wall.
- The re-scarping of the land on the west to form a track and embankment has been deleterious to the setting of the wall and its historic relationship to the mountainside.

- Access to this stretch of wall for locals and visitors is an issue if it is desired for it to become a more prominent feature of any tourist/ heritage walk or tour because it is on private land on both sides.

- If it is to be more accessible then provision of information and presentation of the site needs to be addressed.
- The owner of the land to the west stated that he was amenable to discussion about public access to the wall and although he had not yet replaced the gate to the lane behind the wall, was considering adding a stile when he does and possibly a seat to make it into a small amenity area.

- The condition of the wall and repair of any loose masonry could become a health and safety issue if the wall is to be openly accessible.
- The roots of shrubby vegetation could penetrate into the gaps between stones, loosening the mortar and gradually weakening the structure, if not removed or controlled.

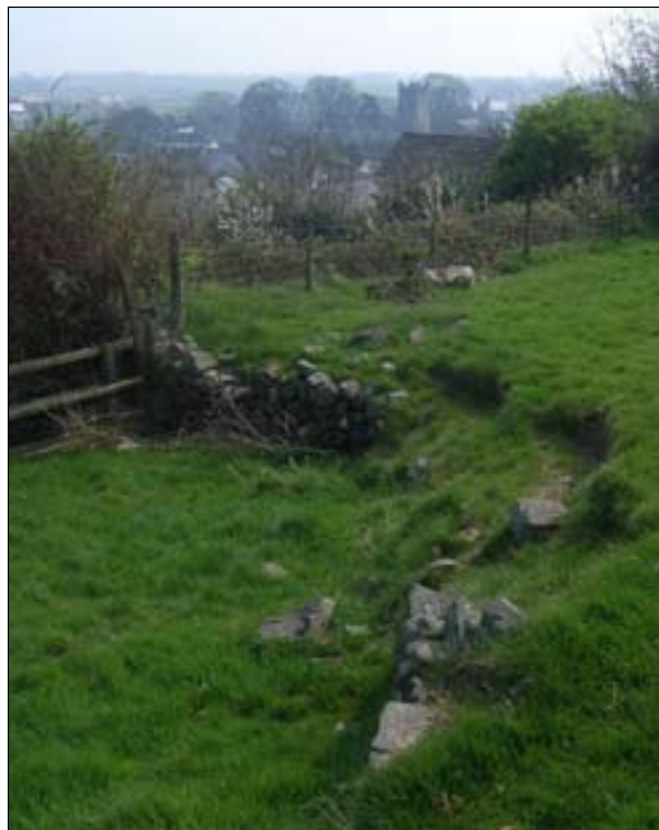
[A] Immediately south of the standing wall (B2.03) are two modern properties with a total boundary to the wall of about 50 m. Along most of this section there is no wall upstanding from ground level on the west, but there is a steep drop to the east of one to two metres, which probably consists of the lower revetting part of the wall, but this was overgrown and not seen from the east. Some odd stones were visible and for a stretch of 15 m near the north end there was surviving wall remnants up to 0.7m high from ground level on the west. The masonry was overgrown with ivy and the rest of the section with bramble and thorn. This section has been scarped externally to make the road.

[B] The next property to the south has a 25 m frontage where the wall has been removed and the bank sloped from the field into the garden. The wall here had been rebuilt at either end of the property projecting into the field at right angles to the wall line and then returning to create a small terraced area. This is shown on the 1836 OS map as the site of a track or roadway running from the pasture onto the plot and down to Back Lane. The wall was therefore dismantled and realigned to allow for a trackway by 1836. The track no longer exists and there is a wire fence in place; the terrace remains have recently been landscaped and removed.

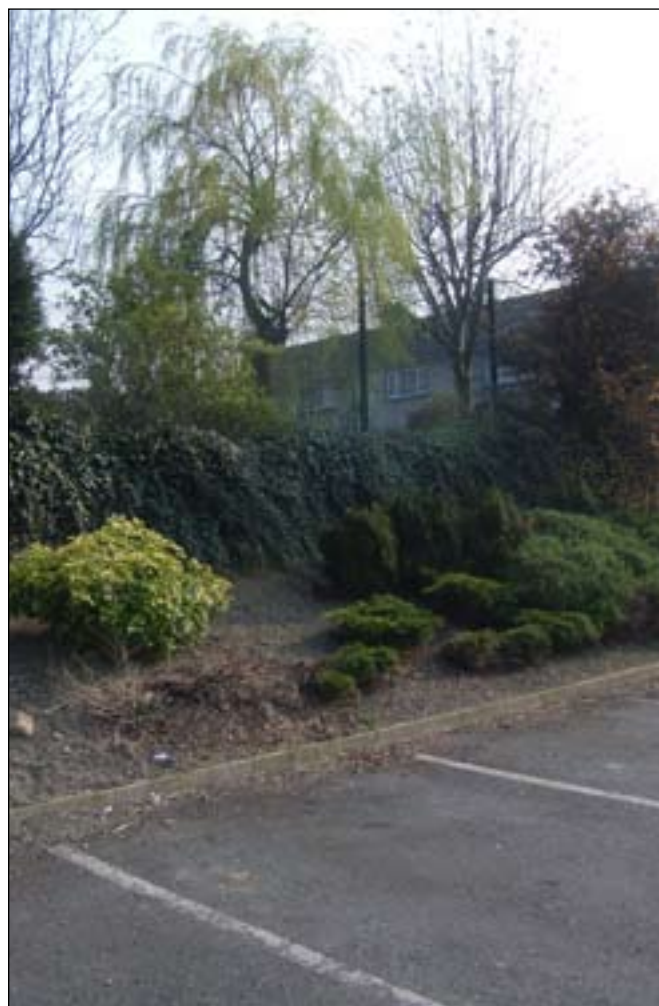
The south boundary of the Trinity Close estate dividing it from St Oliver's estate consists of a low terrace revetted with a dry rubble wall, on the north side, and a modern mesh fence. The line of this is parallel to and a short distance south of the putative wall line. The revetting wall looks like a modern construction but is probably made of reused

stone from former nearby structures and it might possibly be on the line of a former wall. The terrace might though be modern and result from levelling for the construction of the modern estates and this process may have removed any former upstanding evidence of the town wall if it existed in this area.

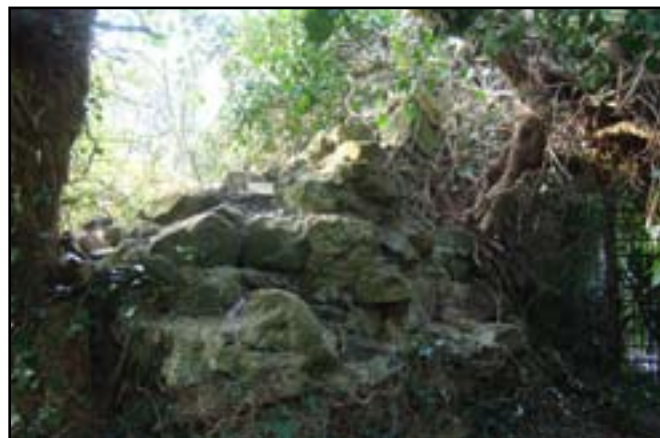
[A] From the east a one metre high stone wall was visible behind the health centre off Trinity Close and this seemed to continue with little differentiation from the last part of the previous section but was heavily covered in vegetation. If the town wall had returned east at this point and the south-west wall was connected with the Friary a change in build would be expected as seen on the postcard, but closer investigation would be needed to reveal this and the wall may of course have been rebuilt.

[B] South of this a three metre high section of wall was seen behind No 11 St Olivers Estate (which is a council owned house). This extended behind the gardens of most of the row (Nos. 11-16) but was largely covered in ivy. The south end was simply broken off, the top of the wall was overgrown so could not be compared with the standing wall to the north. The construction of random rubble and the height and thickness of the wall are similar to the other sections of high standing wall.

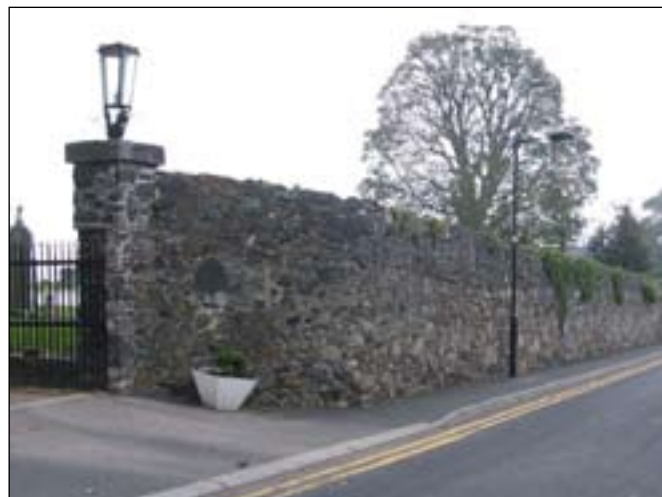
The churchyard is higher than the road on the east and south as well but the differential is not as great as on the north and west. The land rises steeply to the church itself which appears to be built on a natural rise but the height of the churchyard in places near the walls must have been augmented by the burials, so the differential in height may have been less when the walls were first built.

The east and south wall is of random uncoursed rubble about 3m high. The upper metre or so is a later addition in darker stone. On the south side the lower part appears to be of one phase, on the east the lower part, in places, appears to be of two phases with a straight joint between, but the two phases are of similar height, build and material. There is also a long stretch covered in later render on the east face of the wall, north of the east gate.

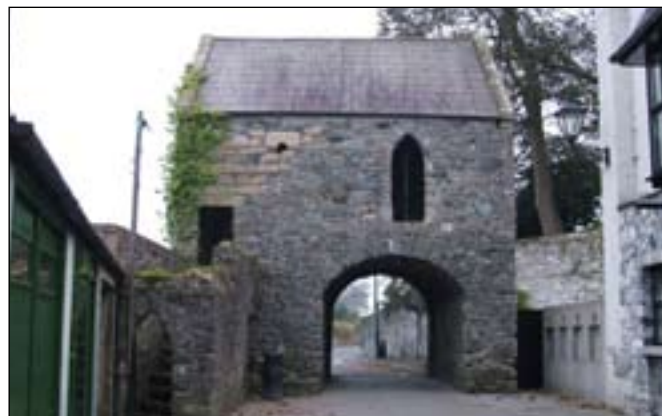
A rectangular gatehouse built of limestone and greywacke rubble, roughly coursed, with dressed stone quoins. It has a flattened barrel-vaulted entranceway with a segmental arch of small greywacke slabs and keystone. It is thought to have been originally of three storeys possibly with a crenellated parapet but the third storey has gone and a modern slate covered pitched roof spans the first floor chamber.

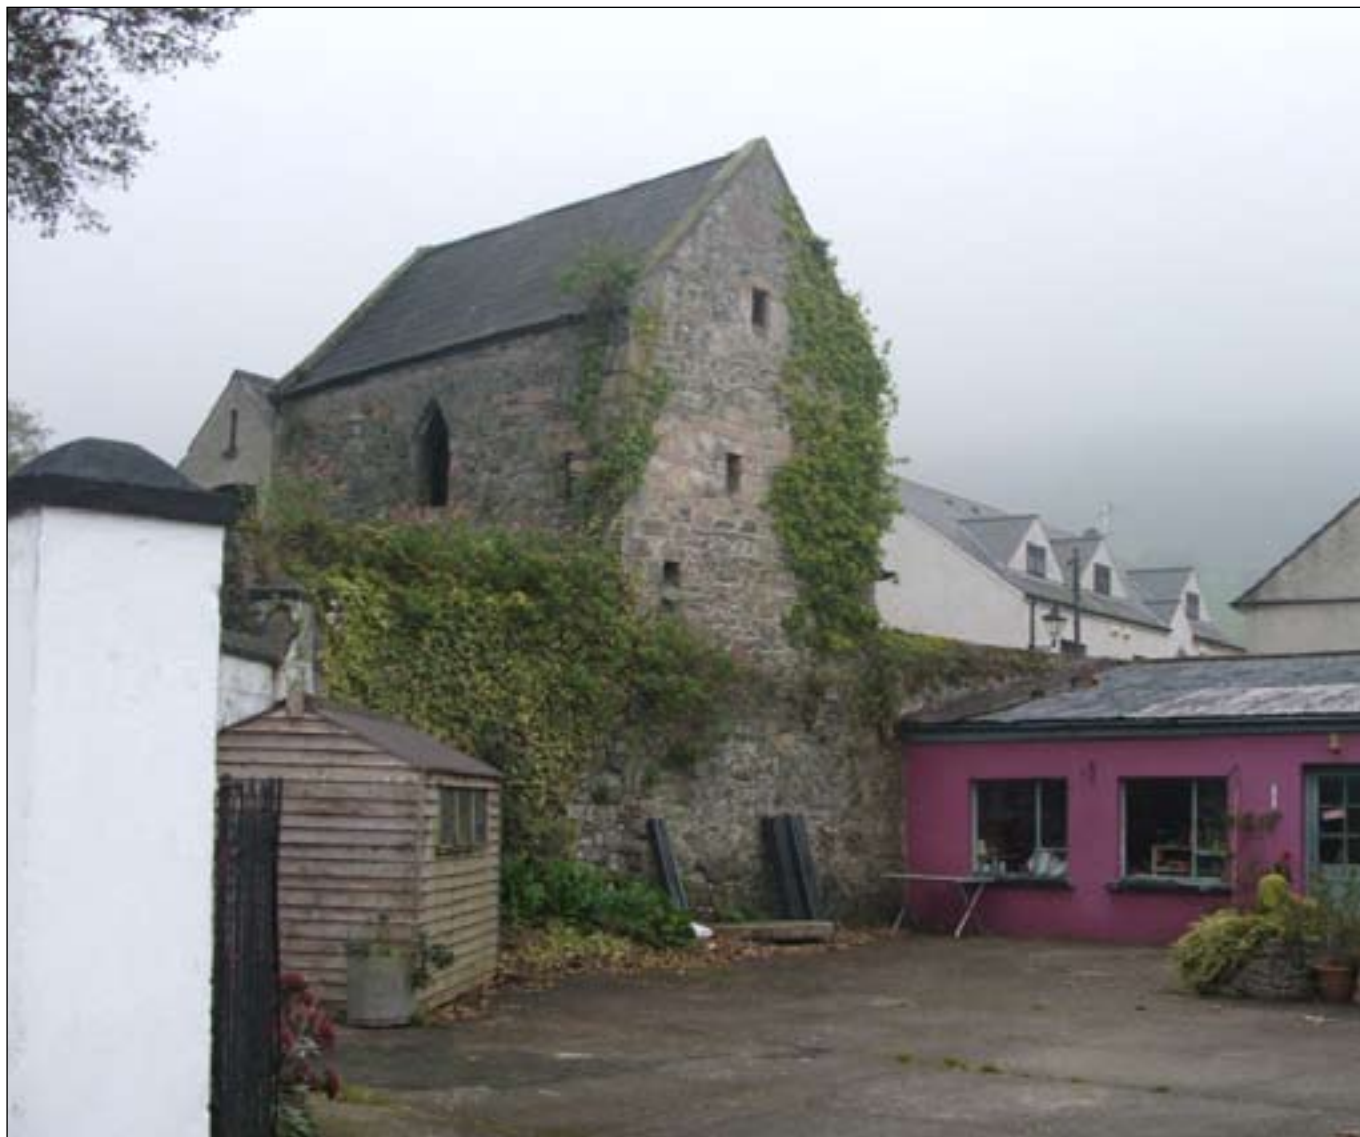
## 2.11 The Tholsel

The west wall also has plain lintelled loops at first- and second-floor level (the current upper gable wall), a cubby-hole at first-floor level in the west corner, and a single splayed opening at first-floor level in the north wall. The building has been much altered with early medieval dressed stone from another building reused to repair this one.

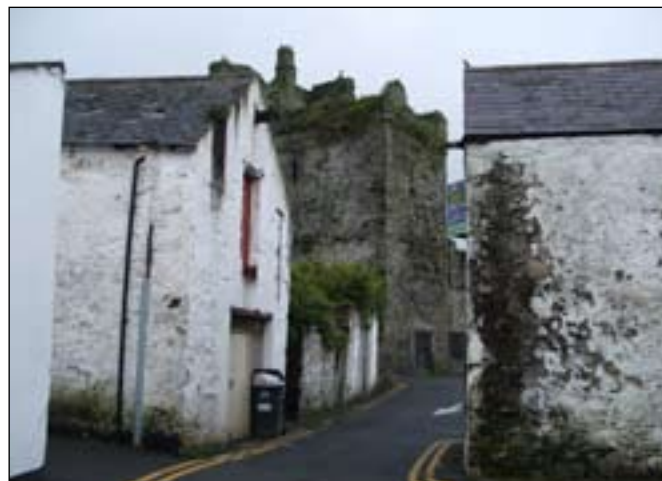
This would imply that the defensive wall or ran north-west along the east side of Tholsel Street from the Tholsel for

an unknown distance. Further north excavation has uncovered a possible medieval shoreline with a feature interpreted as a breakwater roughly in line with the wall extending north from the Tholsel, if this was the shoreline in the medieval period then it is possible that the Tholsel itself was roughly on the shore line and that there was no wall extending east of the Tholsel but rather a wall and perhaps other forms of sea defence structure running north-west from the Tholsel towards Taaffe's Castle.

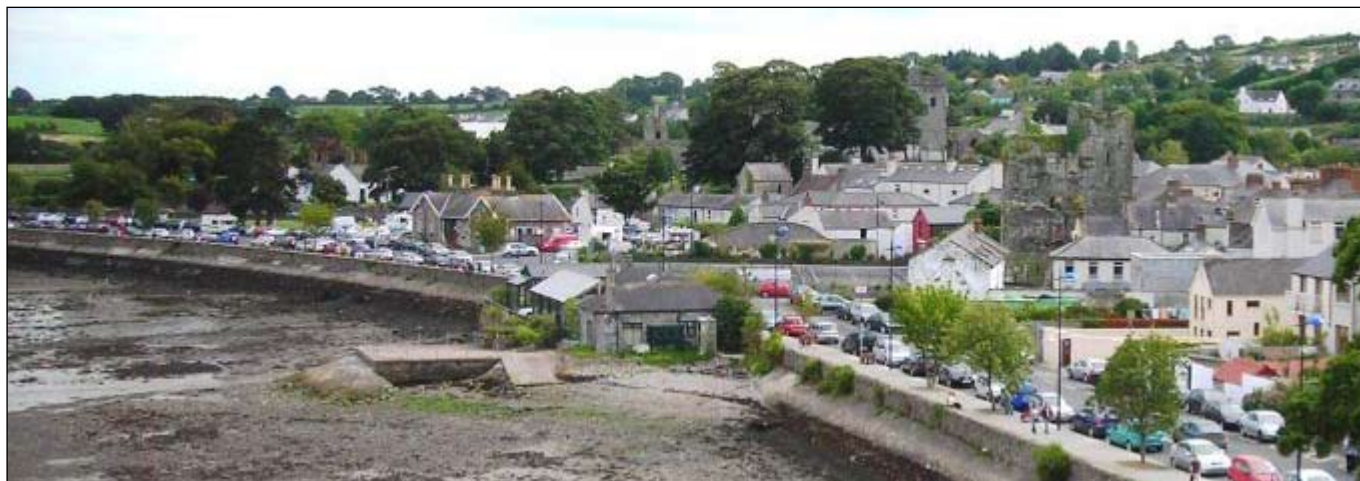
## 2.13 Sea-Shore Defences

ancient wall fabric south of Taaffe's Castle apart from the wall extending north from the Tholsel. That wall, although containing much modern material, including the present Tholsel steps does appear to bond to the Tholsel and is possibly contemporary in origin.
