**APPROPRIATE ASSESSMENT SCREENING REPORT**

**FOR PROPOSED PLAYGROUND, RV PARK,**

**& MINI-GOLF PARK**

**PITCH & PUTT COURSE, NAVY BANK, DUNDALK,**

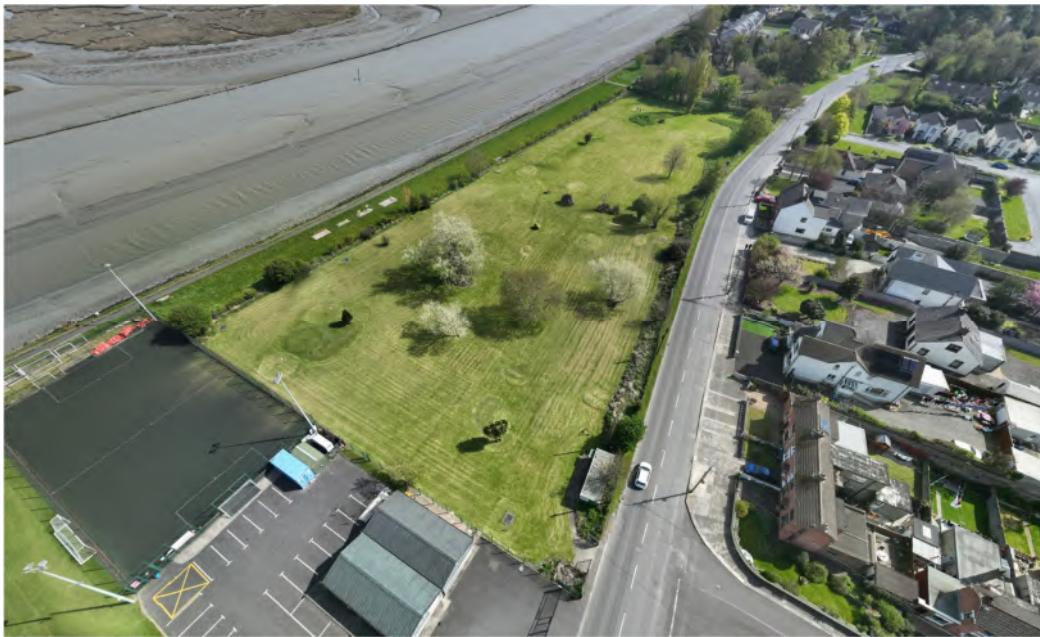
**Plate 1. UAV Aerial photograph of the site at the Navy Bank taken in April 2026 at 60m elevation to the southwest of the site facing in a north-easterly direction**

The site is located along the Navy Bank, to the east of the Quay Celtic Football Club (see Plate 1 below and Plate 2 following and site location maps, Figures 1 to 6). The development shall also provide improvements to the Point Road including a new bus stop, uncontrolled pedestrian crossing point and associated traffic calming measures.

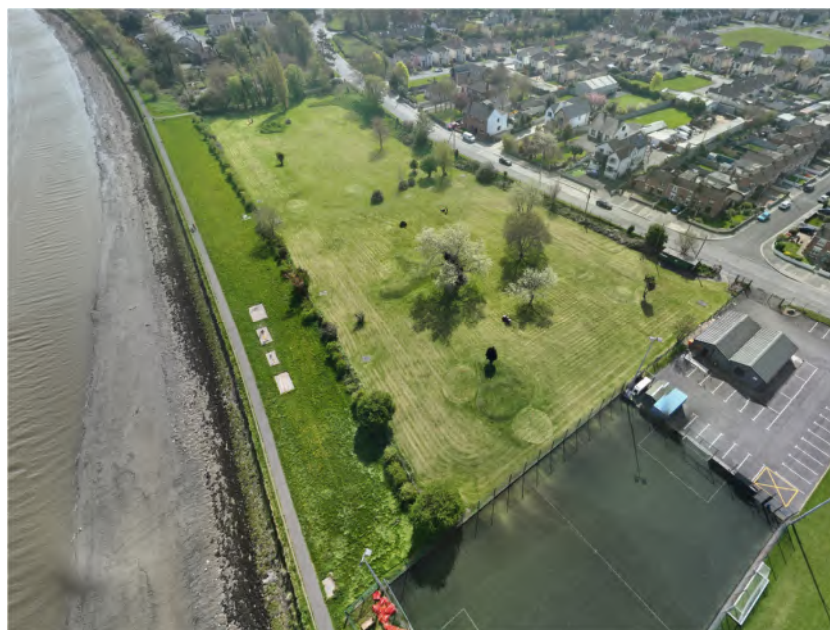
**Plate 2. UAV Aerial photograph of the proposed site at the Navvy Bank taken in April 2026 at 60m elevation to the northwest of the site facing in a south-easterly direction**

An elevated walkway, the Navvy Bank walkway runs west to east along the northern boundary of the site on the southern edge of the embankment. On the northern side of this walkway is a small wall that is approximately 400mm high. As stated, a 6m wide grassed area (i.e., referred to in this report as the Northern Land Strip) is located between the Navvy Bank walkway and the pitch and putt course. The Northern Land Strip contains a selection of outdoor fitness apparatus on its western end (see Plate 2 below).

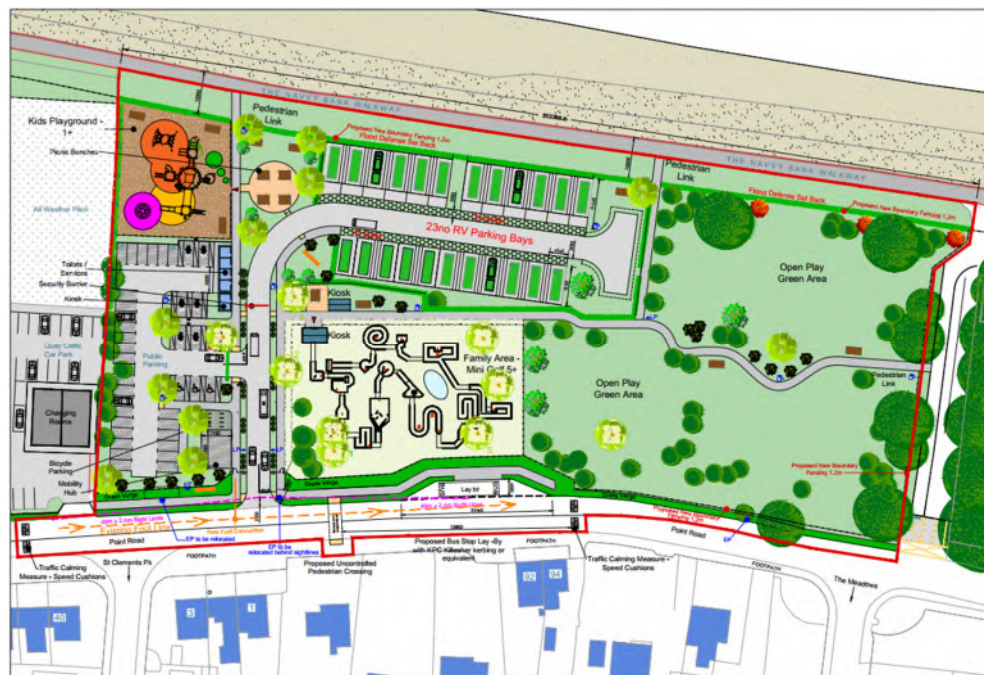
**Plate 3. Extract of Figure 12 showing the proposed site layout for the site and the surrounding ancillary works**

Other amenities proposed are two picnic areas, which are located in RV park, four toilet/services structures located to the northeast of the public park, eight bicycle parking racks in the public carpark, a mobility area to the east of the public carpark, six EV-charging parking spaces in the northeastern corner of the carpark, three blue badge parking bays, and 28 public car parking spaces (see Figure 12 and Plate 3 below).

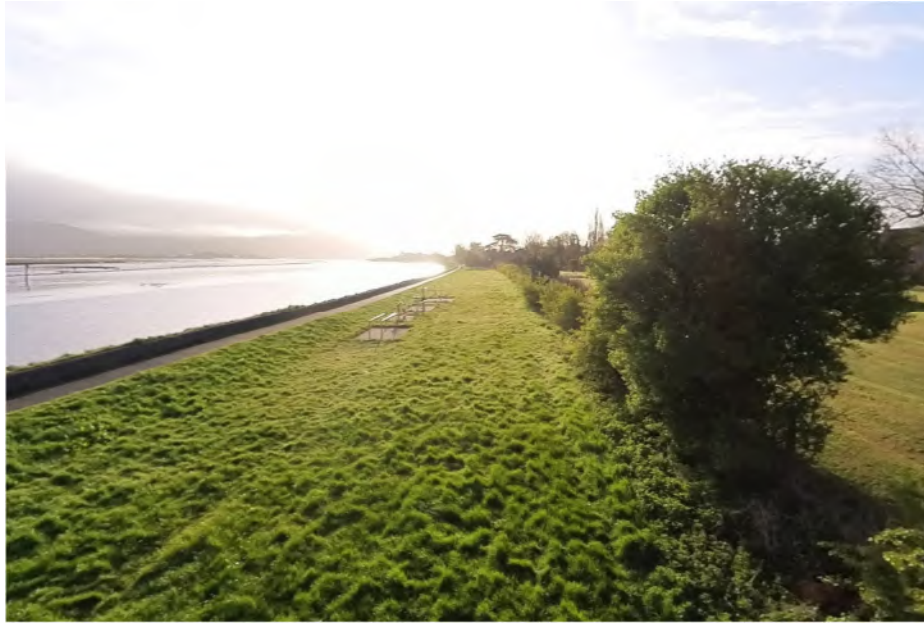
At the northern end of the site boundary, a chain-link fencing/hedgerow runs between the pitch and putt course and the Northern Land Strip, which also has an outdoor exercise apparatus on its western end (see Plate 5). The Navvy Bank Walkway runs along the north side of the Northern Land Strip. On the northern side of this walkway is a small wall that is approximately 400mm high. This walkway and wall run along the Navvy Bank embankment barrier.

**Plate 5. Ground panoramic photograph at the northern boundary of the site facing in an easterly direction (note outdoor exercise apparatus in the background)**

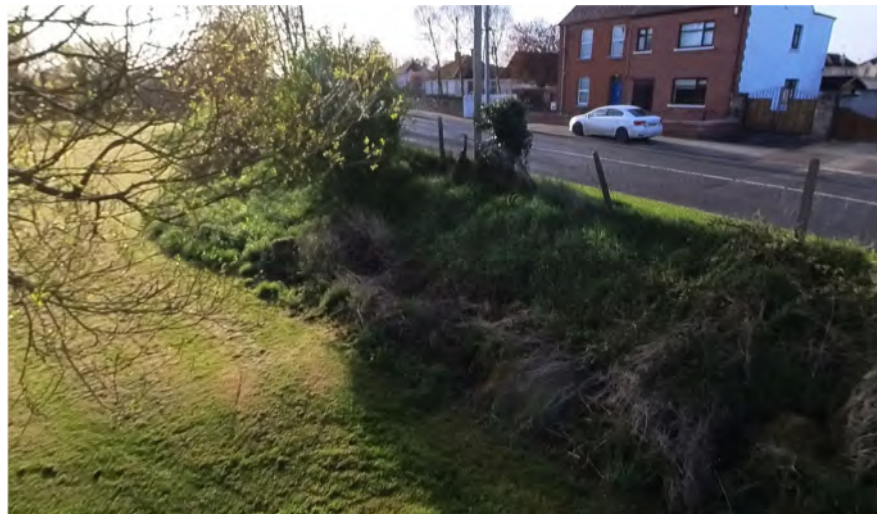
The southern boundary of the site consists of an earthen bank which slopes upwards from north to south towards the Point Road to the south (see Plate 8). The pedestrian pathway and Point Road to the south are approximately 3m higher in elevation than the pitch and putt course.

**Plate 8. Ground panoramic photograph at the southern boundary of the site facing in a southeasterly direction.**

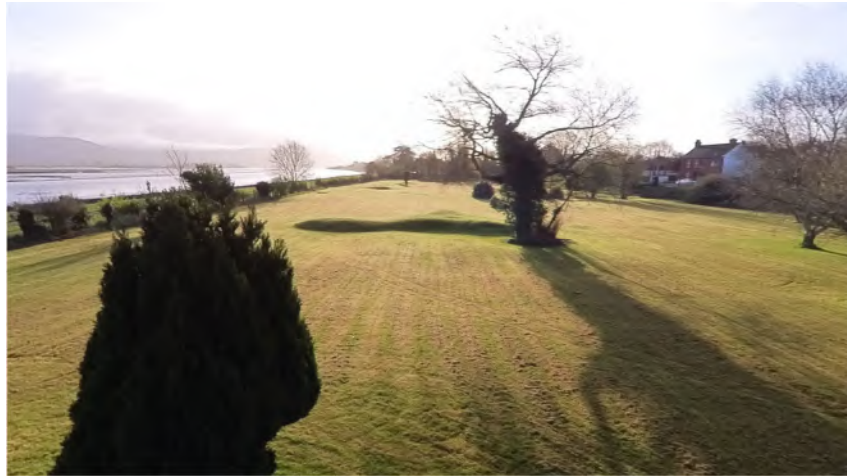
Within the site, there are several constructed mounds that are golfing features of the pitch and putt course (see Plate 9). These mounds can reach as high as 1.60 meters above the normal floor elevation level of the site.

**Plate 9. Ground panoramic photograph at the western boundary of the site facing in a easterly direction.**

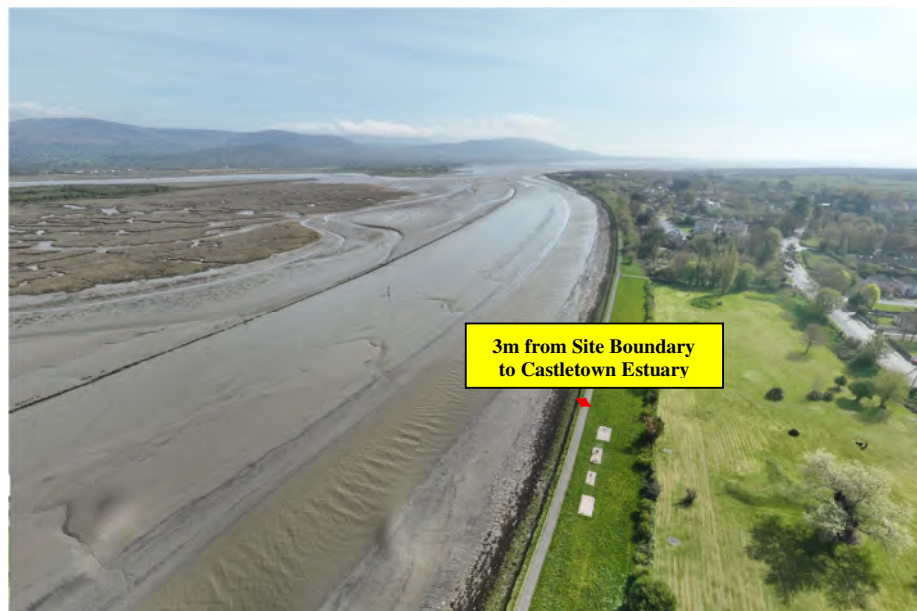
The Castletown Estuary is located 3m north of the development site boundary (see Plate 10 below). The estuary flows in an easterly direction into Inner Dundalk Bay. The Castletown river is 991.6m west of the site. This discharges into the Castletown estuary at multiple points.

**Plate 10. Aerial photograph taken in 23<sup>rd</sup> April 2026 at 60m elevation at the northwestern corner of the site facing in an easterly direction overlooking the Castletown estuary, which feeds into Inner Dundalk Bay**

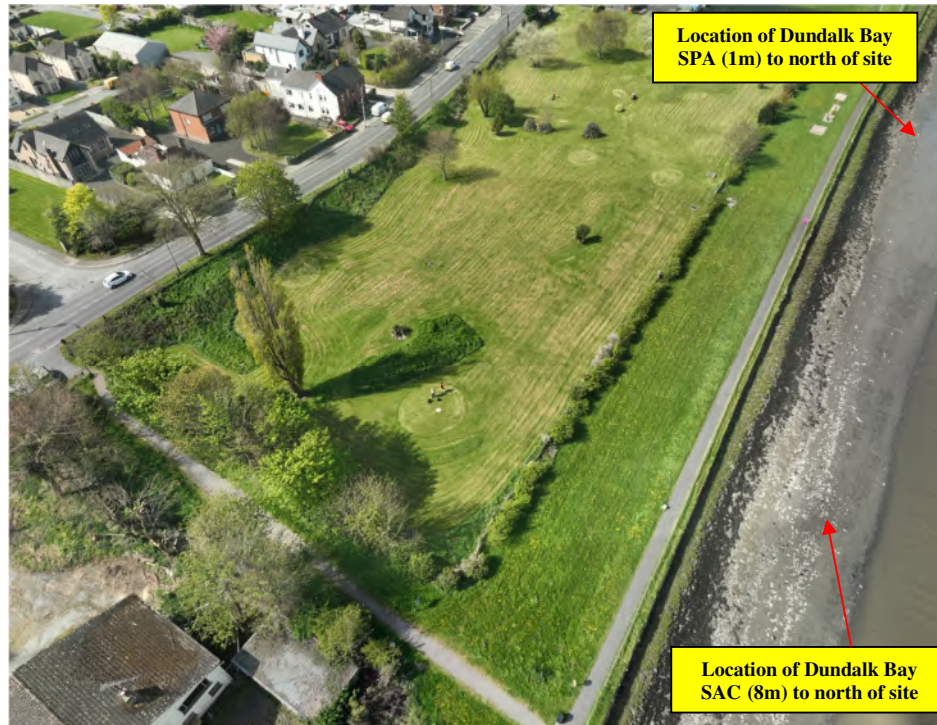
The proposed development site is approximately 9.5m to the south of the Dundalk Bay Special Area of Conservation (SAC) (No. 000455), 1m south of the Dundalk Bay Special Protected Area (SPA) (004026), 4.88km southwest of the Carlingford Mountains SAC (000453), 11.22km southwest of the Carlingford Shore SAC (002306), 12.87km southwest of Carlingford Lough SPA (004078), and 13.60km to the northeast of the Stabannan-Braganstown Special Protected Area (SPA) (No. 004091) (see Figures 1 and 2, Table 1 & Plate 13 below). The proposed development site is approximately 10.5 m from the Slieve Gullion SAC [UK 0030277] which is located in Northern Ireland.

**Plate 13. Aerial photograph taken at 60m elevation over the northeast corner of the site facing in a southwesterly direction towards the Special Area of Conservation (SAC) and Special Protection Area (SPA) boundaries on the foreshore**

An inventory of all Natura 2000 sites (i.e., Special Protected Areas and Special Areas of Conservation) has been carried out within 15km of the proposed development site (see Figures 1 and 2). No Natural Heritage Areas are within 15km of the site. The Navy Bank site is located in Dundalk, with the following Special Areas of Conservation (SAC) and Special Protection Areas (SPA) in the surrounding area, ordered from closest to furthest (see Figures 1 to 5, Table 1 & previous Plate 13):

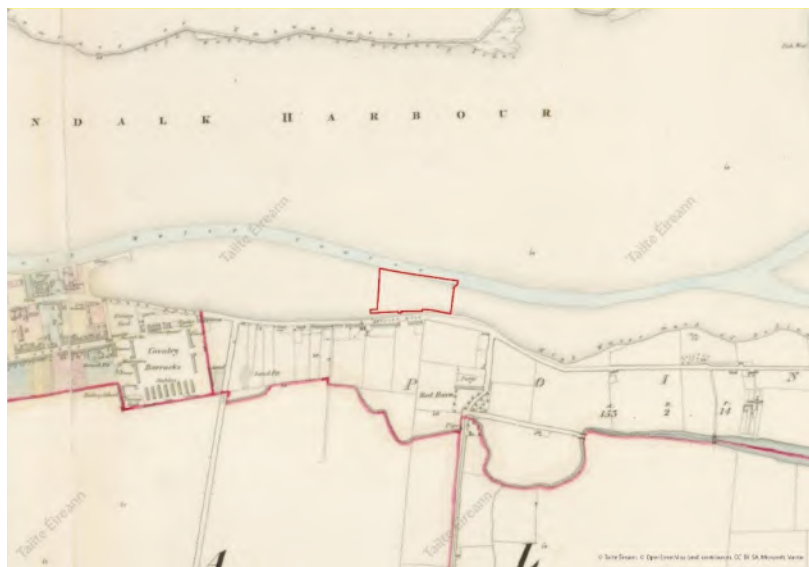
A review of 6-inch historical Ordnance Survey mapping which dates from the 1800s indicates that the site was located at that time towards the southern foreshore of Dundalk Harbour. The footprint of the site was previously located on the intertidal shoreline (see Plate 14 below). This map pre-dates the construction of The Navy Bank embankment which was constructed for flood defence purposes and to create the Dundalk Harbour navigation channel. The Point Road is visible along the southern end of the site. This road was previously named the Shore Road. The Ramparts River is visible to the south of the Point Road flowing west to east (see Plate 14 below).

**Plate 14. Extract of last Edition of 6-inch historical OS Mapping showing site along an intertidal shore (note red boundary indicates the site location)**

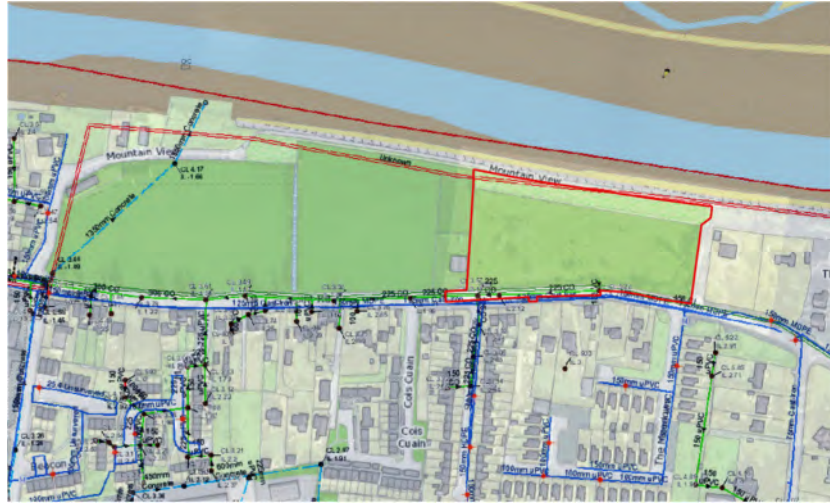
**Plate 18. Extract of Municipal drainage mapping illustrating the Combined Municipal drainage network in the vicinity of the site (note red rectangle represents the outline of the site)**

The properties surrounding the pitch and putt site discharge their foulwater by gravity into a Combined Municipal Sewer which is located under the Point Road flowing east to west (see green pipeline on Plate 17 below and Figure 11). A collection sump/pumping station is located to the west of the site which collects sewage from the surrounding combined and foul sewers and then pumps the sewage into a pressurised rising main which delivers the raw sewage to the Soldiers Point Wastewater Treatment Plant. This pressurised foul rising mains (see double red line pipeline) passes through the northern end of the site pumping sewage to the Soldier's Point Wastewater Treatment Plant located approximately 930m directly to the east of the site.

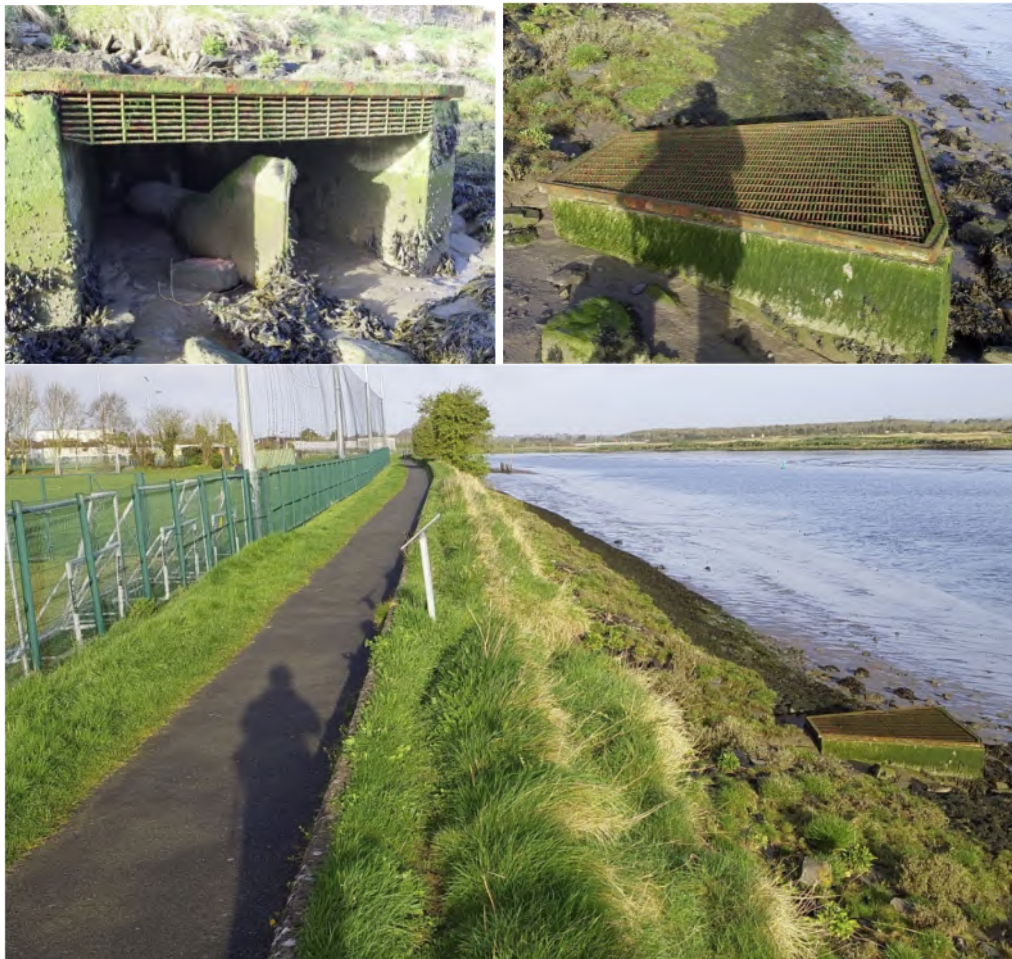
**Plate 21. Various ground photographs of the Stormwater Outfall on foreshore to the north of Quay Celtic F.C.**

A stormwater outfall is located approximately 12m to the west of the site which discharges on to the foreshore (see Plate 21 below). This stormwater drain, which is fitted with a non-return valve, appears to run south to north directly under the Quay Celtic property to the west of the site.

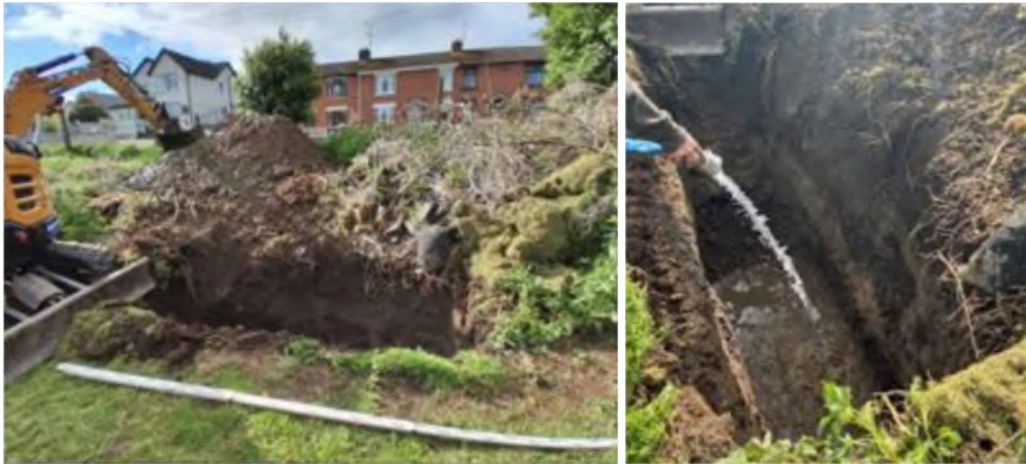
**Plate 22. Ground photographs of trialpitting and BRE365 testing carried out to the south of the pitch and putt course to determine the suitability for a SuDS system**

The infiltration characteristics of the underlying sub-soil at the site was determined by excavating a test hole 1.8m deep trial hole within the site on the 28<sup>th</sup> of April 2026 and carrying out an infiltration test in accordance with BRE 36. The trial pit was located within the site, in the southwest corner (see Plate 23 below).

No rock was encountered within the 1.8m deep test hole. However, some infiltration of groundwater did occur at a depth of 1.6m. The testing indicated that the underlying unsaturated layer of sub-soil has good infiltration characteristics with an estimated infiltration rate value of  $3.28 \times 10^{-5}$  m/s. It is proposed to apply a Factor of Safety = 1.5 to this calculated value in view of the uncertainty surrounding the determination of the infiltration co-efficient from a single test as recommended in the CIRIA SuDS Manual. The infiltration rate to be used in the design of all SUDS features is  $3.28 \times 10^{-5} / 1.5 = 2.2 \times 10^{-5}$  m/s or 80mm/hr.

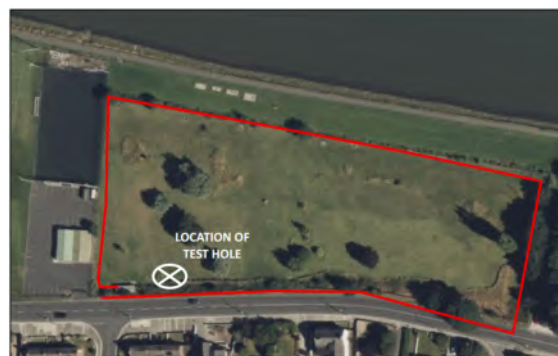
**Plate 23. Location of trialpitting and BRE365 testing carried out to the southwest of the pitch and putt course**

The subsoil in this area was found to comprise of the following strata:

- 0 – 0.30m - Topsoil;
- 0.3m – 1.6m - Stiff sand; and
- 1.6m – 1.8m - Loose sandy gravel.

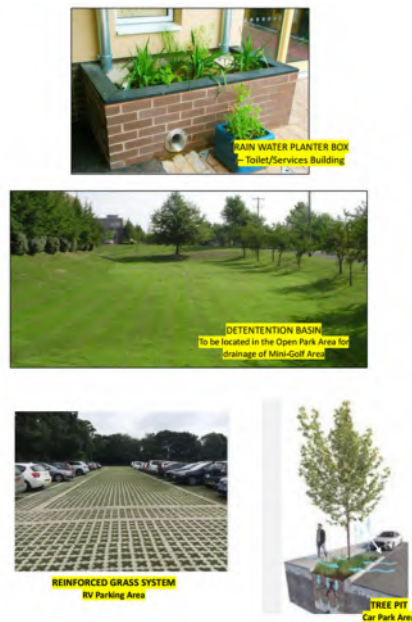
**Plate 26. Proposed Nature Based Solutions for Stormwater/Surface Water Management**

Representative views of some of the recommended Nature Based Solutions are shown on Plate 26 below and Plate 27 following.

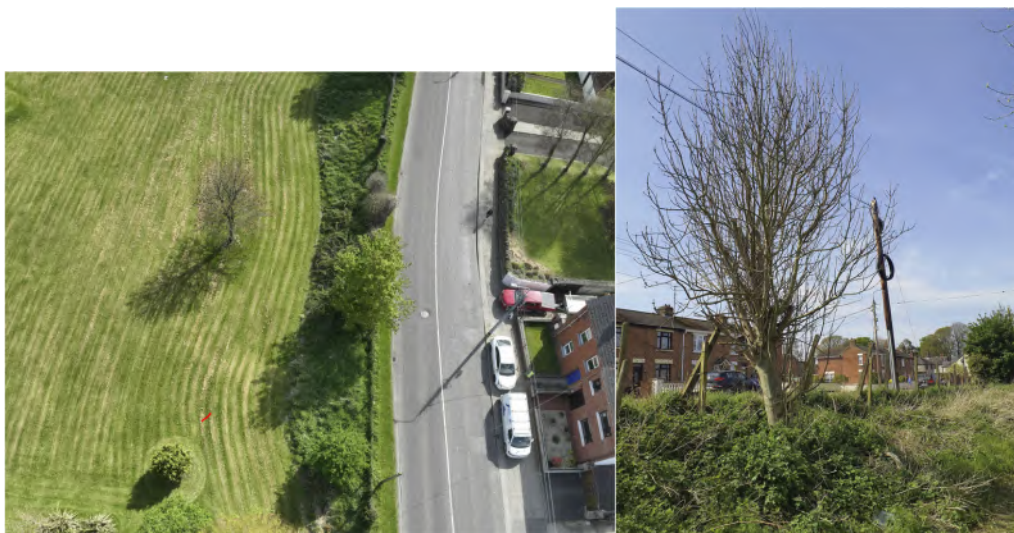
Earth Banks (BL2) are narrow, steep ridges which are commonly utilised as a boundary feature and are typically manmade constructions consisting of local materials such as peat, earth, gravel, or stone. They are usually completely covered in vegetation, consisting primarily of common grasses, broadleaf herbs, wildflowers, and occasional shrubs or trees. An earth bank forms the border between the proposed development site and the Point Road to the south (see Figure 8 and Plate 42 below).

**Plate 42. Aerial photograph taken at 40m above ground level on the southern boundary of the site facing in an easterly direction showing the Earth Bank boundary adjacent to the Point Road and ground photograph showing the vegetation growing within the Earth Bank habitat**

This habitat is bounded at its southern edge by a chain-link fence. The bank (BL2) is wide and increases in width towards the eastern end (see Figure 8).

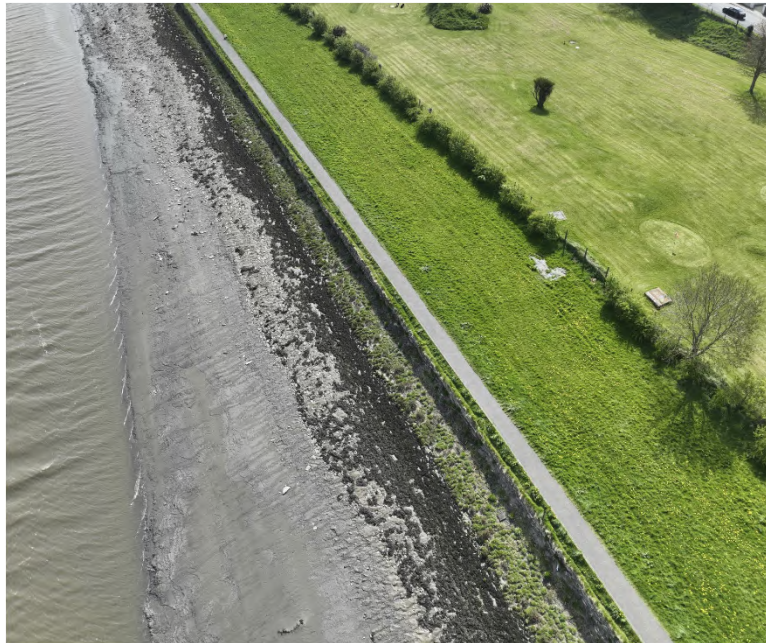
**Plate 46. Aerial photograph taken at 40m above ground level at the northern boundary of the site facing in an easterly direction showing the MW4-Estuarines Habitat located on the foreshore**

The Castletown Estuary lies approximately 3m north of the northern site boundary (see Plate 46 following). While no estuarine habitat occurs within the site itself, its proximity means that the northern boundary and adjacent habitats may experience indirect influences, such as tidal flooding, salt spray, and enhanced invertebrate and bird activity associated with the estuary. The Castletown Estuary supports a mix of mudflats, saltmarsh, and tidal channels that provide important feeding and roosting areas for waterbirds, as well as nursery habitat for estuarine fish species.
