Archaeology
IRELAND

Heritage Guide No. 84

**CARLINGFORD
PRIORY**

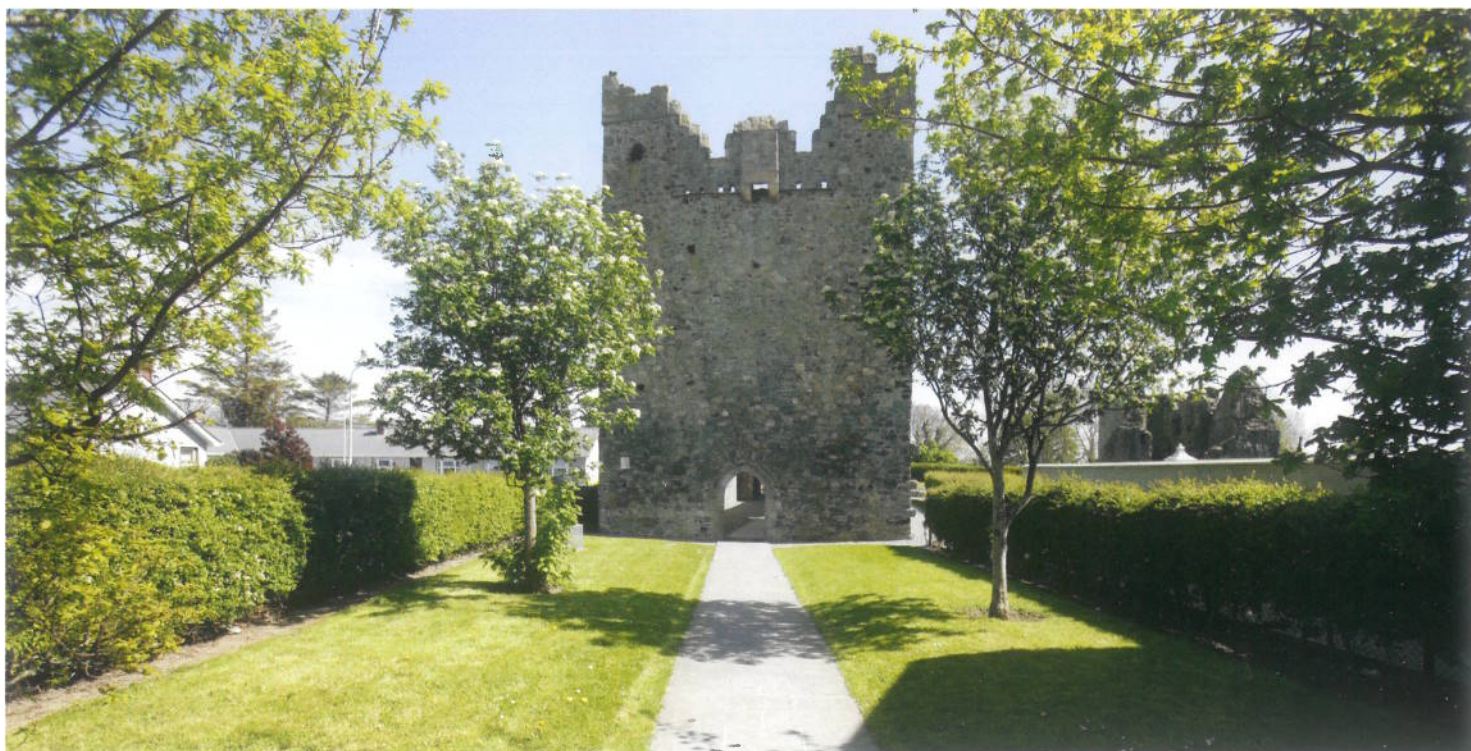
Below: **View of fortified portion of the nave, showing the crenellated west wall, a machicolation above the arched doorway and the added corner towers.**

Being on the frontier between Gaelic Ireland and the Pale, Carlingford was often subject to attack, resulting in the fortification of the priory. Crenellations were added to the west wall and small towers built at the south-west and north-west corners of the nave. In the west wall there are the remains of a two-centred rounded arched window. There are three large windows in the northern side wall, with a smaller one higher up on the eastern end of this wall. There are also the remains of three small windows high up in the nave's south wall. At the east end of the south wall there is a small niche with a high, narrow, inverted V-shaped arch.

A series of square holes in the walls indicates that at some time there were wooden structures inside and outside this building—for example, to support the roof of the cloister walk on the south side, of which no other evidence is visible. The present entrance to the priory is from the street through an original arched doorway, surrounded by medieval stonework, in the west wall. Above this is a machicolation resting on two corbels, part of the later defensive works. The outline of a (blocked-up) window is also visible above this door.

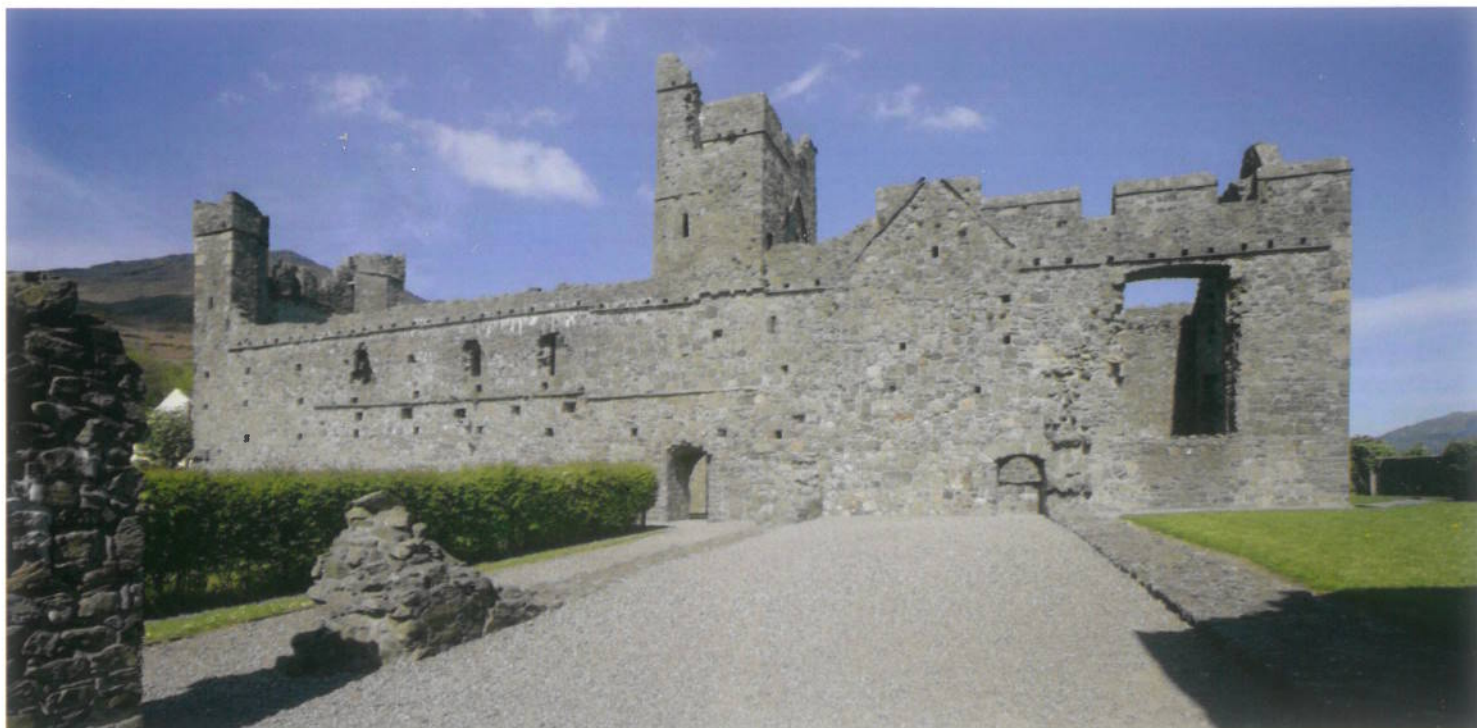
Top: **View of the south wall of the church, showing large flat-headed window and doorways leading to nave and chancel. The external string-course along the western portion of the south wall marks the position of the cloister roof. The gable lines of the east range can be seen to the right of the south wall.**

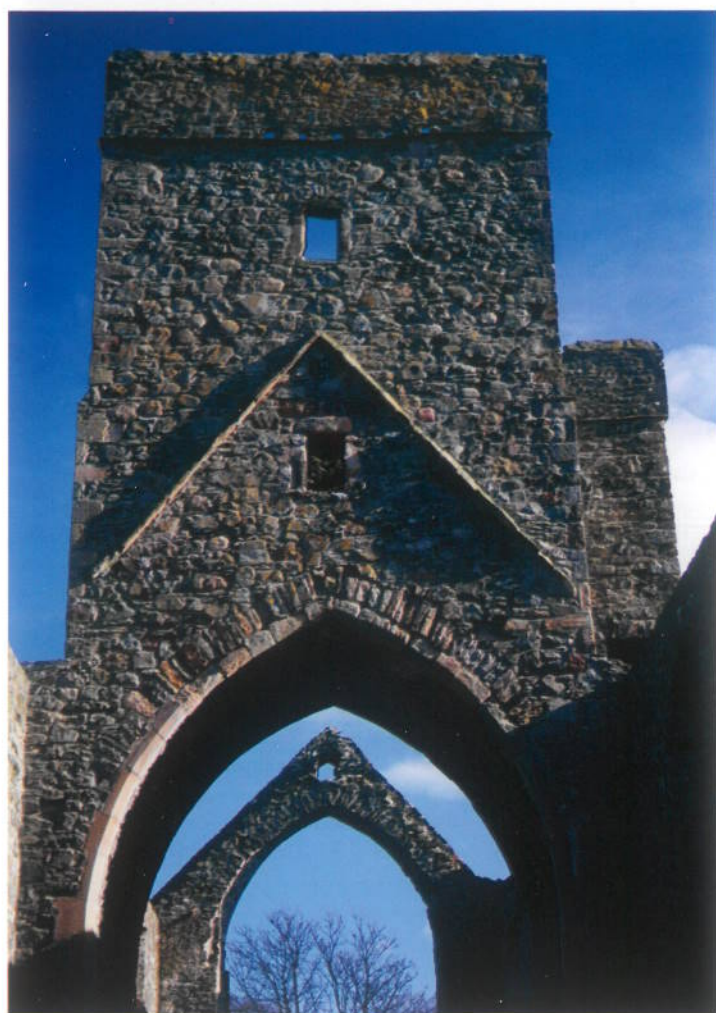
Above: **The central tower and the eastern gable, viewed from the west** (Chris Corlett).

The central tower is a later addition, probably dating from the first half of the fifteenth century. It is rectangular, with the remains of a stairwell in its south-east angle. It has two floor levels above the arch, with rectangular openings in the western and eastern façades at the lower level and in the upper at the west side. Access to the tower was gained from the first-floor level of the domestic range, which adjoined the south side of the chancel via a doorway (now blocked).

There must also have been access to the chancel via stairs from the first-floor level and from the domestic range. A limestone corbel at the first-floor level indicates the former existence of a wooden gallery and stairs, which would have led to the choir. The rectangular openings would have been doorways giving entrance to the lofts over the nave and chancel. In the east and west walls of the tower can be seen the original line of roofs. Below the south side of the tower a doorway leads outside.

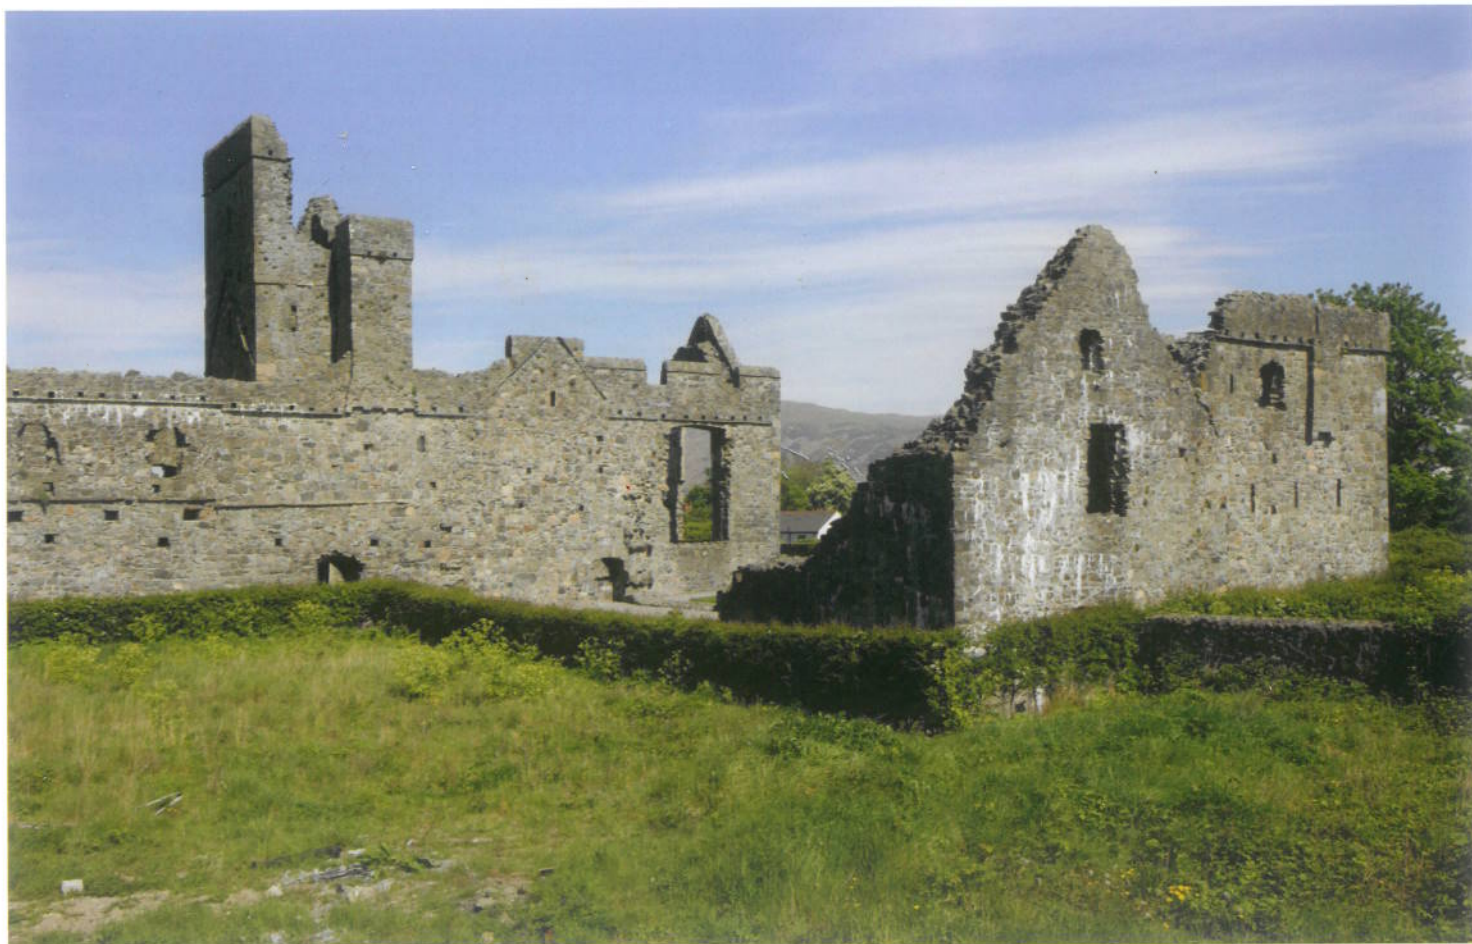
Above: **View of the surviving portion of the priory's domestic buildings, which would have extended northwards to join the chancel. A tower-house-like addition is located on the right of the domestic gable.**

Situated about 20m south of the main building are the remains of what would have been the priory's domestic buildings, clearly consisting of two parts. The eastern part is butted against the remnants of the western building, indicating that it was added on at a later date (probably by Nicholas Bagenal). This eastern building is the one that resembles a tower-house and has a combination of slit and rectangular windows. The other half is what remains of the priory's domestic range and consists only of the southern gable wall with the remnants of another wall at right angles to it, in which there is the lower half of a doorway. The *Archaeological Survey of County Louth* (1991, 236) states that the standing gable has 'a window which was later converted into a fireplace', although there is no sign of this now. Originally the domestic range would have extended northwards to join onto the chancel, fitting the standard pattern of a Dominican priory.
