Draft Louth County Development Plan 2021-2027

No 18. Ship Street

Condition Report No.18 Ship Street.

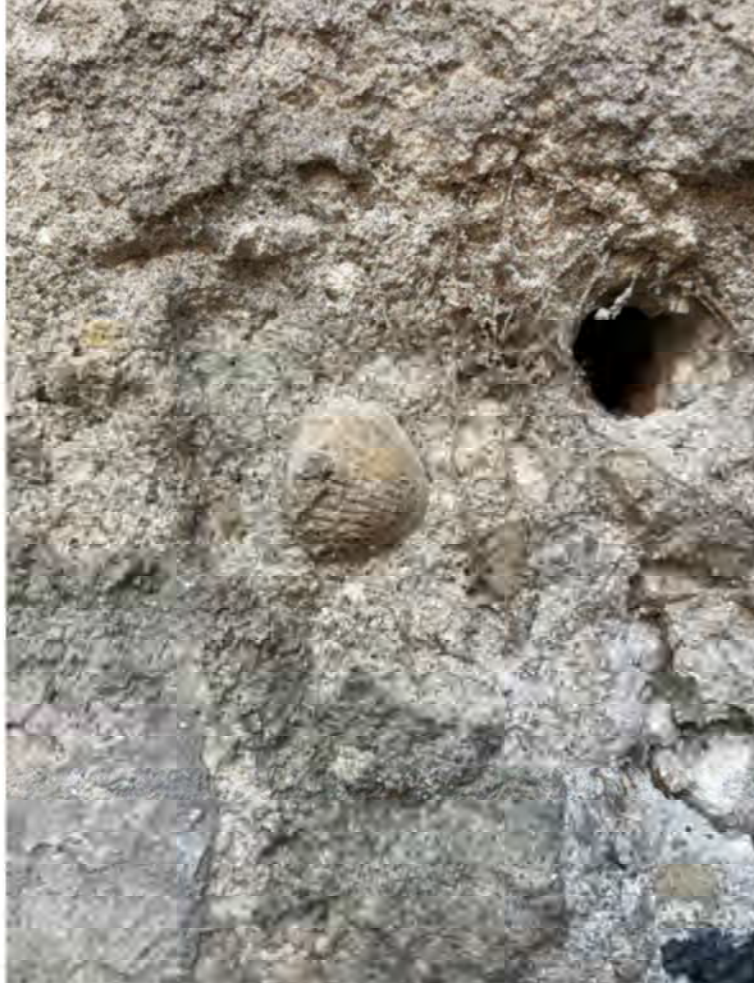
Plate 0.15
View of local sea shells forming part of the aggregate within the original lime plaster
