Submission to Draft Louth County Development Plan 2021-2027

BOYNE COTTAGE CONSERVATION APPRAISAL

**Conservation Appraisal
in respect of
Protected Structure Designation
of
Boyne Cottage
Cord Road
Drogheda
Co. Louth**

Architectural Inventory and Photographic Survey - Boyne Cottage

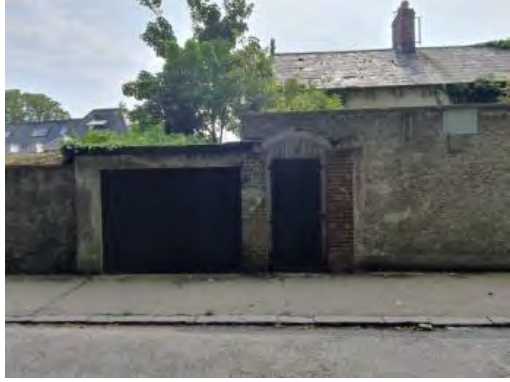
<p>20thC garage and pedestrian entrance from Chord Road</p>	
<p>Eastern Facade</p>

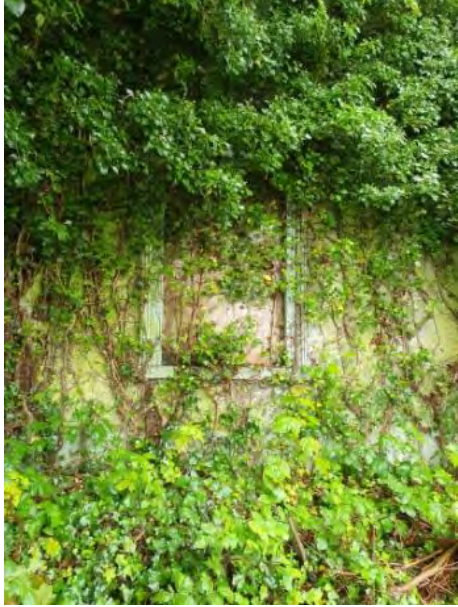
<p>Western Facade</p>

<p>Natural slate roof with rows of decorative scalloped slates. Brick chimneys. Timber fascias on twin masonry brackets. Pierced decorative barge boards to gables. Walls are pebbledashed (20th C). Moulded plastered reveals to windows. Cast vermiculated quoins. Stone window cills. Replacement aluminium windows 19th C cast iron railings on masonry base.</p>	<p>This facade is overgrown and obscured by ivy.</p>
