Louth County Council

**Declaration In accordance with Part IV, Section 57 (2) of the Local Government
(Planning and Development) Act, 2000(as amended).**

REF: DB21-03
Applicant's Name: Pillardale Limited
Status: Owner occupied
Location: 8 and 9 St Laurence Street, Drogheda, Co. Louth

8 LAURENCE STREET, DROGHEDA, CO. LOUTH STRUCTURAL REPORT

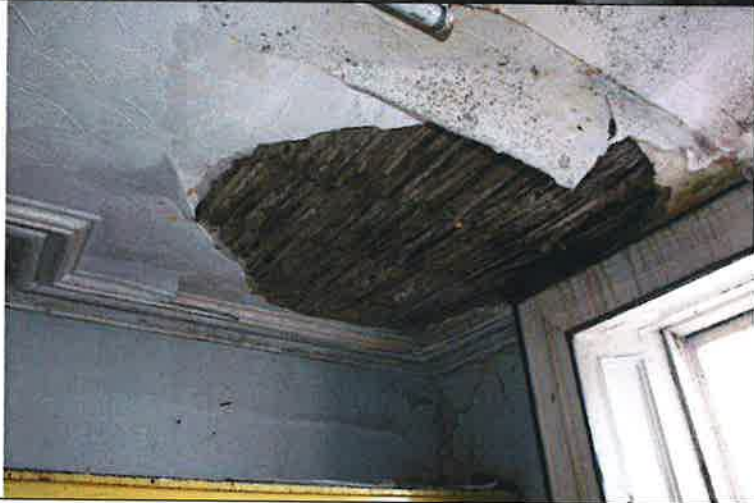
Second floor front room (5234)

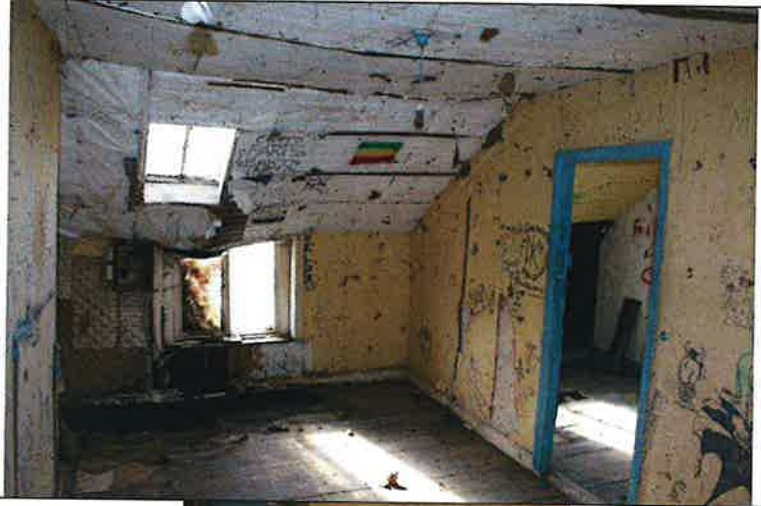
Third (attic floor) rear. (5227)

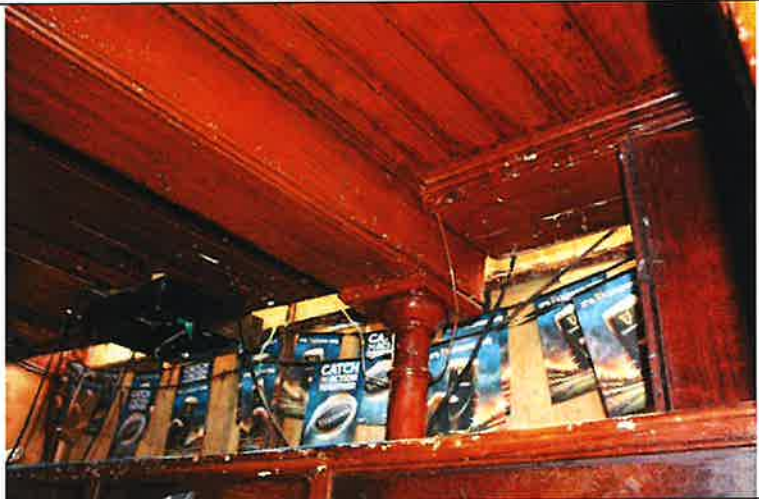
Tongued, grooved and rounded boarding of ceiling. (3947)
