Louth County Council

**Declaration In accordance with Part IV, Section 57 (2) of the Local Government
(Planning and Development) Act, 2000(as amended).**

REF: DB21-03
Applicant's Name: Pillardale Limited
Status: Owner occupied
Location: 8 and 9 St Laurence Street, Drogheda, Co. Louth

8 LAURENCE STREET, DROGHEDA, CO. LOUTH STRUCTURAL REPORT

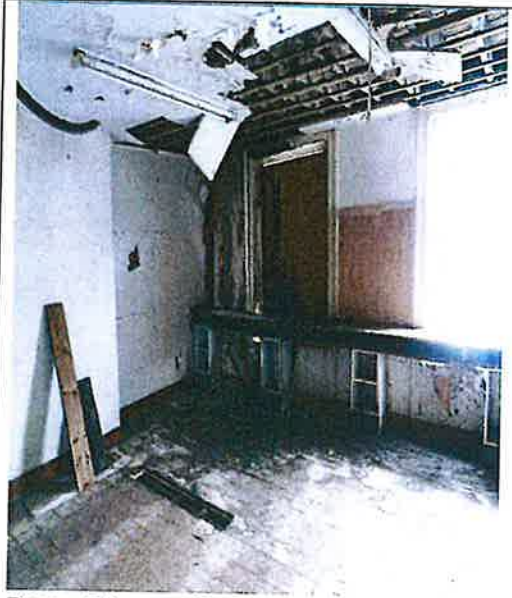
FIGURE 5 THIRD FLOOR ROTTEN RAFTERS AND HEAD

1. Remove vegetation and repoint the front wall.
2. Replace the rotten rafters ends and timber heads at Third Floor level.
3. Insert ridge purlin, if not present.
4. Expose the joint ends at all floors to check for rot.
5. Expose the First-Floor support mechanism for the party walls.

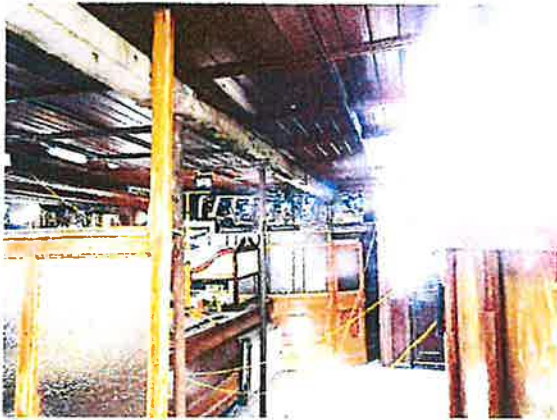
Figure 1 Timber Beam

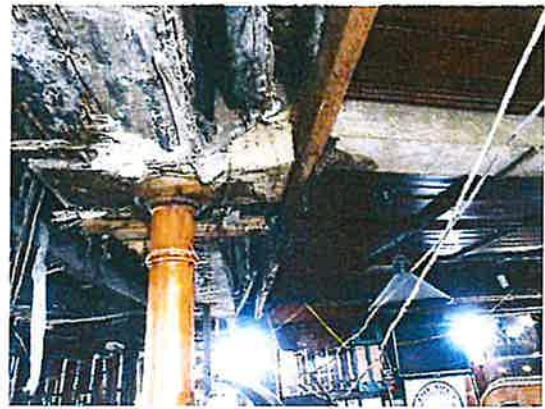
Figure 2 Timber Beams

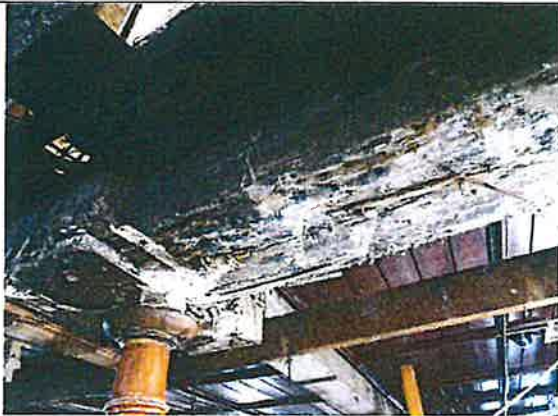
Figure 3 Timber Beam

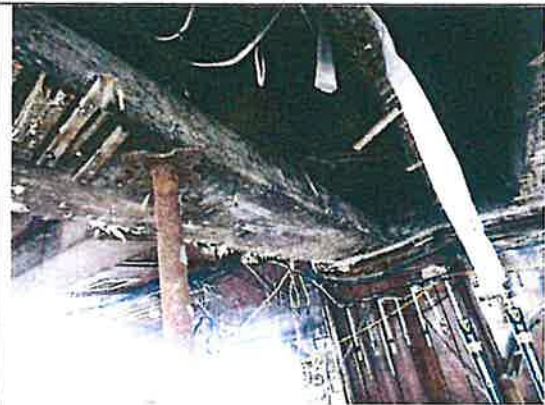
Figure 4 Timber Beam

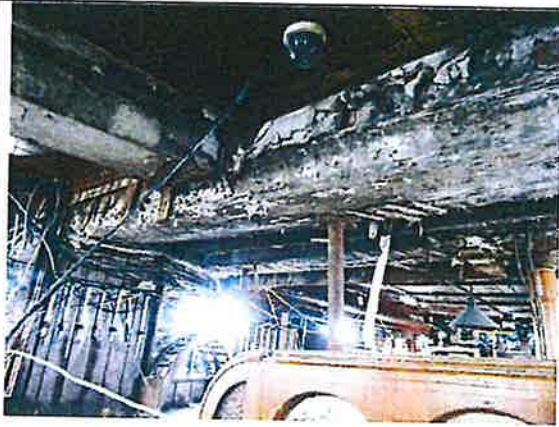
Figure 5 Timber Beam

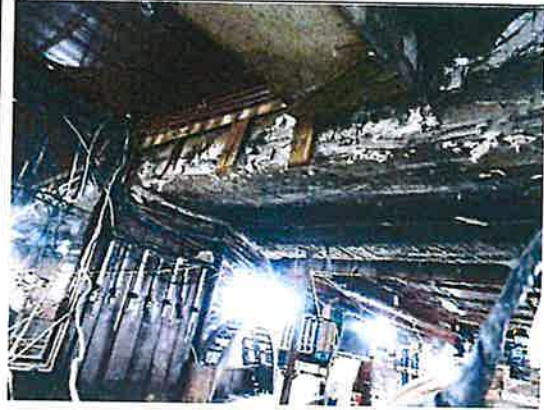
Figure 6 Timber Beam

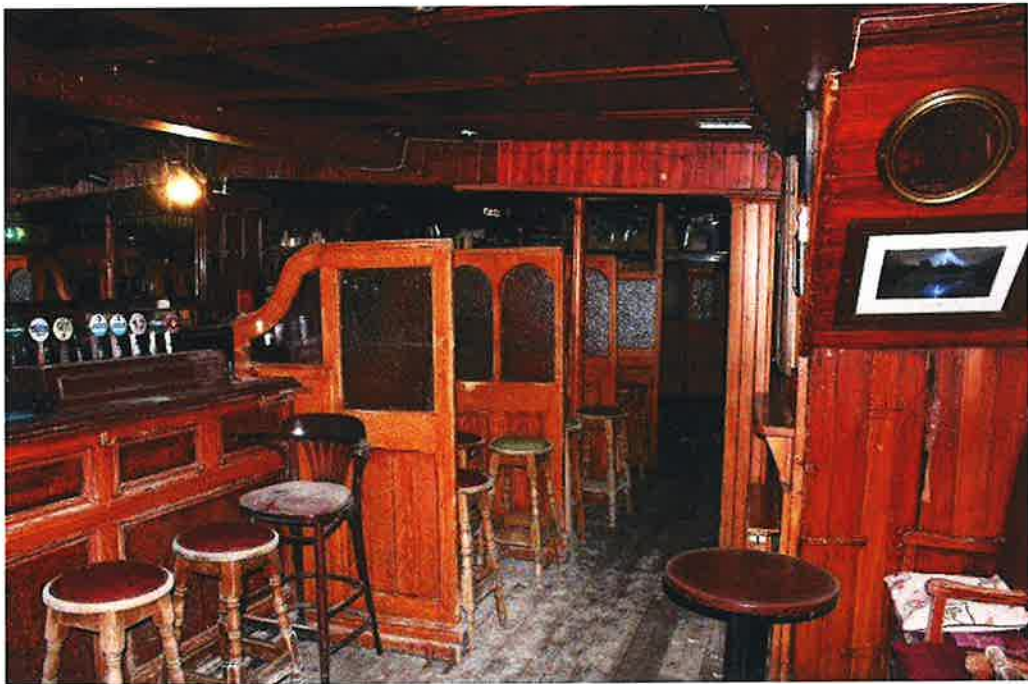
Figure 7: Ground floor bar.(3777)

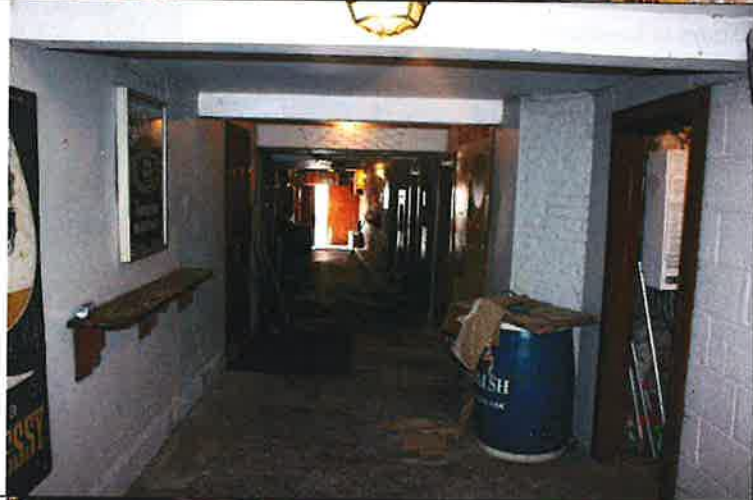
View of bar room from the front. (3722)

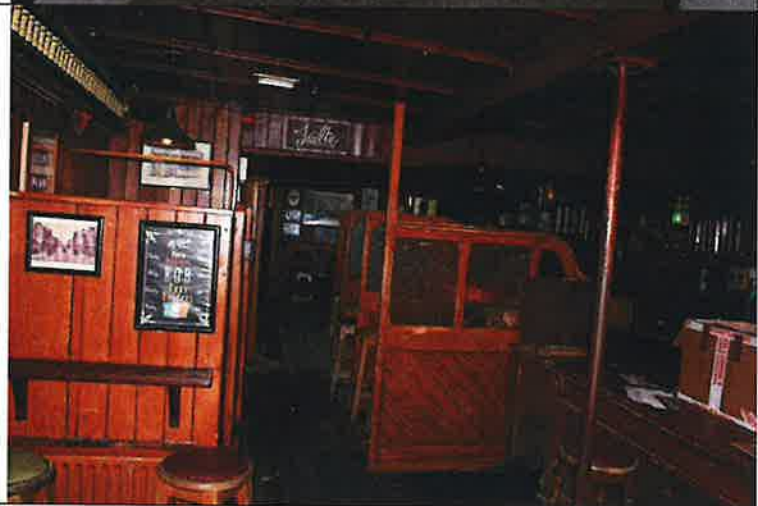
Snug. (3773)

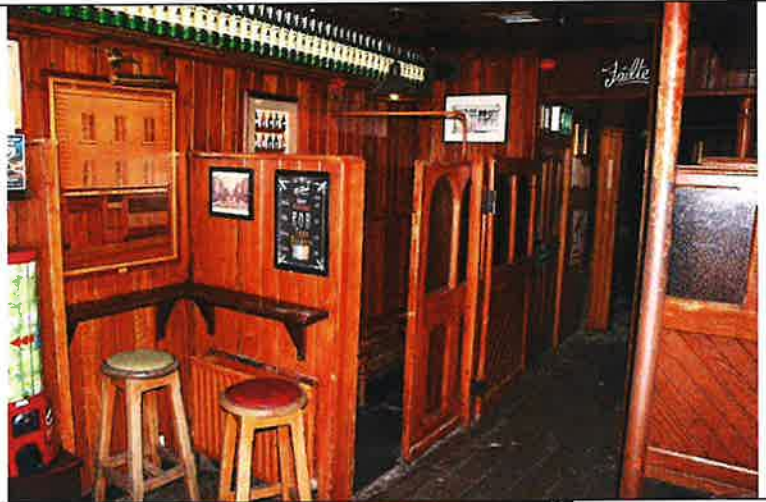
Snug. (3800)

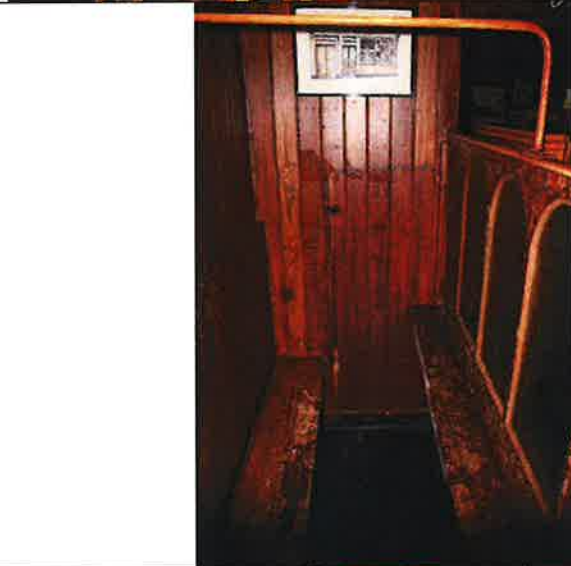
*View of the bar from rear.
(3777)*

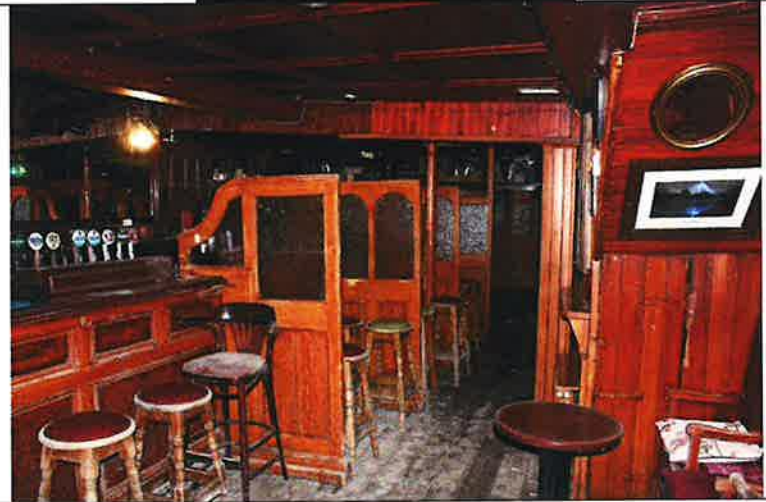
Rear of the bar. (3776)

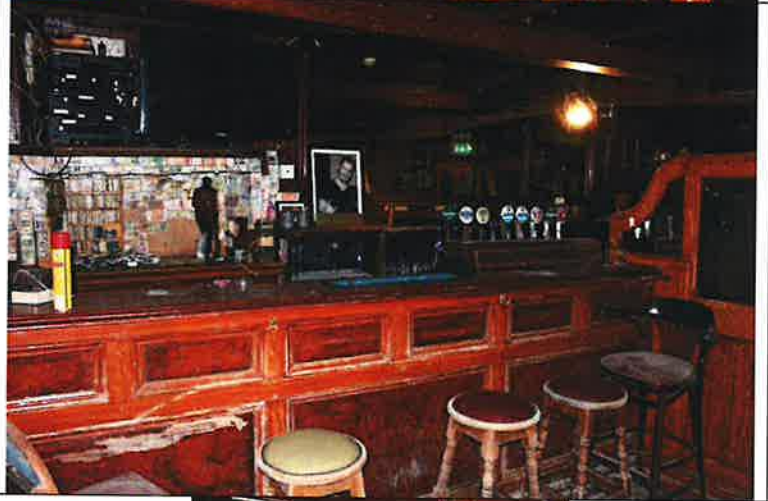
Behind the counter. (3794)

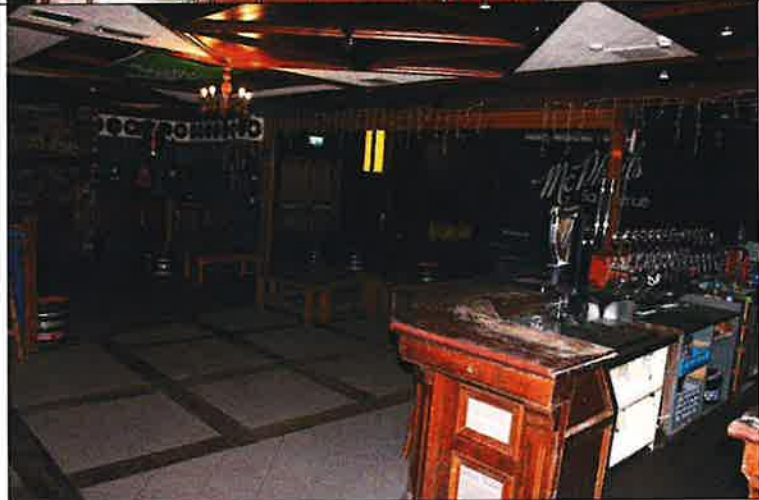
*Modern extension to the bar.
There are no features of note.
(3784)*

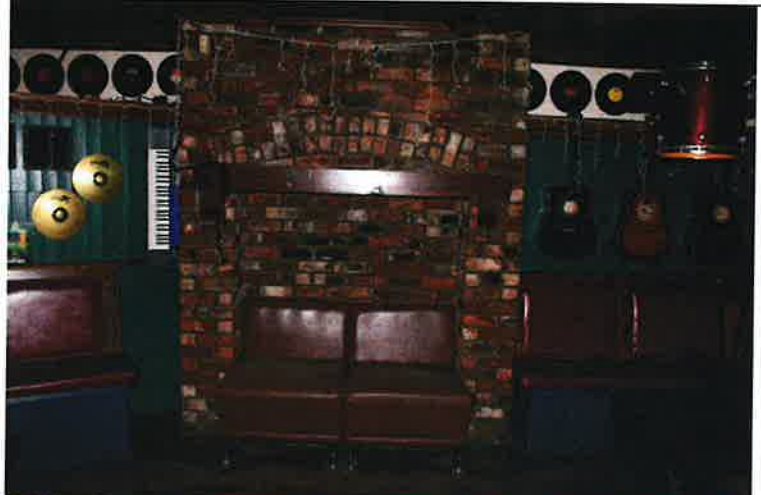
*Modern extension to the bar.
There are no features of note.
(3786)*

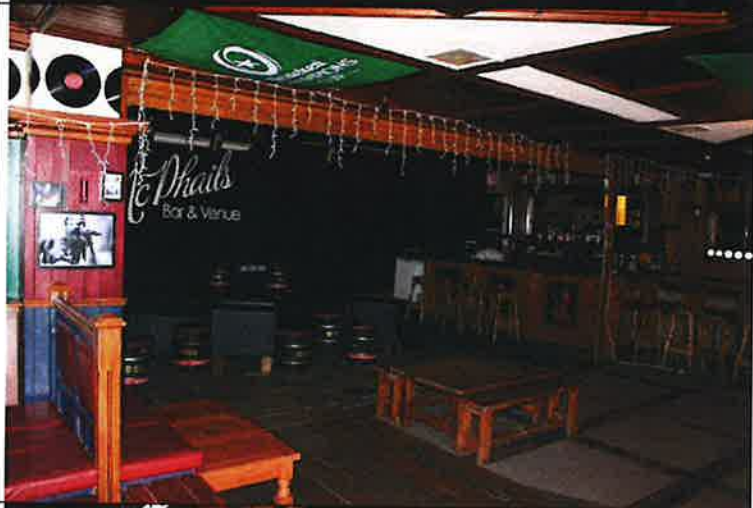
*Modern extension to the bar.
There are no features of note.
(3787)*

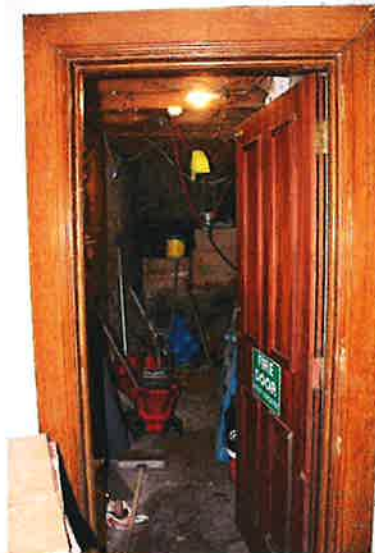
Door surround and four-panel door. (3742)

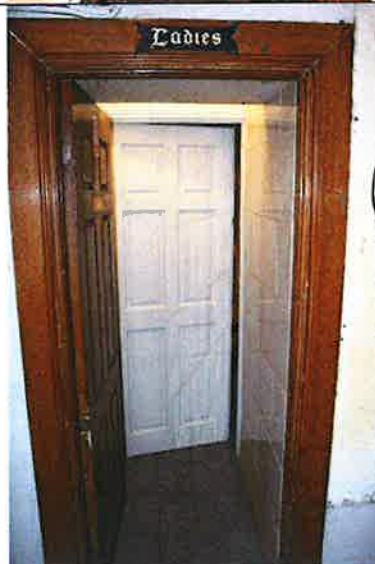
Toilets. There are no features of note. (3809)

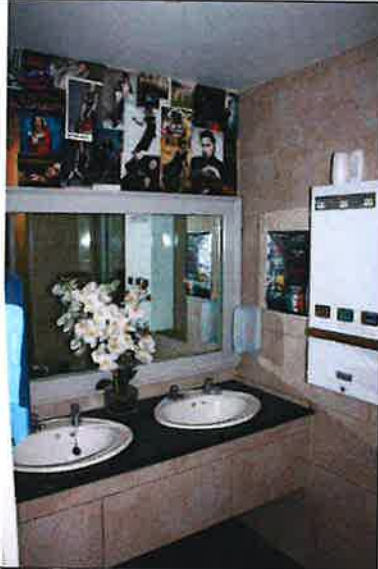
Toilets. There are no features of note. (3808)

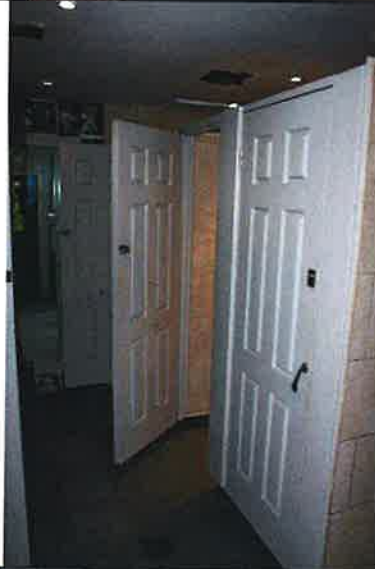
Toilets. There are no features of note. (3807)

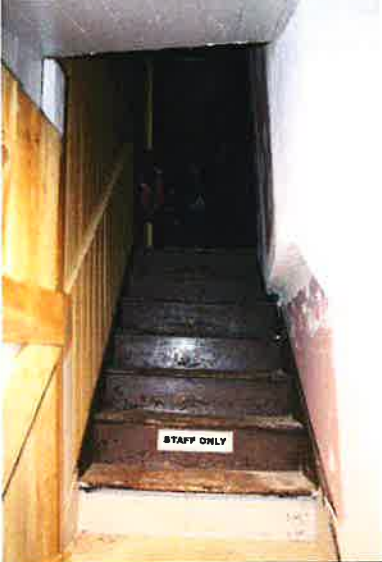
<p><i>Stairs with early Balustrade. (3748)</i></p>

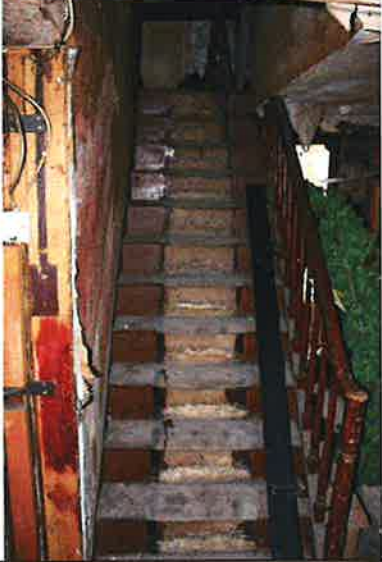
Figure 8: First and second floors and note the second floor is missing.(3754)

<p><i>First and second floors. The second floor has been removed, there are four two-over-two paned sash windows and surrounds. There are no other features of note. (3754)</i></p>

The proposed repair is considered to have a **Direct Positive Impact** as it will save a building of heritage importance from endangerment.

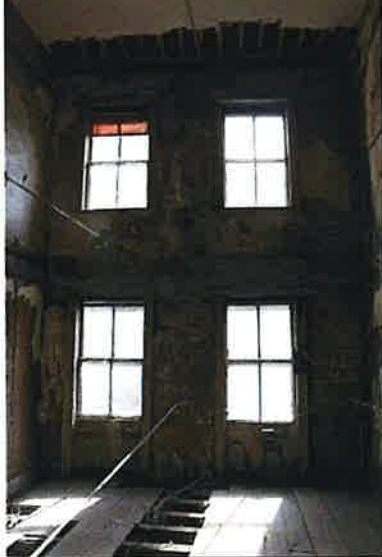
First and second floors. The second floor has been removed, there are four two-over-two paned sash windows and surrounds. There are no other features of note. Note ties to the front wall. (3756)

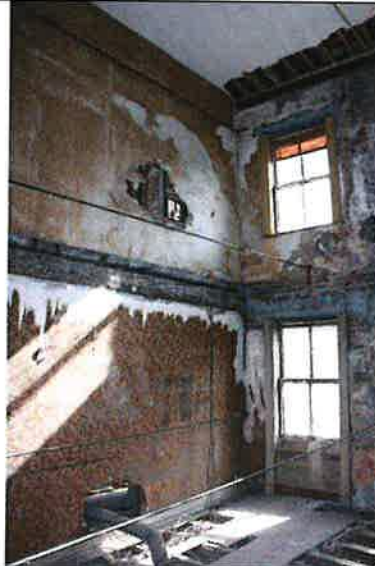
Rear wall and chimney breasts. (3811)

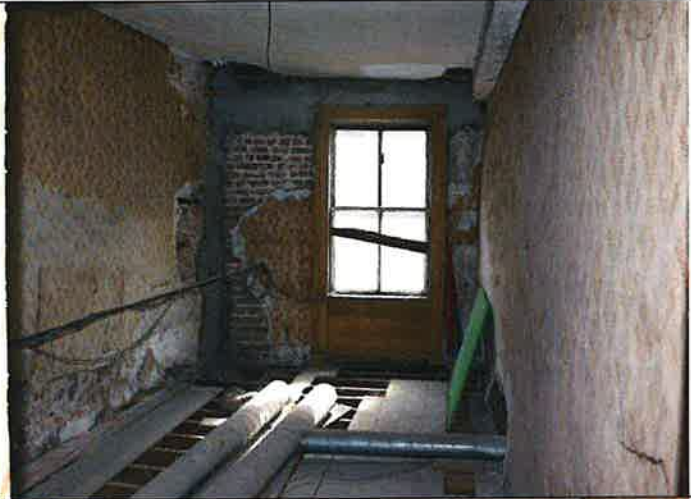
Smaller room on the first floor. (3764)
